EXPERT REPORT (PART 2)

CAPTAIN NIGEL R PRYKE

Expert Witness appointed by the Commission of Inquiry
into the Collision of Vessels
near Lamma Island on 1 October 2012

3 March 2013

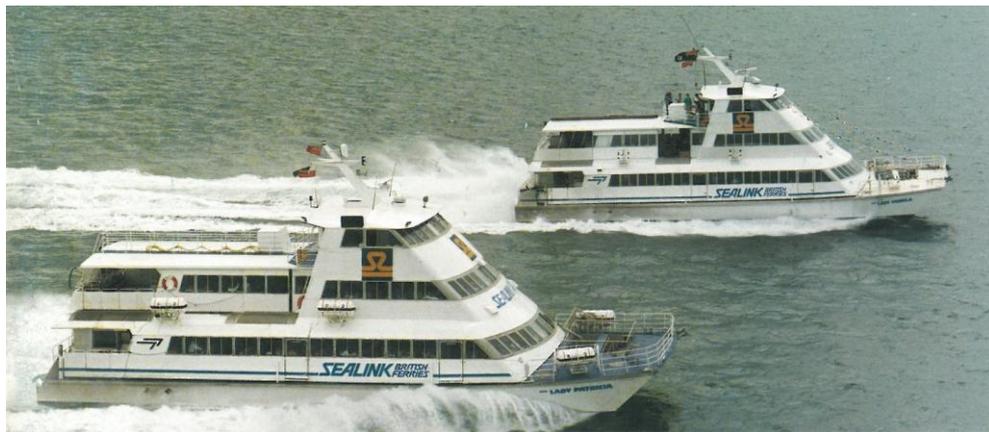
Photograph 1 of “Our Lady Patricia” and “Our Lady Pamela”
which I introduced in 1986.

65. I believe that all vessels carrying more than 12 passengers should be required to carry liferafts sufficient to accommodate all persons on board if the voyage extends beyond Victoria Harbour. This is not just because of lifesaving in the event of collision or grounding but also in the event of fire. I realise that there is currently no such requirement in Hong Kong legislation¹⁶⁷. **Photograph 1** below shows two local high speed ferry vessels (which are very similar to “Sea Smooth”) I managed the introduction of in 1986 on the route from Portsmouth Harbour to Ryde Isle of Wight.

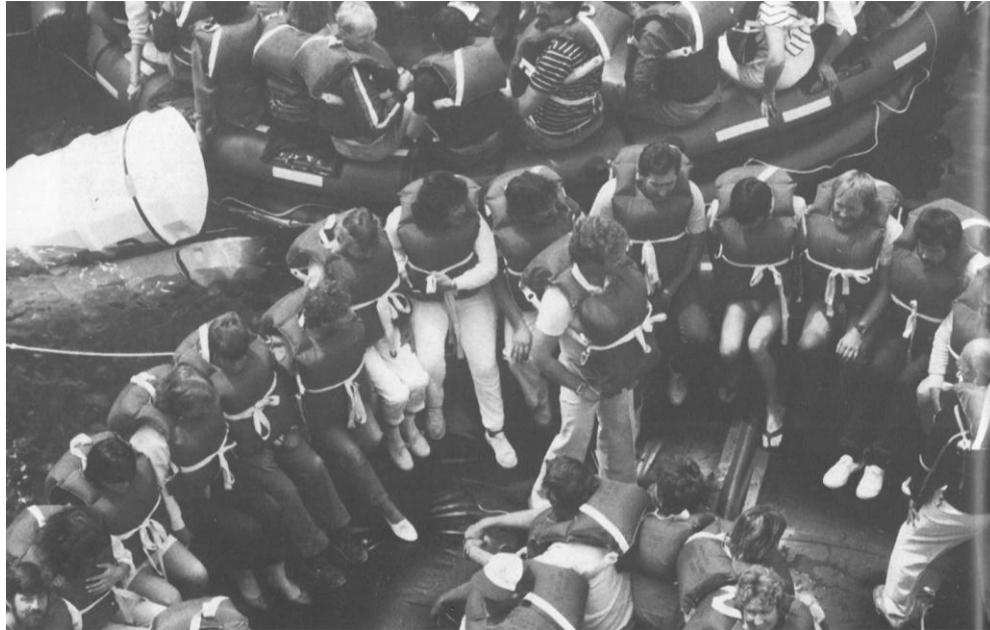
Photograph 2 of liferafts used during evacuation of “Our Lady Patricia”.

66. In my view, in line with “*the evolution of the regime concerning life-saving appliances for local vessels*”¹⁶⁸, consideration should be given to the provision of liferafts for all persons on board in respect of longer voyages. **Photograph 2** shows the liferafts used in the mass evacuation exercise of “Our Lady Patricia”.

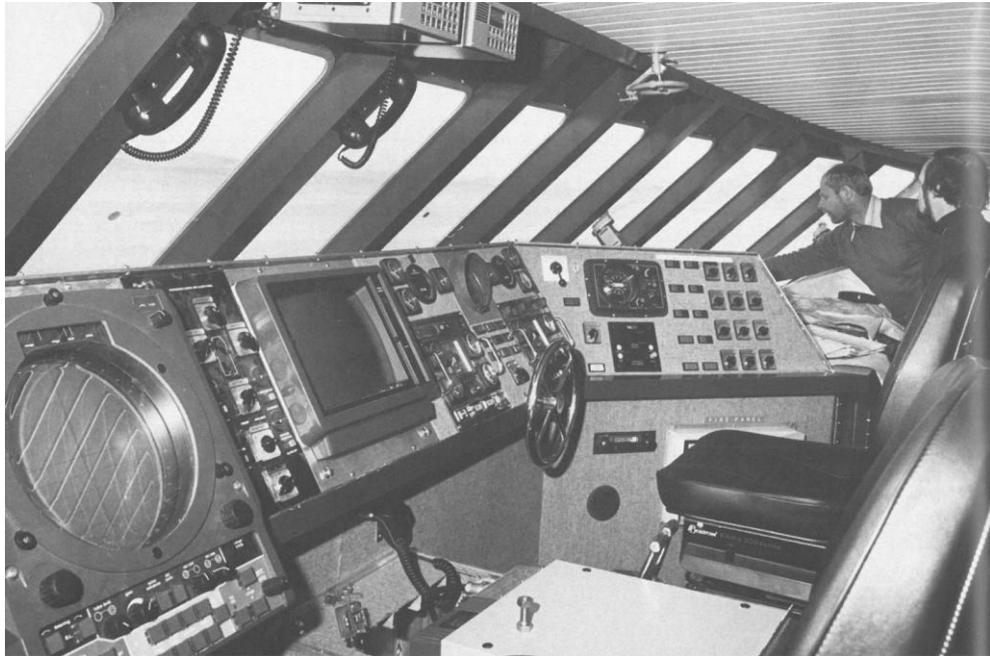
Photograph 3 showing the bridge of “Our Lady Patricia” which has 2 operating seats, 2 radar sets and 2 VHF sets.

74. In vessels carrying more than 100 passengers, appropriate use must be made of VHF radio, radar, AIS and any other navigation equipment provided. All such vessels must ensure that radar operators are properly trained. For coxswains of local high speed craft, I would suggest a requirement for a high speed radar simulator course¹⁹¹.

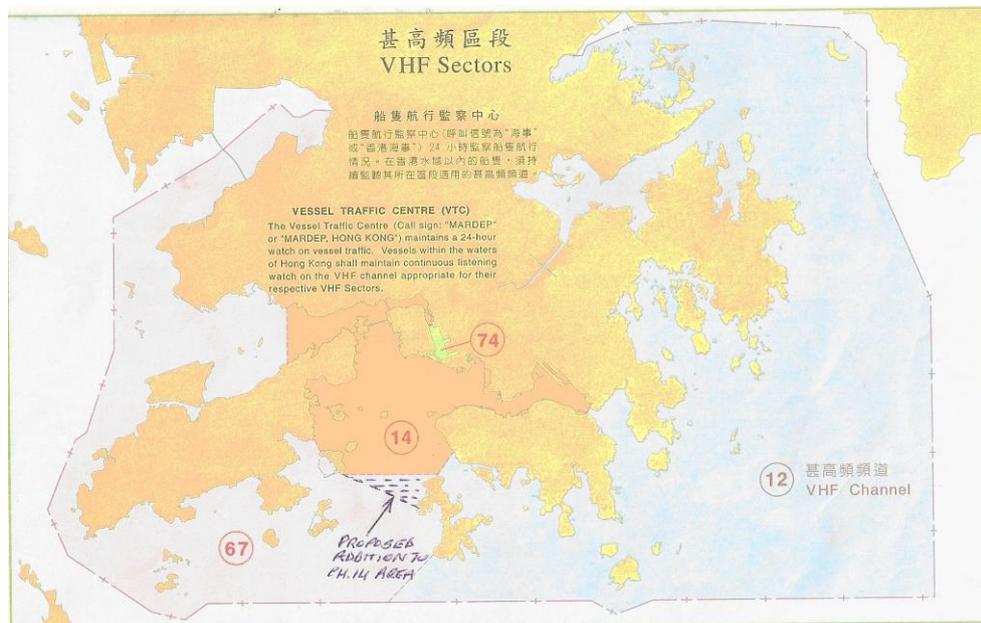
Diagram 1 showing suggested extension of VHF Channel 14.

slight adjustment to the VTS boundary between VHF coverage of Channel 67 and Channel 14, such that the ferry pier and the typhoon shelter are brought within the Channel 14 area. A simple illustration of such adjustment is shown in **Diagram 1** below. This would avoid the need for vessels running into the Lamma Island berths to change channels at a crucial time.

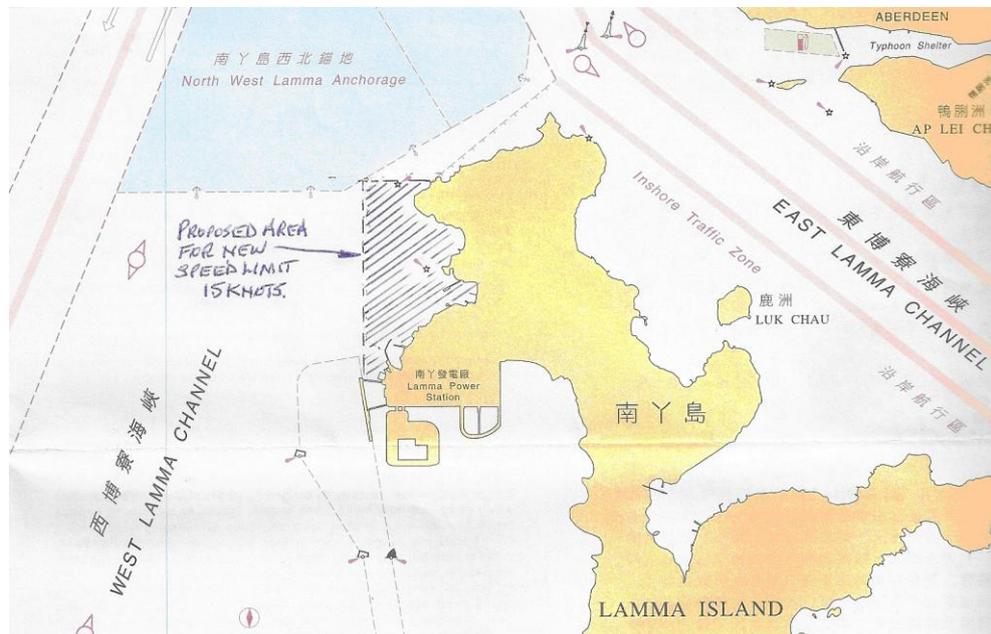
Diagram 2 showing proposed area for new speed limit of 15 knots.

80. In my view, consideration should be given to a new speed limit of 15 knots maximum covering the approaches to Lamma Island, as shown in **Diagram 2** below. The boundary might run from the northern end of the coal pier due north until the boundary of the NW Lamma anchorage then due east to the Lamma Island shore. This formal speed limit would guarantee an added degree of safety to the approaches to the ferry piers where there is no formal port control. It would add less than a minute to the passage time of the fast ferries.
