2ND SUPPLEMENTAL EXPERT REPORT

Expert Witness appointed by the Commission of Inquiry
into the Collision of Vessels
near Lamma Island on 1 October 2012

25 January 2013

Naval Architect of Fastships (Australia) Pty Ltd, Coogee, Western Australia

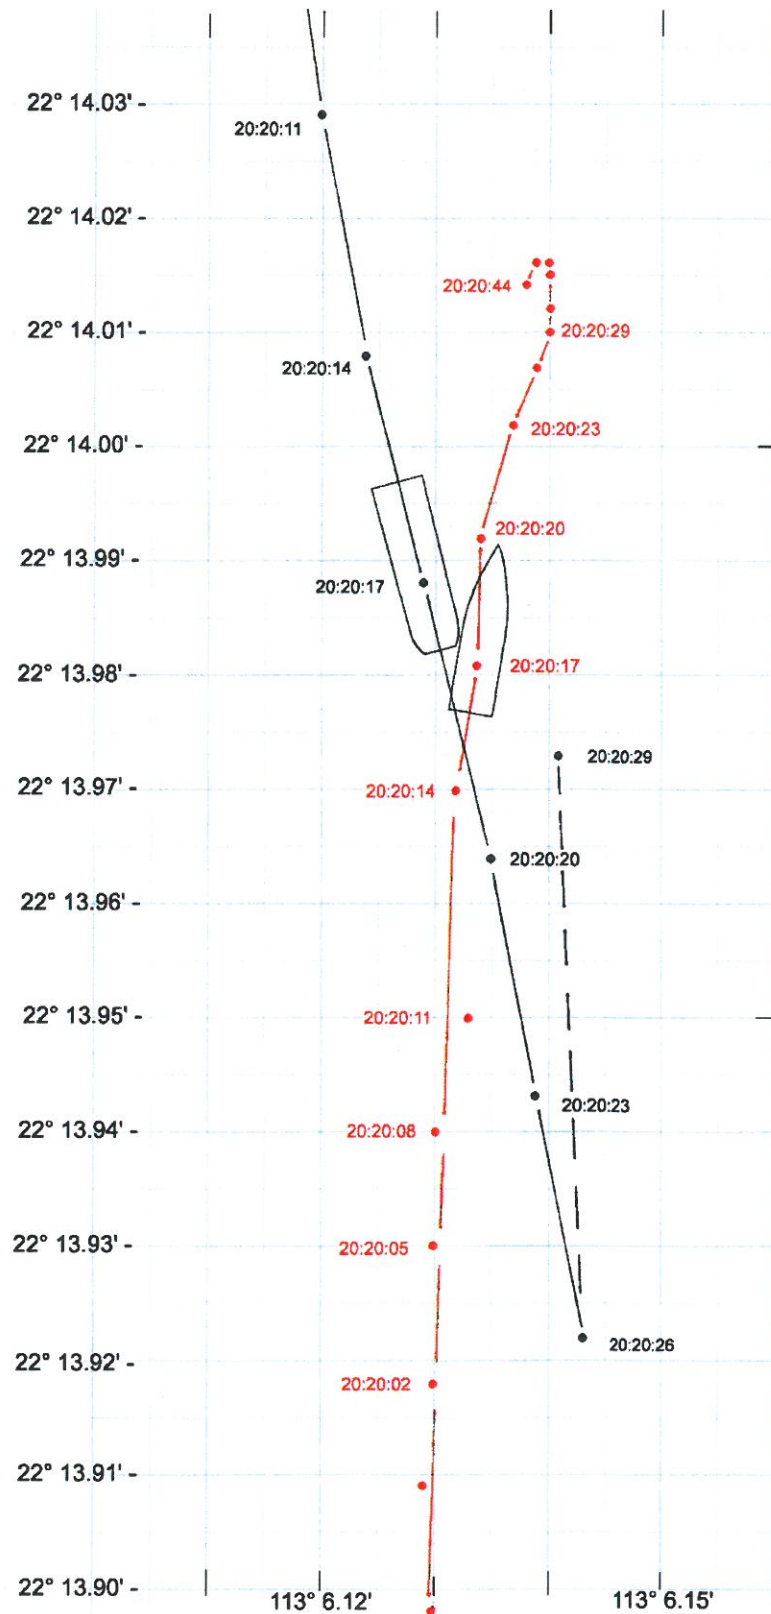
Radar Tracks for Sea Smooth and Lamma IV

31. The MarDep radar information provided in Captain Pryke's Supplemental Report suggests that *Sea Smooth* appeared to continue on past *Lamma IV* after the collision for some distance before back-tracking at very high speed¹³. These echoes are, I believe, spurious. They could be caused by the large wave wake wash that was being generated by *Sea Smooth* at that time as previously discussed, owing to the critical speed and depth of water, but more likely it was a function of the radar which I believe attempts to be predictive as to the next location of the echo in order to maintain continuity of tracking individual targets. As such the system does not cope well with sudden changes of course or deceleration such as may happen during a collision. The radar echoes are also historical, in discrete time steps of 3 seconds owing to the antennae rotation, and the radar only indicates the course over the ground. However I am not an expert in radar. Nevertheless I believe that the radar echoes related to *Sea Smooth* between 20:20:17 and about 20:21:00 are spurious. The result of the spurious echoes is that it is easy to conclude that the vessels glanced off each other and continued approximately on the same course as previously.

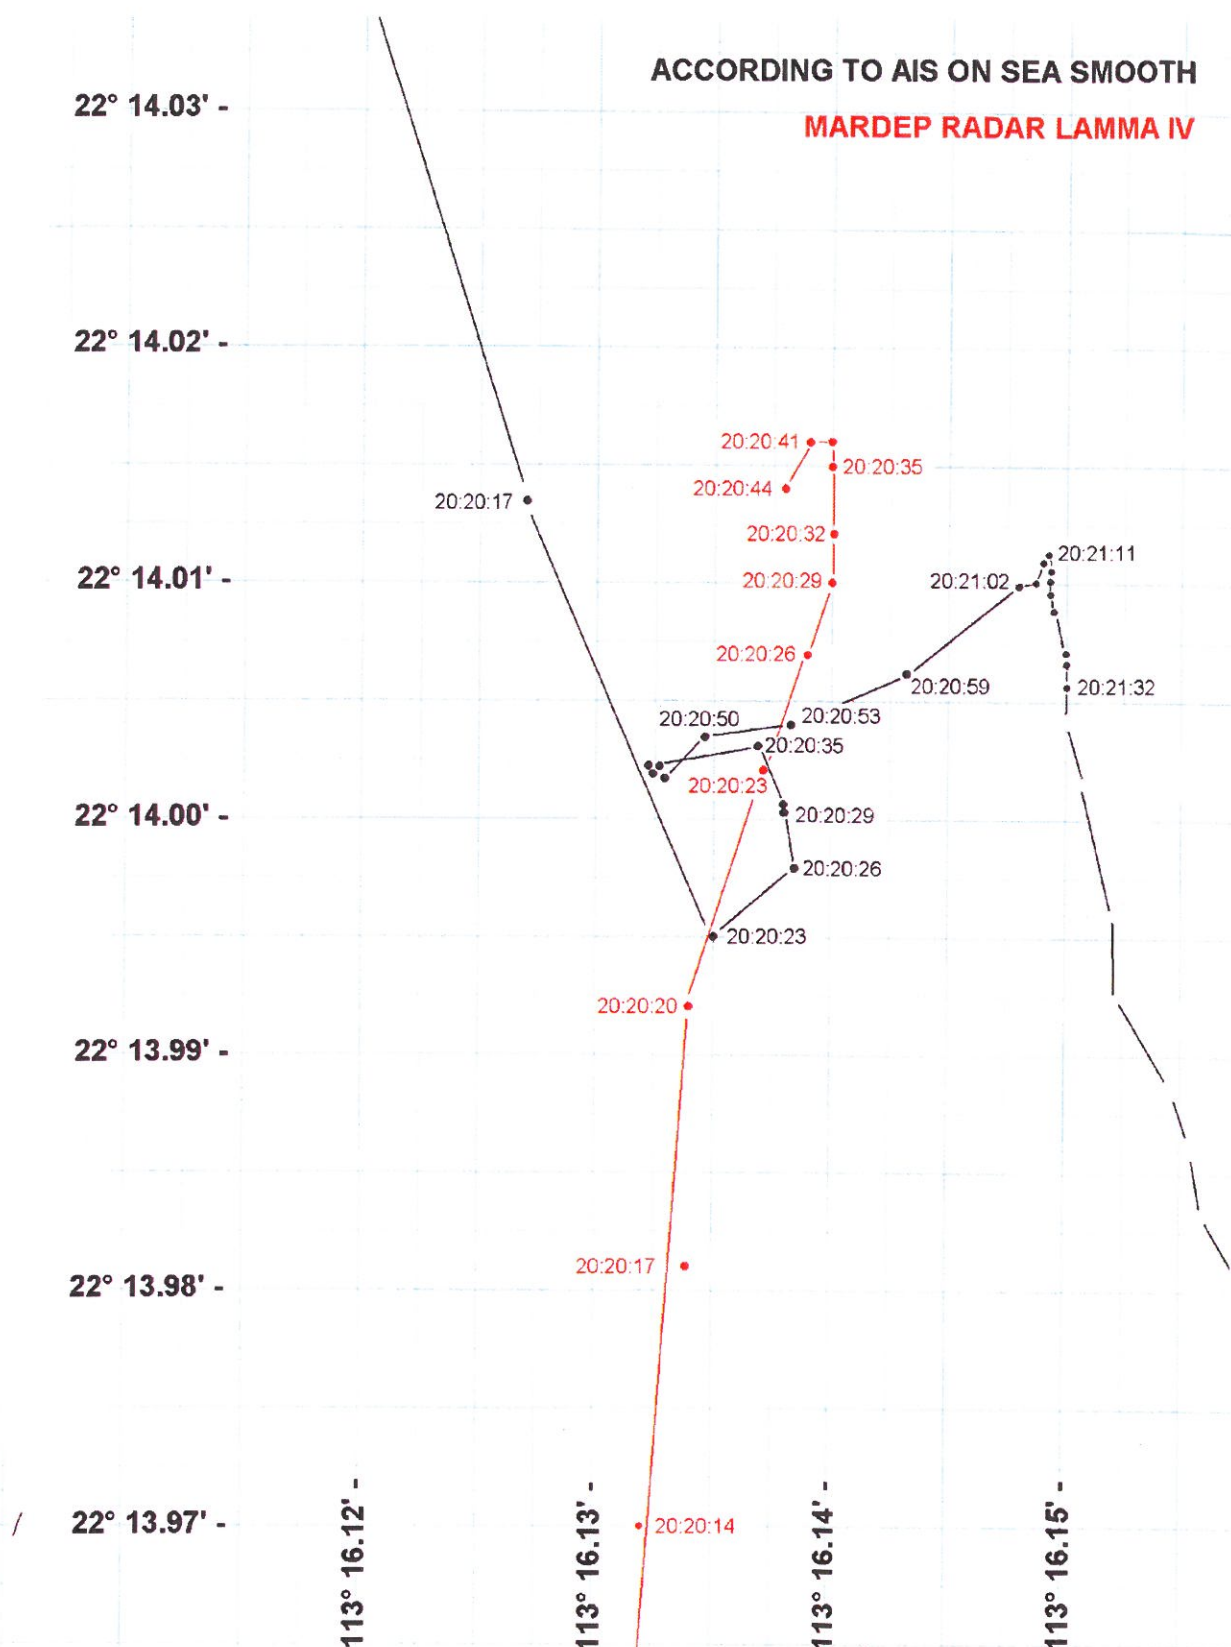
AIS/ GPS for Sea Smooth and Radar Track for Lamma IV

33. Given the unreliability of the radar track, I therefore looked at the AIS data produced by the ship's GPS system¹⁴. The GPS location is not as accurate as the radar data for actual location, but I believe it does accurately represent relative changes in location over short time intervals. The location of the two craft as given by the radar for *Lamma IV* and by the GPS for *Sea Smooth* in three-second intervals is given in Appendix IV Item 20. The paths are similar to those predicted by analysis of the structural damage, and the location of the vessels agrees with the description of some of the witnesses. *Sea Smooth* was stationary for at least 15 seconds

34. I also note that in this plot the vessels meet at 40 degrees, as indicated by the cut in the deck of *Lamma IV*. This greater angle than previously indicated is a result of *Lamma IV* turning to Starboard more rapidly than had previously been thought by examination of the radar track. That *Lamma IV* turned rapidly is supported by the translation of witness statements of Cheung Kwok-hong¹⁵, To Nin Chee Angel¹⁶, Wong Yee Yi¹⁷, Chan Kin Yan¹⁸, Lee Kin Fai¹⁹, SzetoLan²⁰, Wong Tai Wah²¹, Tsu Chi Keung²², Lam Muk Lin²³, Chan KamHo²⁴, and Tang Ying Kit²⁵, who comment that they felt the vessel accelerate in the seconds before the collision, although in which direction is not generally stated, and it was dark, so it could have been the vessel turning that was felt. It is also supported by the translation of the witness statement of Tang Ying Kit²⁶ who was standing on the upper open deck looking aft and commented that he saw the wake change just before the collision. Given that it was dark, the wake must have turned white for it to be visible, and I suggest that this is consistent with what would have been seen if the rudders were put hard over and full power applied.

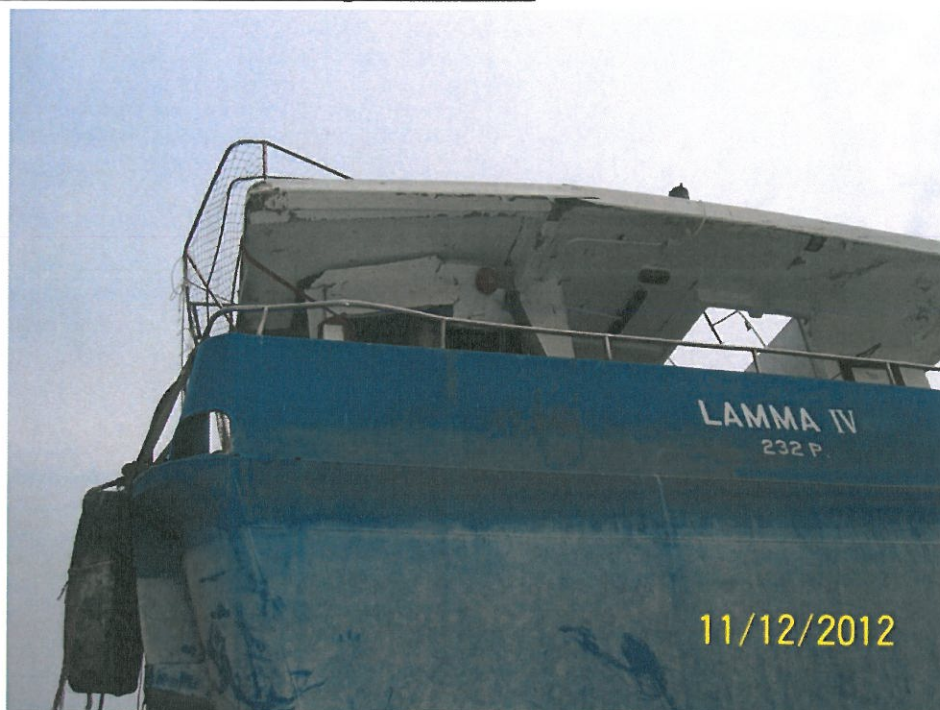
Appendix V – Photo 1. Stern view of *Lamma IV* illustrating limit of damage to the after end of the hull and superstructure

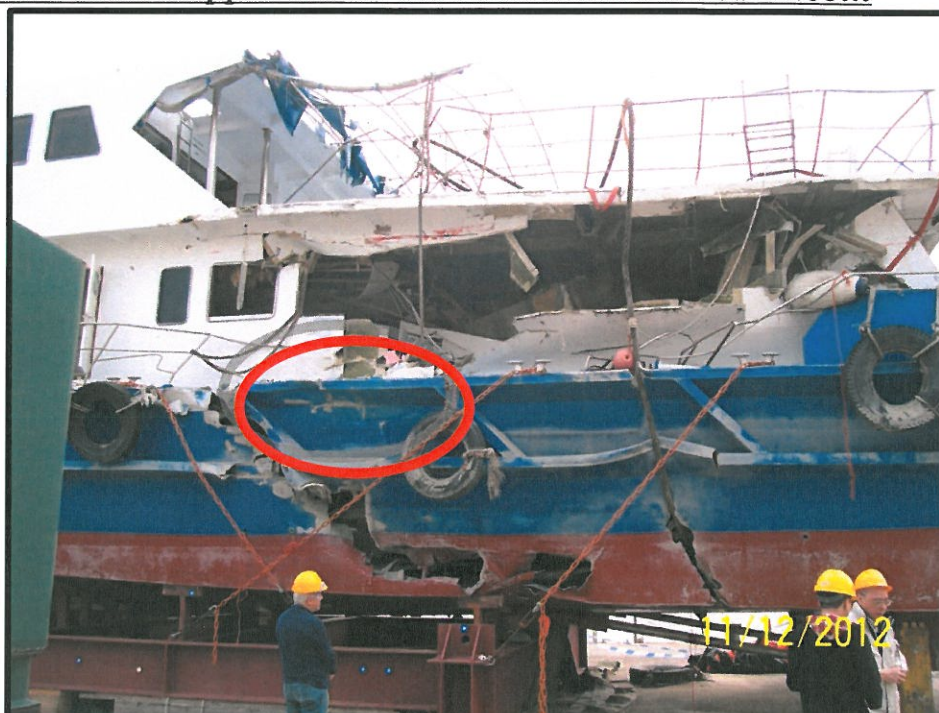
32. The evidence from the damage on both vessels, and specifically on *Lamma IV*, is that the vessels did not glance off each other, and in fact the upper part of *Sea Smooth* did come to rest within the cabin of *Lamma IV* and did not pass through it, as detailed in my Report and further discussed in My 1st Supplemental Report. I also estimated the relative positions of the two craft in my Report and suggested that *Sea Smooth* probably rotated and extracted itself and thus appeared to anyone within the cabin to back out of *Lamma IV*. I also noted that it was possible that *Sea Smooth* could have been mechanically reversed, but that there was no evidence of this from my inspections.

Appendix V – Photo 2. *Lamma IV* showing damage from collision bulkhead of *Sea Smooth* which stopped the forward momentum of *Sea Smooth*

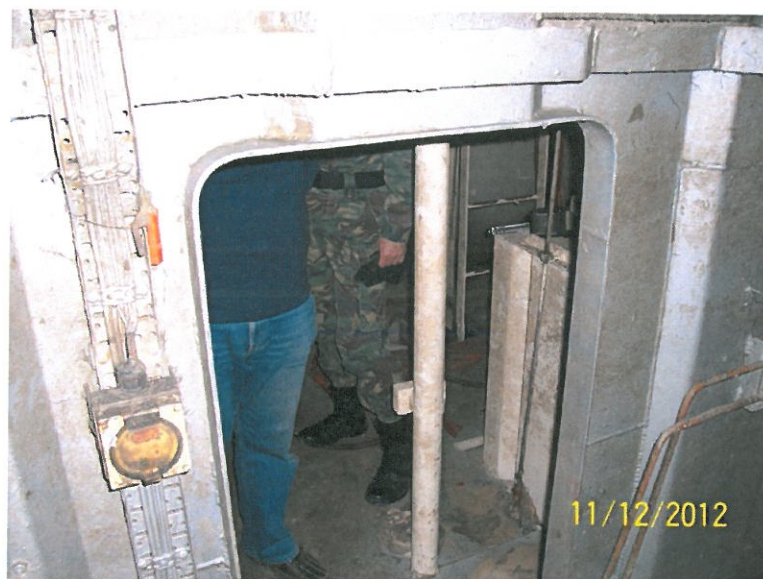
Appendix V – Photo 3. Access opening in Bulkhead ½ seen from inside the steering gear compartment, showing corrugated bulkhead above door coaming, and illustrating lack of room to fit a watertight door. This could be overcome by fitting a wider door coaming.

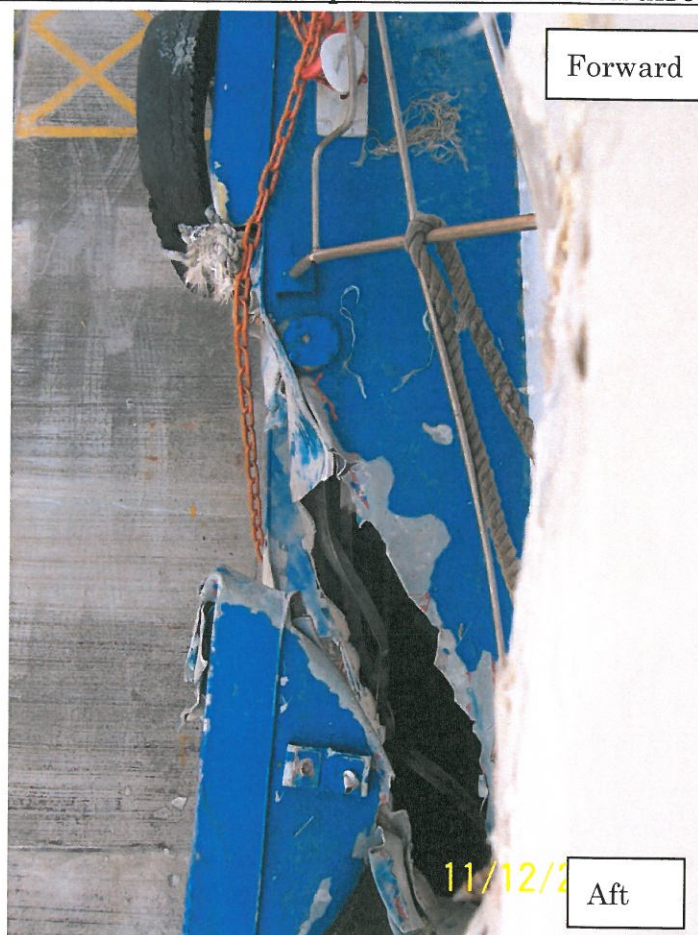
Appendix V – Photo 4. The cut in the port-side deck from directly above.
