EXPERT REPORT

Expert Witness appointed by the Commission of Inquiry
into the Collision of Vessels
near Lamma Island on 1 October 2012

3 January 2013

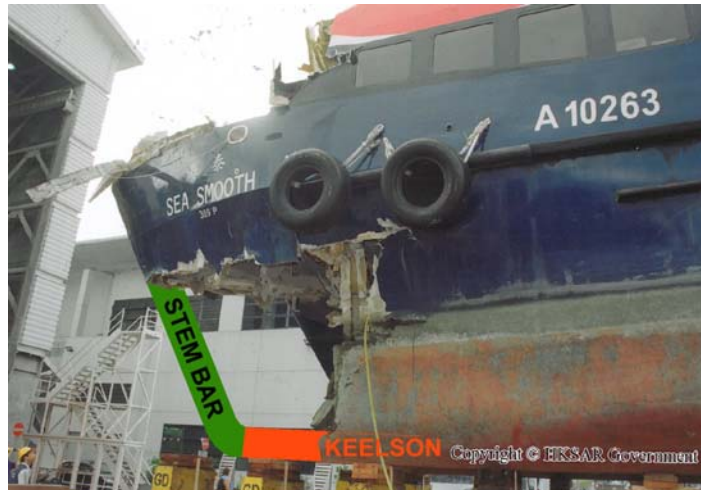
App IV - 1. Stem Bar and Keelson

Illustration of how the stem bar and keelson form the bow structure of the *Sea Smooth*, superimposed on picture Police Photo Album VIII p. 397. These two items are the same material and the same size, and were responsible for most of the damage to the hull of *Lamma IV*.

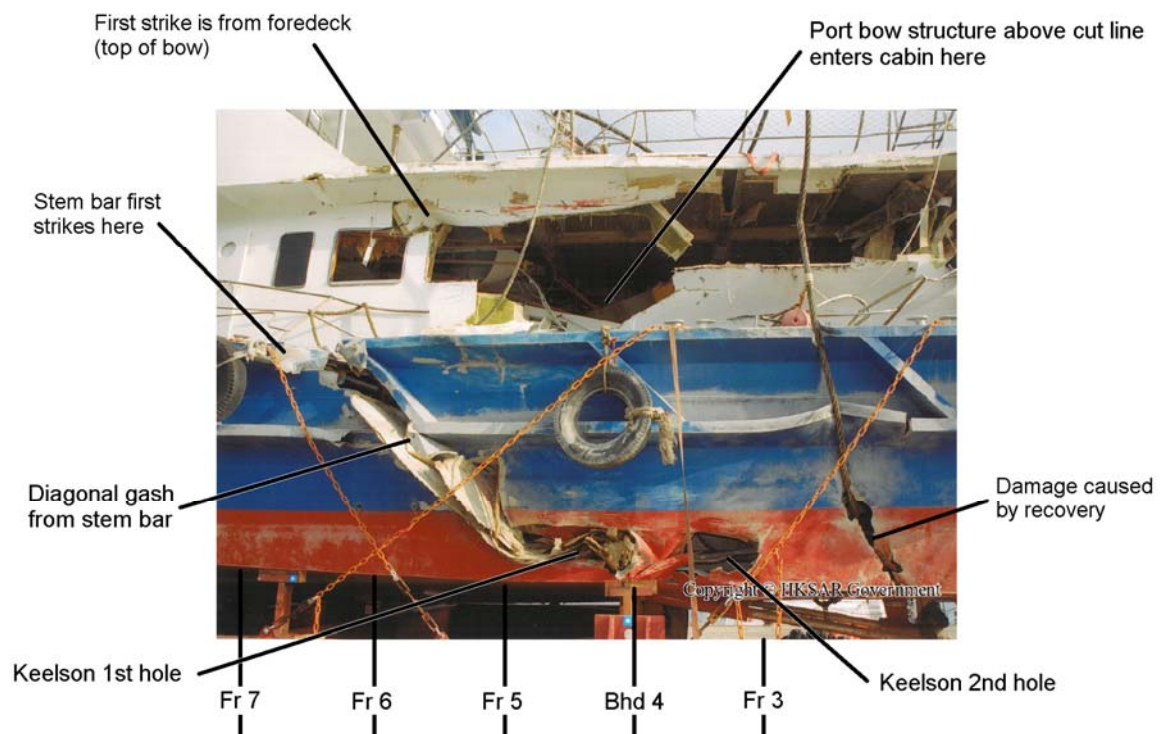
App IV - 2. Principal damage to Lamma IV watertight integrity

7. In order to understand the sinking process it was necessary to identify the structural damage to the vessel. The wreckage of *Lamma IV* was inspected on the hard-standing at the Hong Kong Government Dockyard during the morning of 11th December 2012, in the presence of Senior Inspector C.M. Tang of the Hong Kong Marine Police. The manner in which the structure had deformed at the point of impact was assessed, and measurements of the damaged area were taken, as reproduced in Appendix IV item 8. The alignment of the individual parts of the damaged structure was also noted as a means to determine the direction in which distorting forces had been applied. Deep scratches in the hull plating in way of the damage was also noted.

Annotations on Photograph in Police Photo Album VIII, Page 415

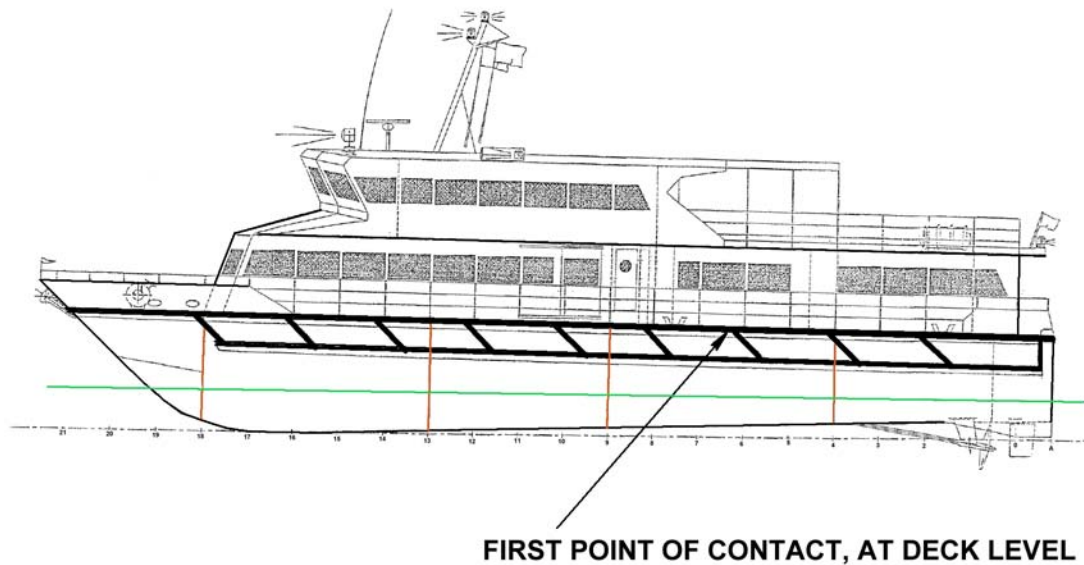
Sketch AppIV-3.1: Stem bar of *Sea Smooth* strikes deck of *Lamma IV* forward of a strong sloping fender.

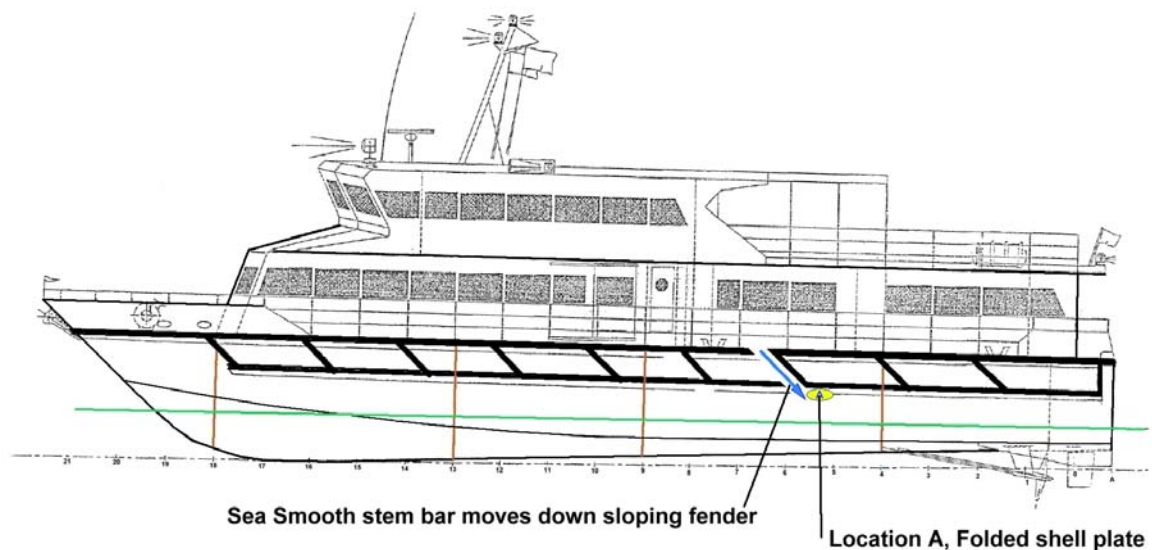
Sketch AppIV-3.2: Stem bar penetrates into *Lamma IV*, and travels downwards relative to the shell. It displaces *Lamma IV* plating which finally ends up below the sloping fender at Location A. The stem bar is twisted by the combination of the presence of the sloping fender and the relative motions of the two vessels, and strikes the strong Frame 6, which further stresses it.

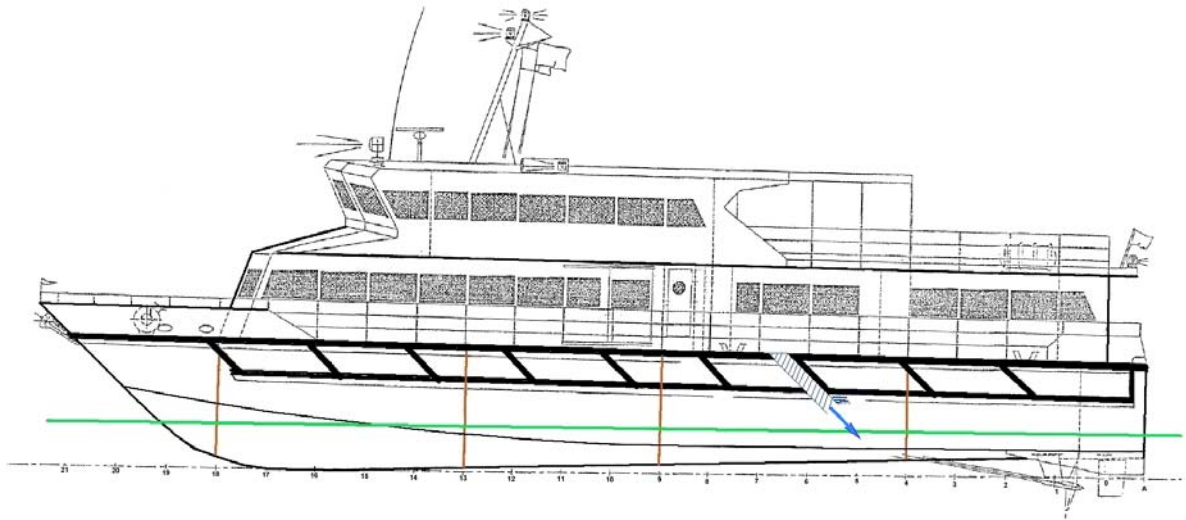
Sketch AppIV-3.3: The stem bar travels down, clears the fender and possibly relieves stress by breaking at the lower fender level.

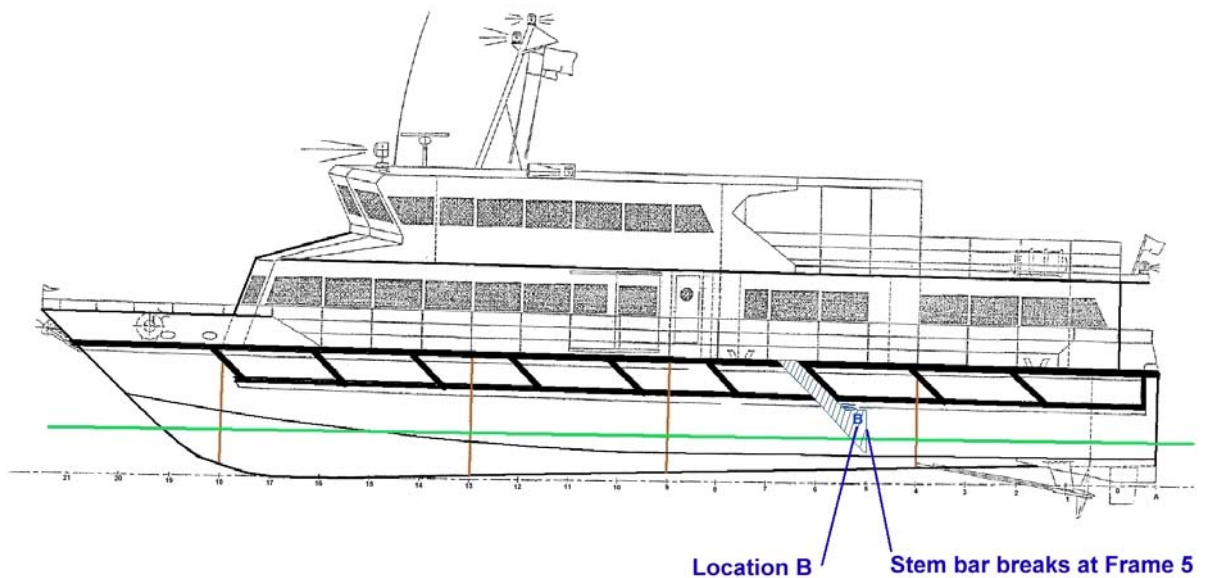
Sketch AppIV-3.4: The remaining stem bar removes plating from *Lamma IV* (Location B) until it strikes the strong frame 5, where it again breaks off.

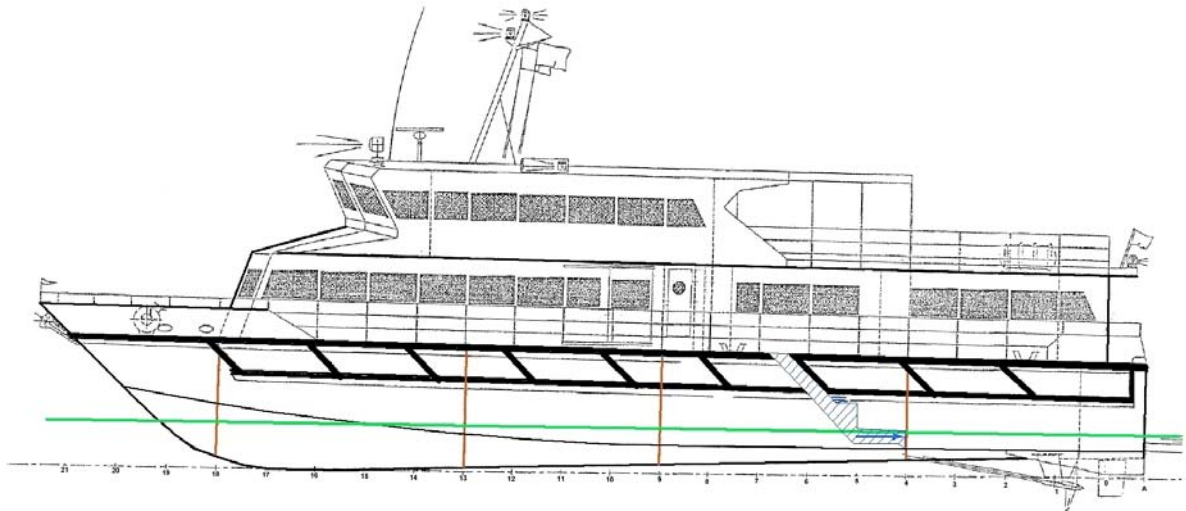
Sketch AppIV-3.5: the stem bar has broken off inside *Lamma IV*, but the keelson continues to enter the shell and removes more plating up to the Watertight Bulkhead 4.

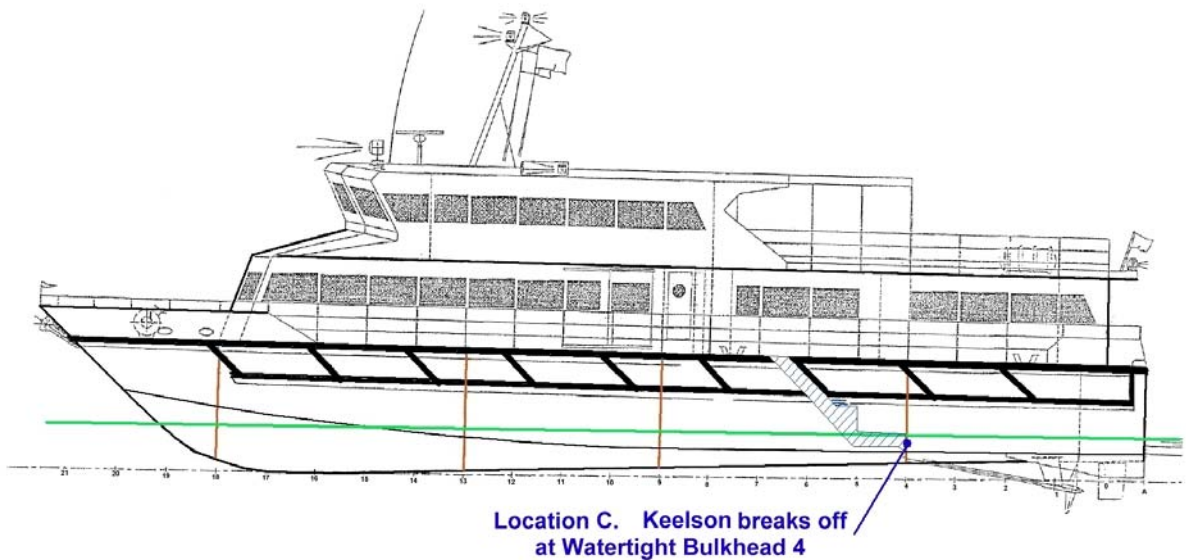
18. Despite the forces from the keelson on impact, the watertight bulkhead 4 structure remained intact, although distorted, with some small fractures. At this point of time in the collision sequence the momentum of *Sea Smooth* was sufficient to keep it moving towards *Lamma IV*. Eventually the keelson again penetrated the side plating of *Lamma IV*, this time making a roughly rectangular hole into the tank room²⁴. It is this second hole which allowed the flooding of the tank compartment and was a major factor contributing to the loss of the vessel. After travelling aft on *Lamma IV* a distance of approximately 700 mm, the keelson broke off once more and the remaining intact structure of *Sea Smooth*, which by now had travelled sufficiently far to reach the extremely strong collision bulkhead with no remaining structure in front of it in the way of *Lamma IV*, caused it to glance off the side of *Lamma IV* and disengage, leaving parts of the bow outer port-side plating and stem bar within *Lamma IV*.

Sketch AppIV-3.6: The keelson breaks off at Watertight Bulkhead 4.

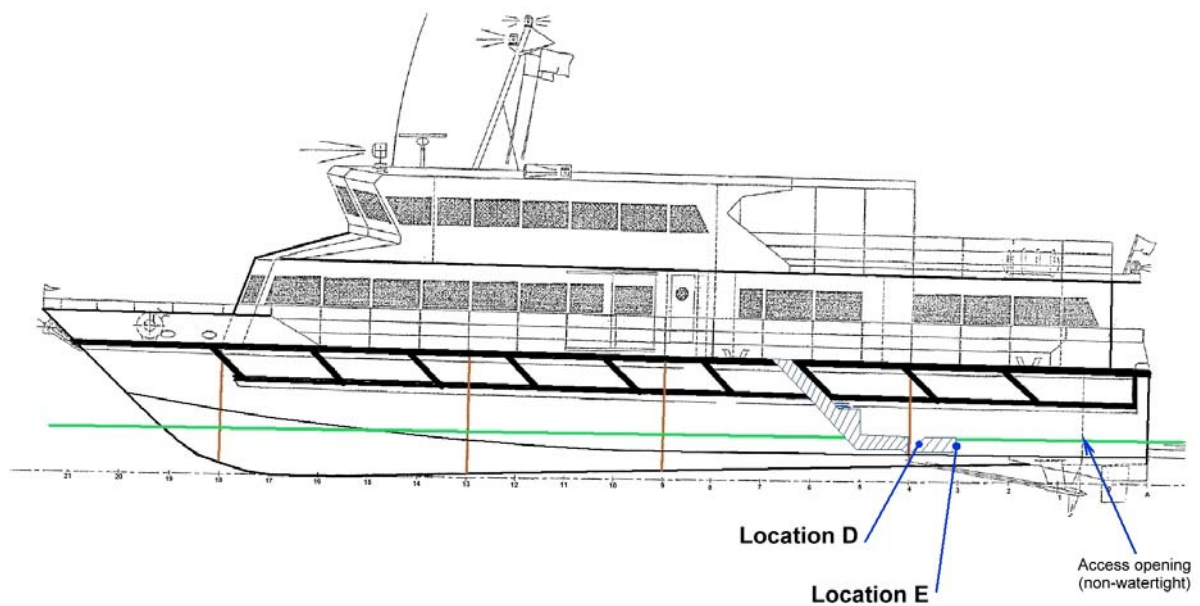
Sketch AppIV-3.7: Owing to the continuing forward motion of *Sea Smooth*, the keelson again penetrates the shell plate of *Lamma IV* (at location D) until it meets Frame 3 at Location E and again breaks off. At this point the collision bulkhead of *Sea Smooth* meets the side of *Lamma IV*, and the surfaces in contact are now large enough for the motion of *Sea Smooth* to be arrested, causing no further hull damage.

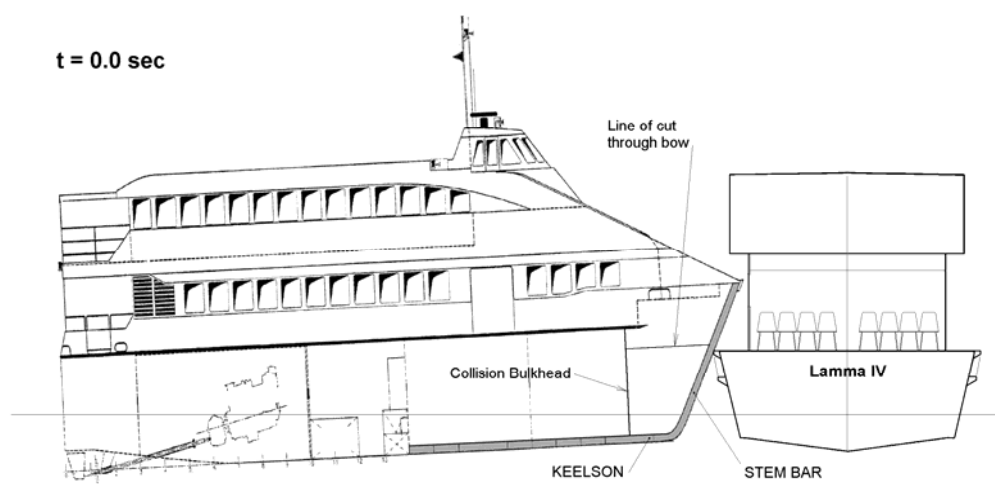
App IV - 4. Relative positions of *Lamma IV* and *Sea Smooth*

14. A diagram showing the estimated relative vertical locations of the two craft at the time of impact is illustrated in Appendix IV Item 4. This diagram shows close correlation with the extent of damage to the bow of *Sea Smooth*¹⁸ and to the sequence of structural failure on *Lamma IV* as further explained.

Based on the estimated loading of the two vessels, using the data within the stability books, the draughts at the forward and after end can be calculated. *Sea Smooth* was travelling at speed which would have produced substantial stern trim, which has been calculated for a vessel at 22.5 knots and in the depth of water of 13.44 m. The positions of the two craft correlate well with the measured extent of damage.

Sea Smooth appears to be foreshortened here because it was at an angle of approximately 40° to *Lamma IV*. (See paragraph 15 of the main Report for justification of the 40° angle).

Note the line of cut through the bow of *Sea Smooth*, coinciding with the deck level of *Lamma IV*. The stem bar of *Sea Smooth* first strikes the fender of *Lamma IV* very close to Frame 7.

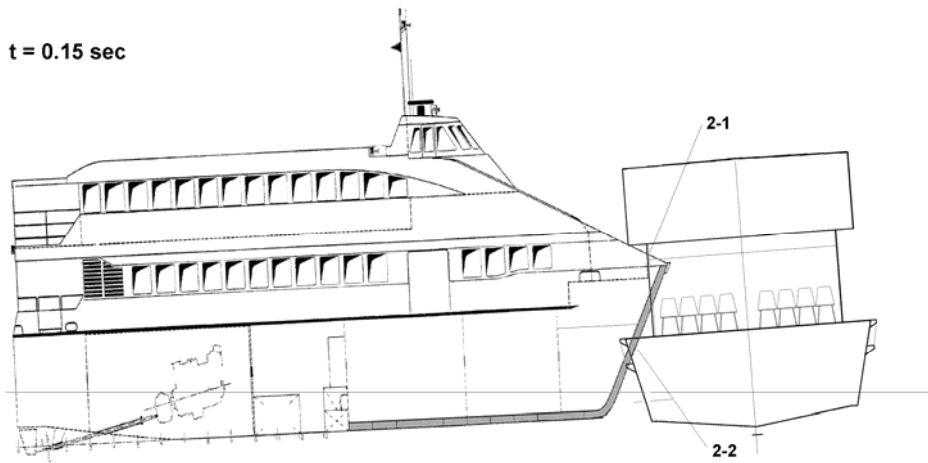
Sketch AppIV-4-2-1 The foredeck of *Sea Smooth* strikes the deckhouse of *Lamma IV* just above the window level, as can be seen the annotated photograph in App IV Item 2.

Sketch AppIV-4-2-2 The stem bar of *Sea Smooth* cuts through the deck and side structure of *Lamma IV*.

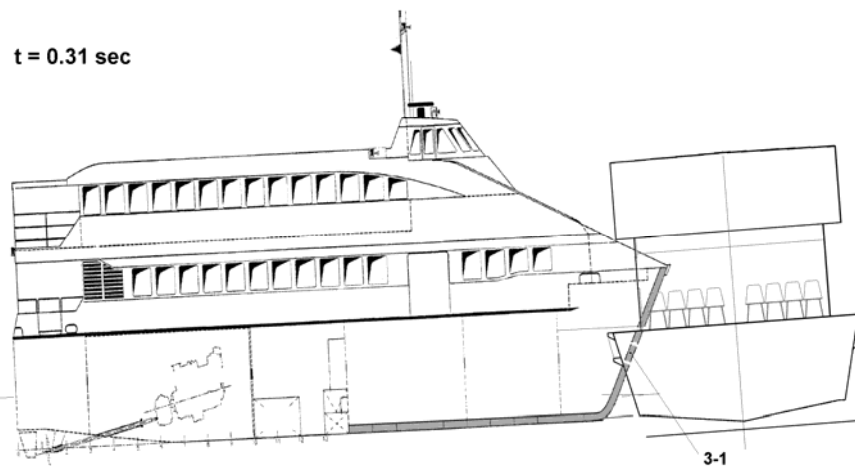
Sketch AppIV- 4-3-1 The diagonal gash in the side of *Lamma IV* is caused by the stem bar entering at an angle and the forward motion of *Lamma IV*. Constrained in its path by the sloping fender, the stem bar twists and breaks in way of the deck.

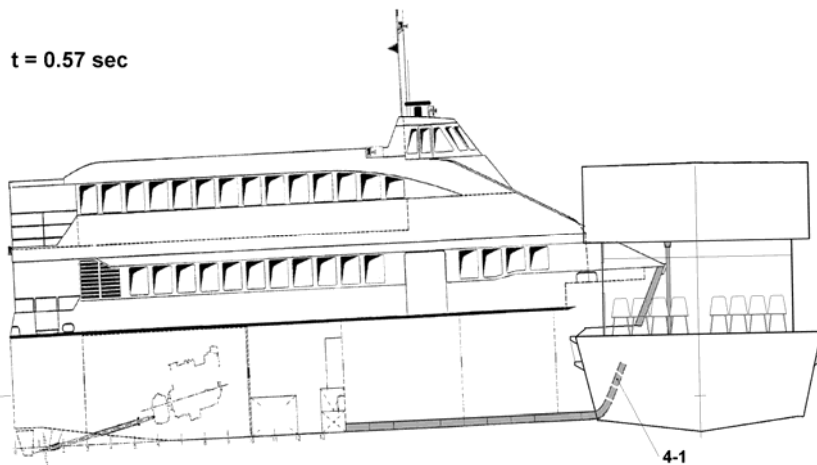
Sketch AppIV-4-4-1 The lower part of the stem bar strikes a strong point of the structure of *Lamma IV*, Frame 5, and breaks into pieces below decks, leaving the keelson within *Lamma IV*, which continues to make a rectangular hole through the shell plating.

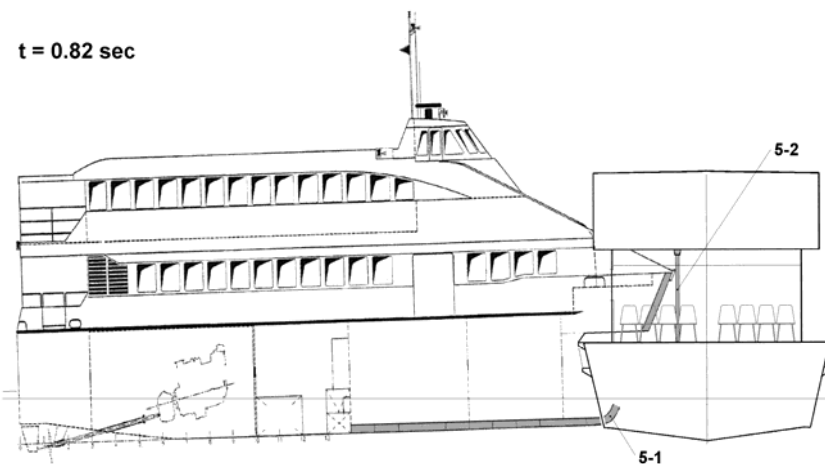
Sketch AppIV-4-5-1 The keelson strikes Bulkhead 4 in its travels down the length of *Lamma IV*, and breaks off.

Sketch AppIV-4-5-2 the foredeck of Sea Smooth makes contact with a supporting pillar within the cabin and displaces it to an angle of about 10° .

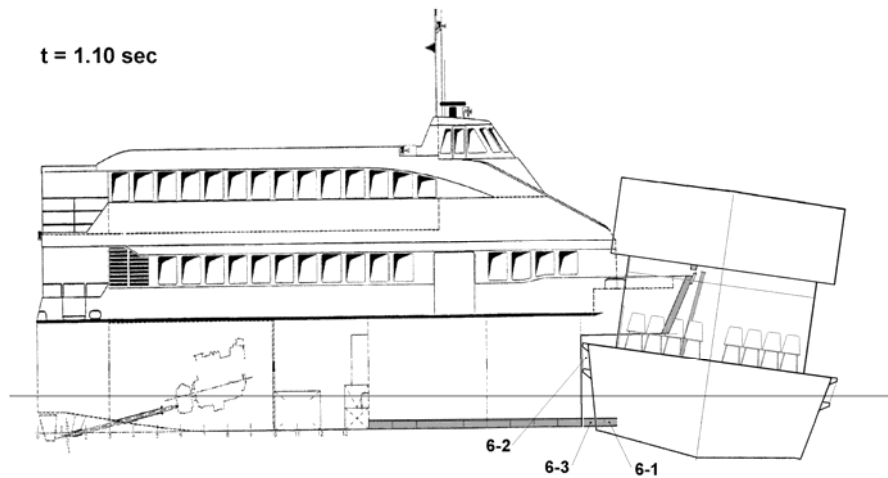
Sketch AppIV-4-6-1 Shortly after breaking off at Bulkhead 4, the stem bar re-enters the hull of *Lamma IV* causing a hole into the Tank Compartment.

Sketch AppIV-4-6-2 the “forward” motion of *Sea Smooth* is effectively halted by the very strong collision bulkhead (port side hull) meeting the hull of *Lamma IV*.

Sketch AppIV-4-6-3 At this stage both vessels are moving together through the water at about 3½ knots , with *Lamma IV* going backwards but rotating relative to *Sea Smooth*, causing the keelson to break off *Sea Smooth* near the collision bulkhead, and further intrusion into the hull of *Lamma IV* ceases at this point.

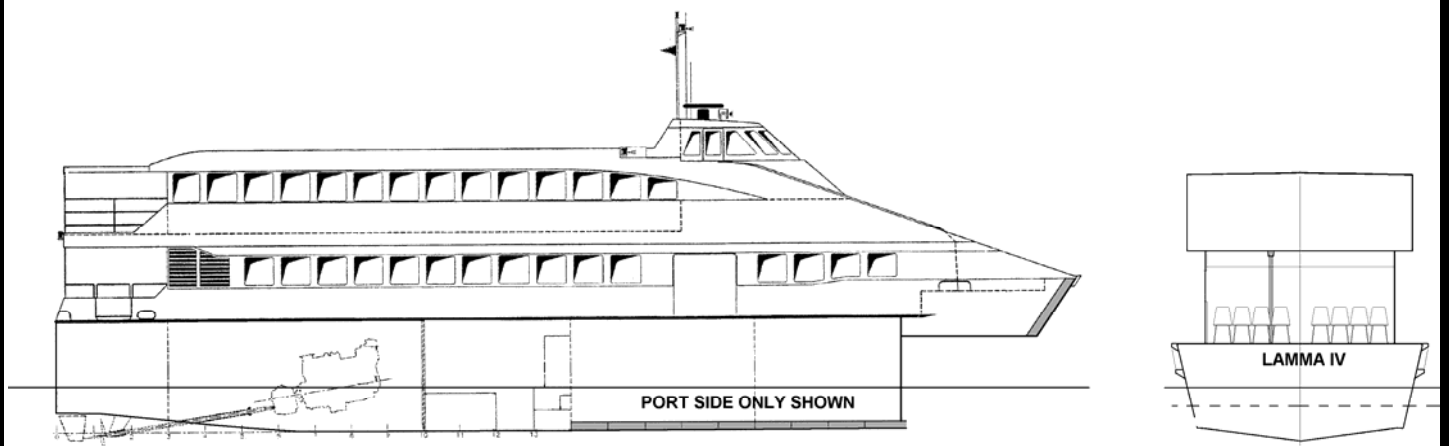
Sketch AppIV-4-7 *Sea Smooth* separated from *Lamma IV* after the collision

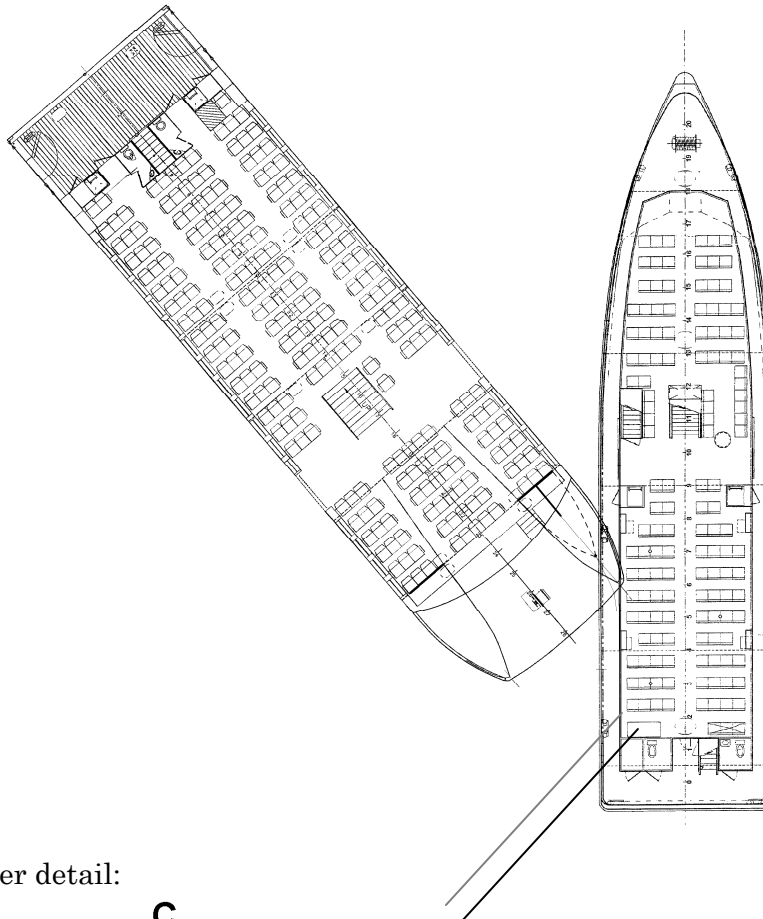
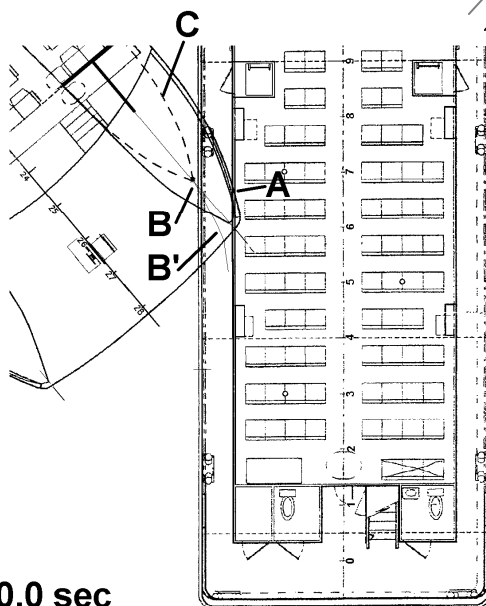
Time = 0 secs

Lamma IV at 11.5 kn, Sea Smooth at 22.5 kn, relative heading 40°

- A. First contact, see App IV Item 2
- B. Stem bar strikes fender.
- B'. Cut line of stem bar through deck, as measured.
- C. Shape of bow at deck level of Lamma IV.

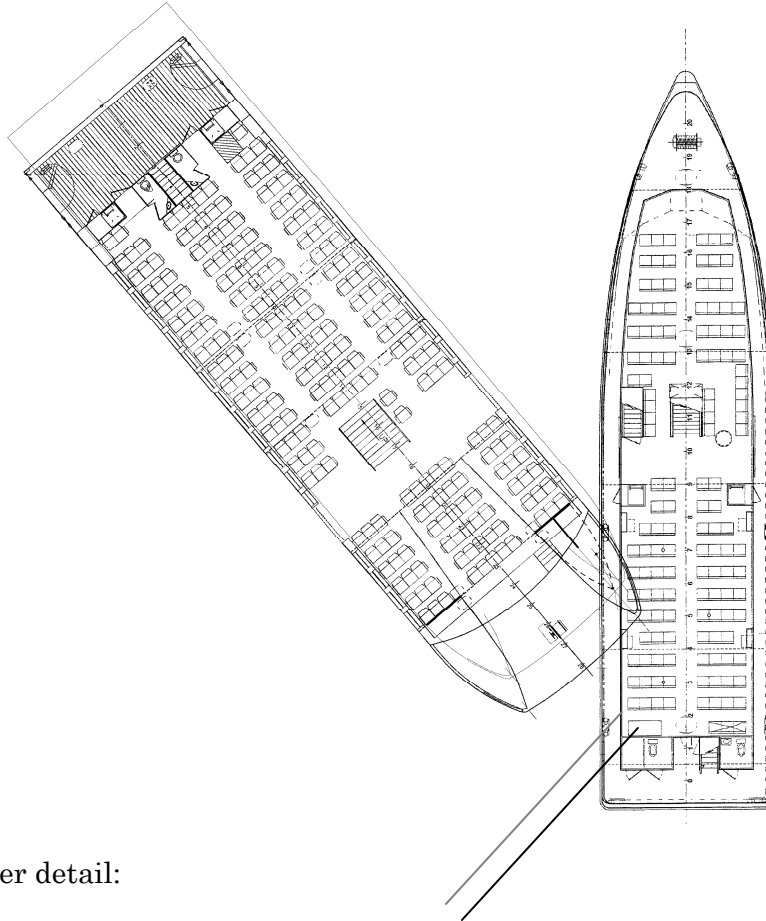
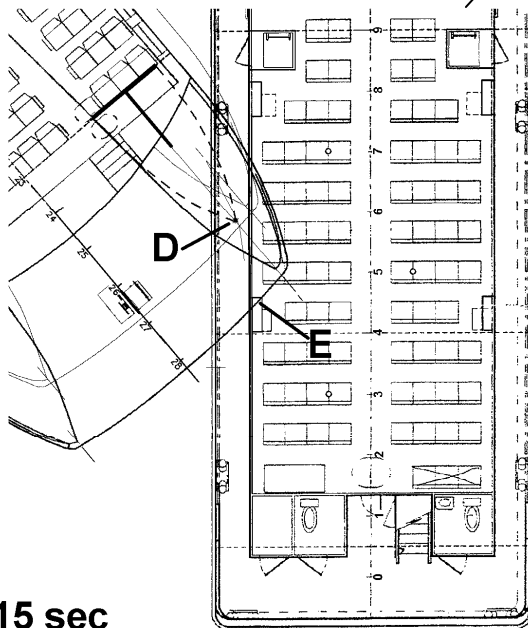
Time = 0.15 secs

D. Stem bar following cut line
in deck.

E. Foredeck strikes vent
trunking causing visible
marks on the bow of Sea
Smooth

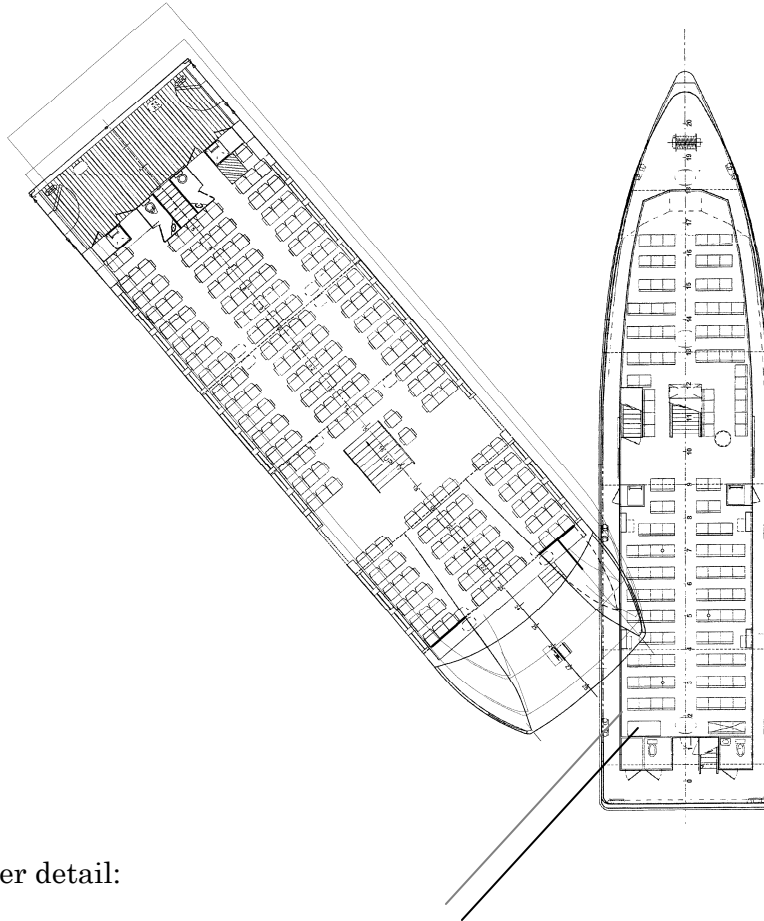
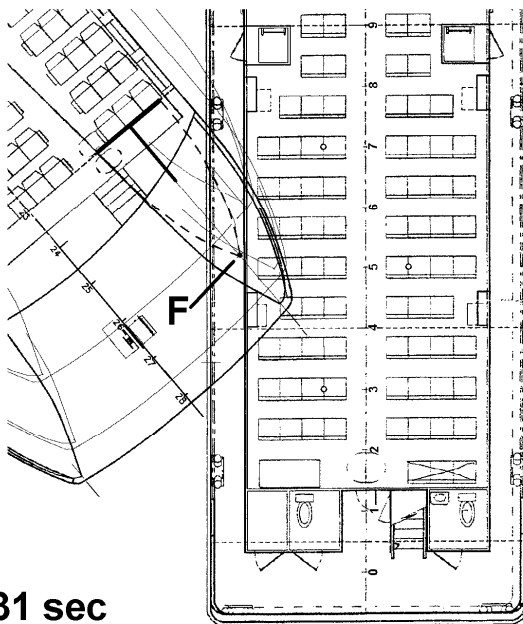
Time = 0.31 secs

F: Stem bar meets Frame 5
and breaks at deck level and
below.

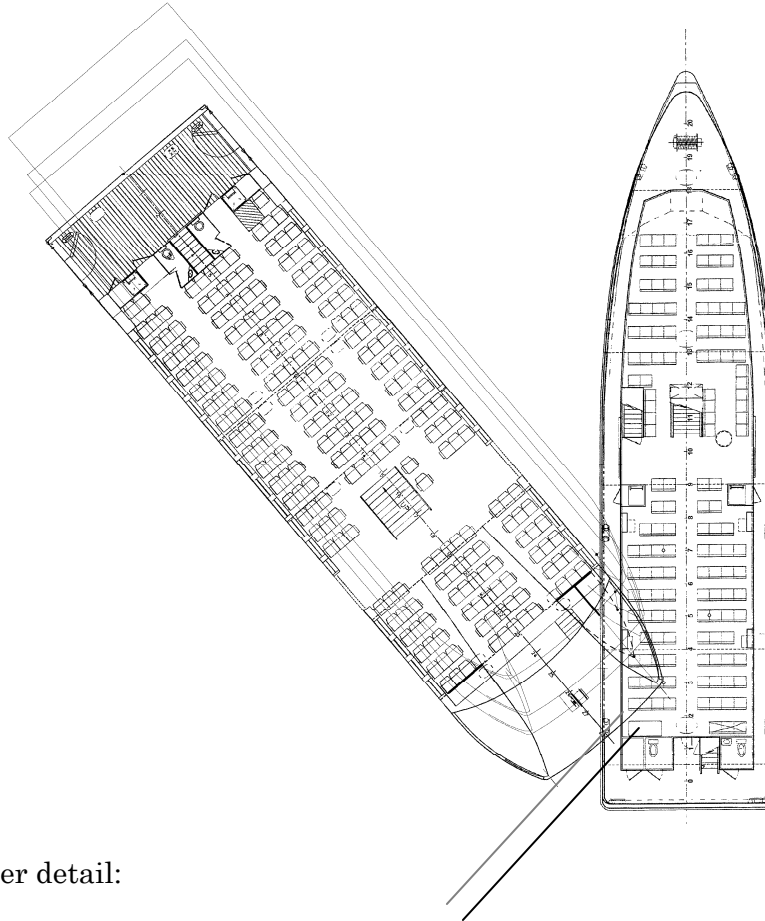
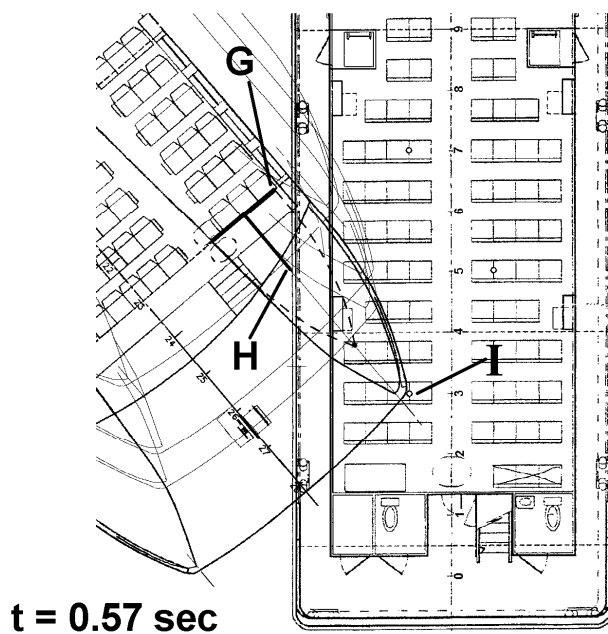
Time = 0.57 secs

G: Collision bulkhead contacts hull of *Lamma IV*. Forces result in turning of *Sea Smooth* and heel of *Lamma IV*

H. Keelson first enters hull

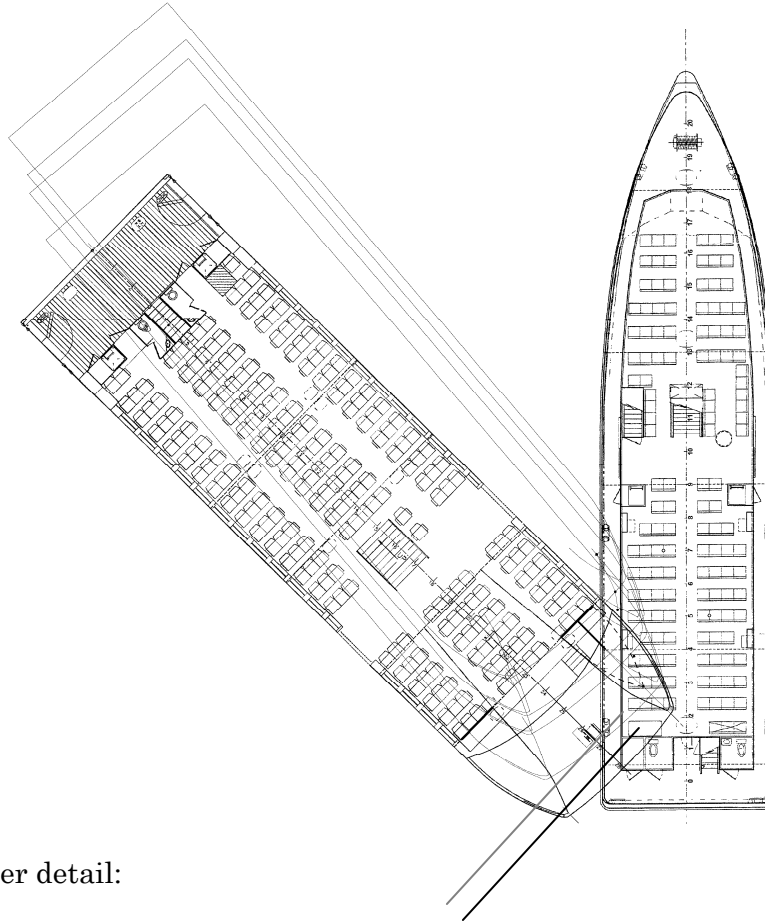
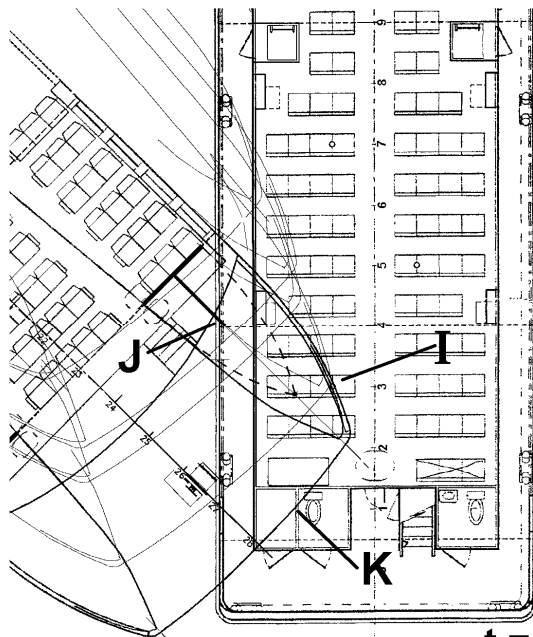
Time = 0.82 secs

J: Keelson breaks on Bulkhead 4, and then re-penetrates the hull on the after-side of the bulkhead.

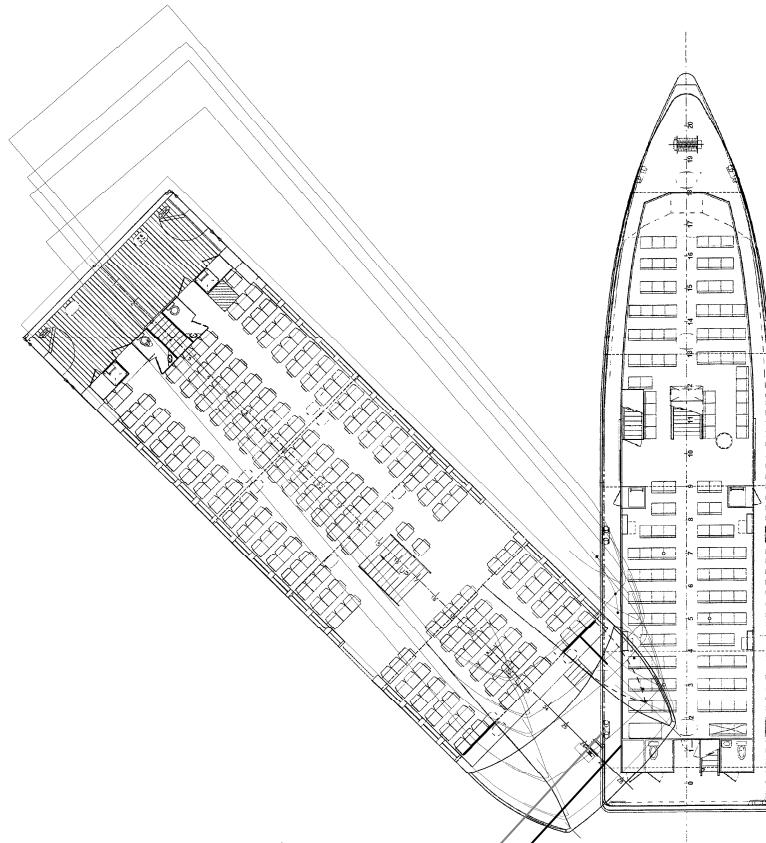
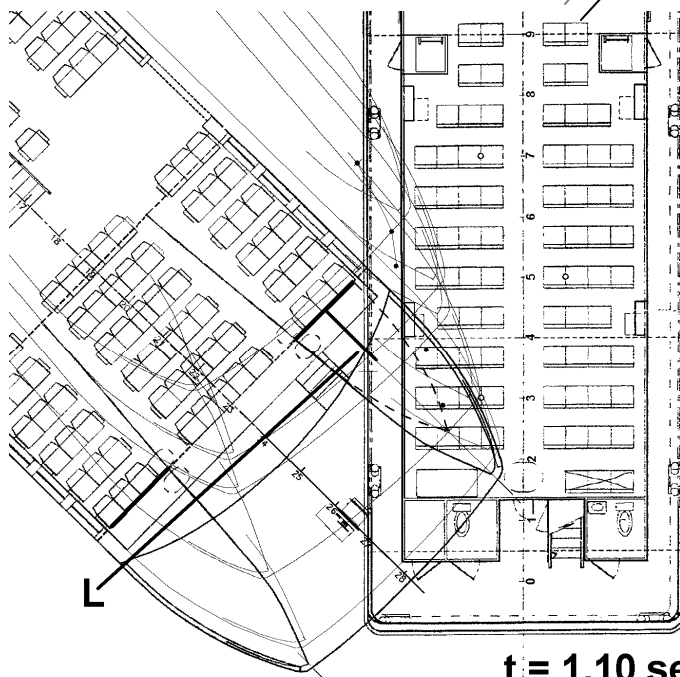
Time = 1.10 secs

Momentum of *Sea Smooth* has been substantially reduced, and some converted to rotational energy

L: Keelson breaks before Frame 3,
with no further hull penetration.

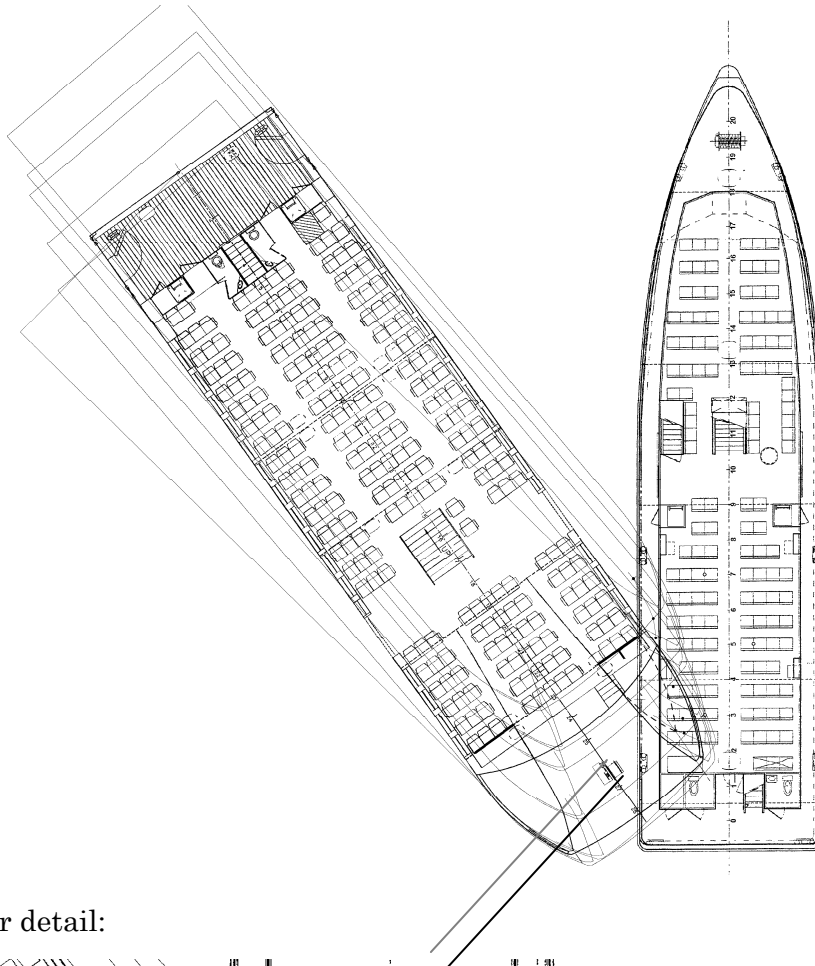
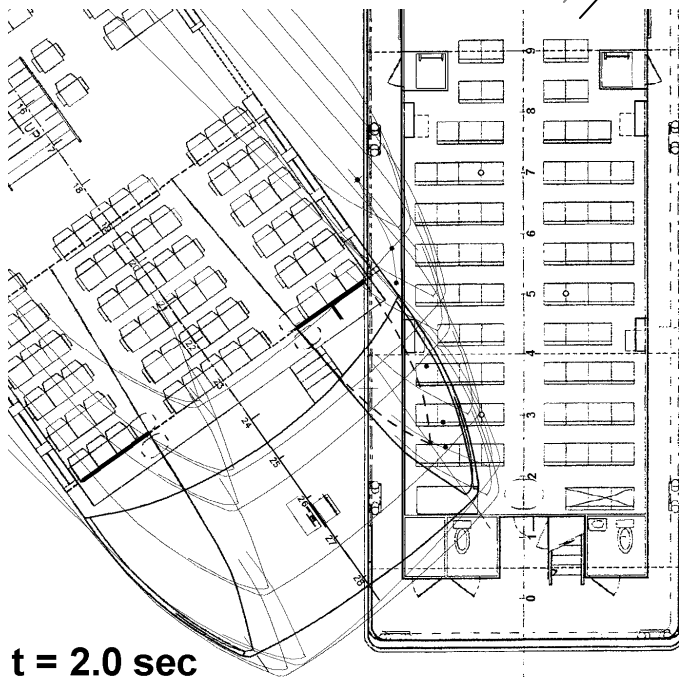
Time = 2.0 secs

Forward speed of Sea Smooth halted. Lamma IV rotates relative to Sea Smooth, reducing the angle between them. Both craft moving together at about $3\frac{1}{2}$ knots (Lamma IV moving astern)

This is the furthest penetration into the cabin of Lamma IV. Lamma IV possibly continues to move astern leaving Sea Smooth behind.

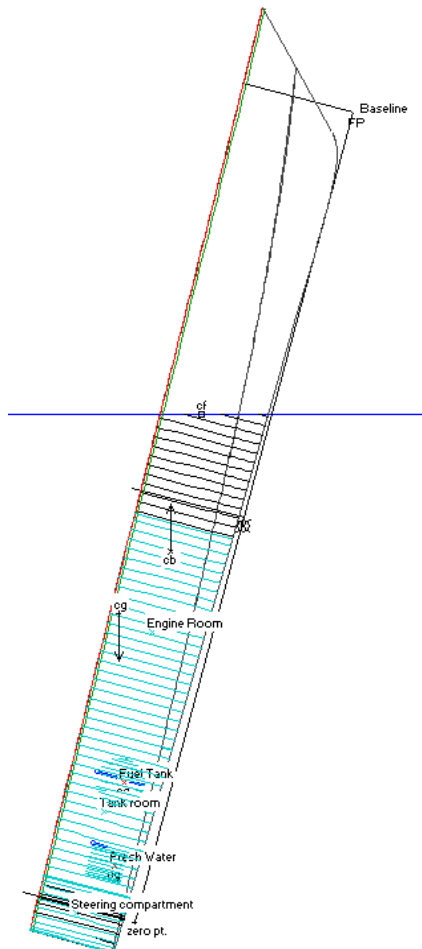
App IV - 6.2 Two-compartment damage – Engine Room & Tank Compartment

2. With the Tank Compartment and the Engine Room flooded (two-compartment damage). This replicated the damage to the craft, **but assumed that a watertight door had been fitted to the aft peak bulkhead**. The vessel eventually became stable after about 165 seconds (1¾ minutes) from the time of collision. The inflow rate of water varied considerably between 0.4~1.4 tonnes/

Note that the stern is almost submerged, but the vessel remains afloat.

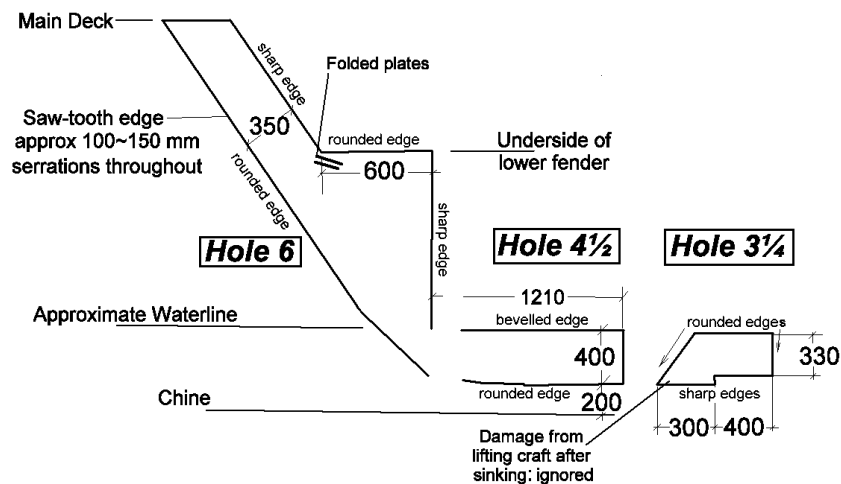
App IV – 8. Information on the holes in the shell plating Lamma IV

36. The size and location of the holes in the hull of *Lamma IV* were carefully measured during an inspection on 11th December 2012, and are shown in Appendix IV Item 8. For the purposes of the numerical calculation, the hole into the Engine Room was considered as if it were two holes, one being the hole caused by the keelson and located at the bottom part of the side plating and roughly rectangular in shape, and the second hole being the diagonal penetration caused by the stem bar which had a roughly constant width of opening and extending from the top to the bottom of the

Measurements were taken on 11 December 2012 to assist with setting up a numerical model and calculating the area of the holes which influence the inlet flow velocity.

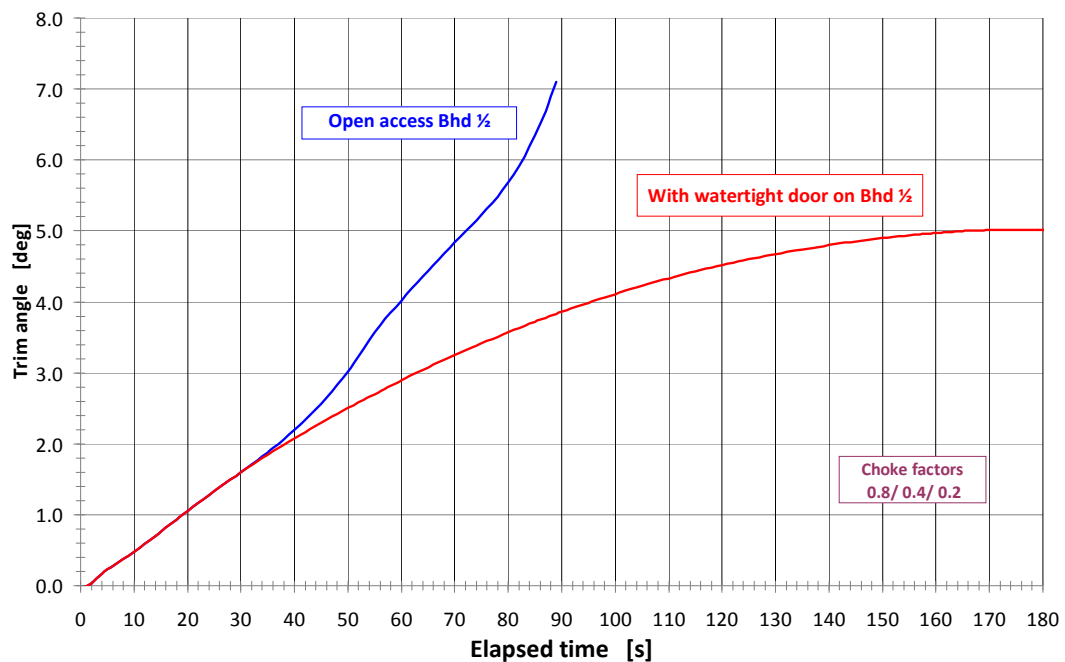
Diagram App IV-9-1

3. With the Tank Compartment, Engine Room and the Aft Peak flooded (three-compartment damage). **This replicated the actual damage to the craft** without a watertight door in the aft peak bulkhead. The results of the numerical simulation suggested that the craft would sink at a faster rate than the second simulation, with the main deck at the stern sinking below the water level about 87 seconds from the time of the collision. The inflow rate remained the same as in scenario 2 above, but once it had overflowed the sill of the access opening in Bulkhead ½, the water became centred further aft, causing worse trim aft.

A dynamic numerical model of the flooding of Lamma IV was prepared to simulate the flooding process and to examine the reason for the apparent rapid sinking and excessive stern trim of *Lamma IV*. The prediction from the simulation is illustrated against elapsed time in the following diagram for a vessel with an access opening located in the bulkhead at Fr^{1/2}. The vessel becomes unrecoverably sunk when the transom disappears below the waterline, in about 87 seconds from first breach of the hull.

The same simulation was also run with a watertight door on the open access at Bulkhead ¹/₂. In this scenario the vessel floated with equilibrium despite the damage.

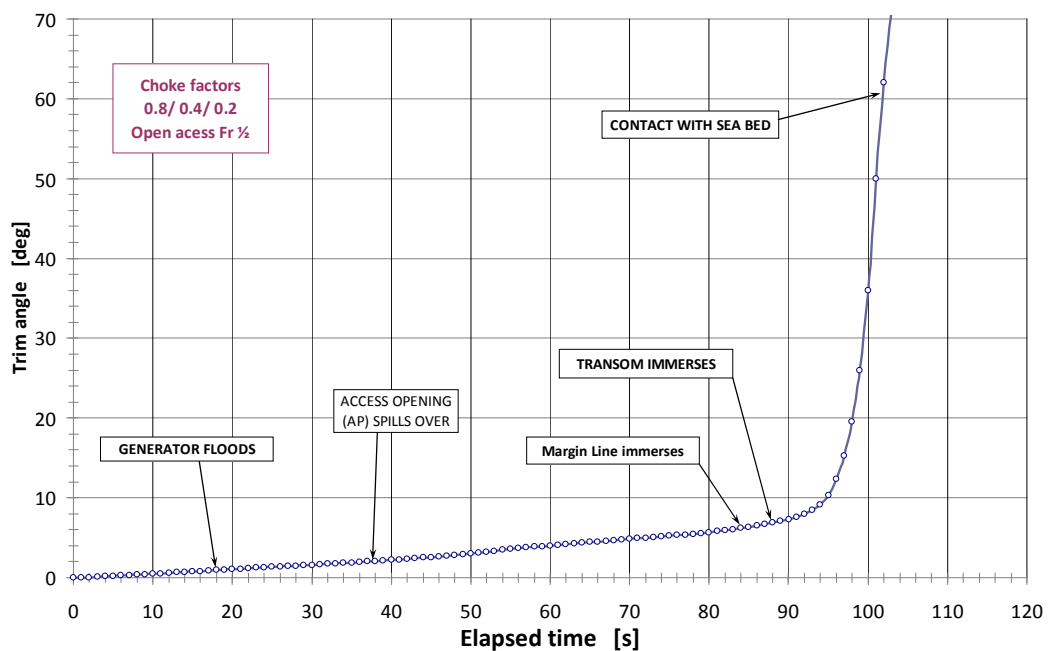
Diagram App IV-9-2

The above simulation only calculated the flooding of the vessel and not the sinking. The output from the simulation was used as a starting point for a further simplified mathematical model which predicted the attitude of the vessel as it sank to the sea bed. The timeline of this second simulation is illustrated below:

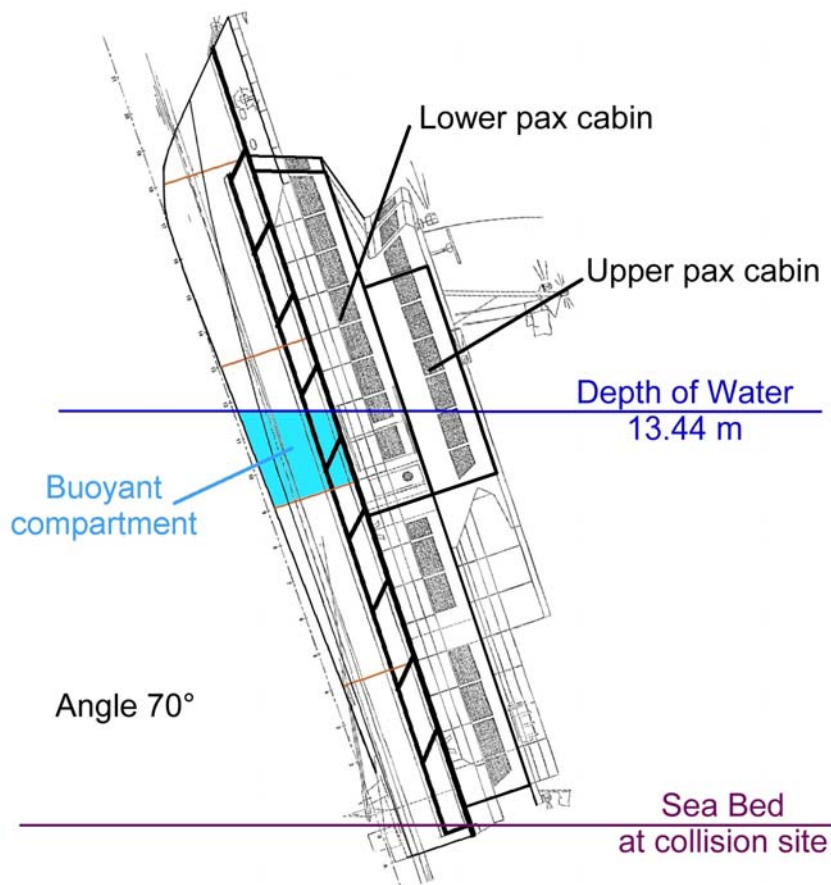
App IV - 9.3

The attitude of the vessel taken from the numerical simulation after 102 seconds from the first contact between the two vessels is illustrated below:

SITUATION AT 102 SECONDS AFTER COLLISION
VESSEL STABLE, NOT FLOODING FURTHER

This compares closely with a photograph taken during the initial rescue process.
