EXPERT REPORT

Expert Witness appointed by the Commission of Inquiry
into the Collision of Vessels
near Lamma Island on 1 October 2012

3 January 2013

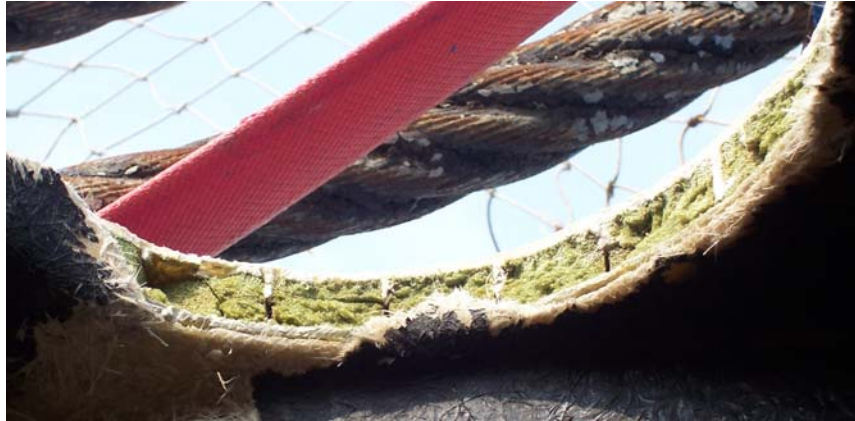
App IV - 10. Detail of the upper deck GRP (fiberglass) laminate construction

42. Following flooding, *Lamma IV* assumed a severe stern trim. This attitude caused the failure of all of the fastenings connecting the seats to the upper deck, with the reported exception of one seat. From inspection, the seats appear to have been screwed to the deck using a variety of different sized screws of various types⁴⁶. There were many screws left lying on the deck when the vessel was recovered.
43. The upper deck was manufactured as a glass fibre composite structure⁴⁷, which was made up of three components as follows:
- 2.1 mm thickness of woven rovings and chopped strand mat
 - 25 mm thickness of foam
 - 2.1 mm thickness of woven rovings and chopped strand mat

The following photograph was taken by Dr. Armstrong during an inspection of *Lamma IV* on 11 December 2012, which shows the deck construction in way of a ventilation trunk which became displaced during the accident. According to the construction drawings the laminate at this location is the same as at all other locations where there were seats.

46. The seat connections on the upper deck should have been through-bolted, meaning a bolt should have been used that had a nut under the deck with a washer sufficiently large to spread the load so as not to crush the foam. The seat foundations on the lower deck did not fail, because all of them were screwed through the aluminium

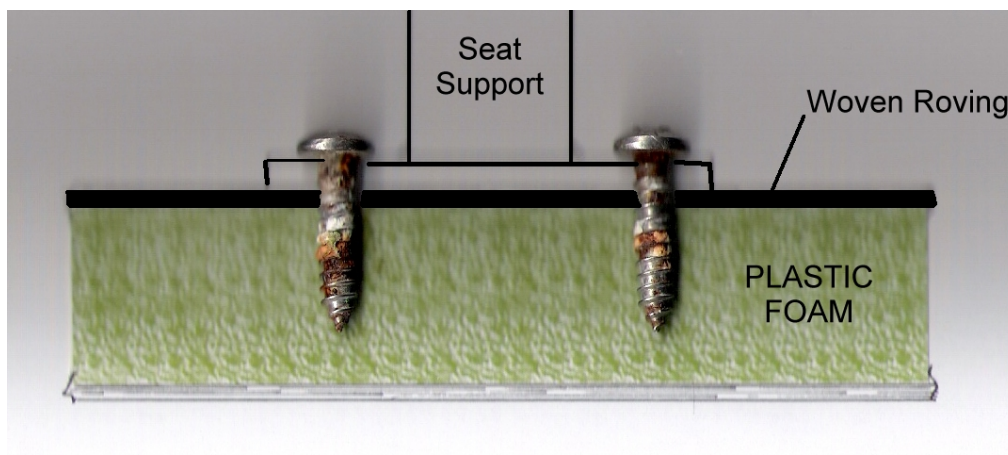
App IV - 11. Sketch of the seat foundation arrangement on the upper deck

48. It is noted from the annual survey items that the seats generally appear to have performed adequately since 1995. There is evidence that some of the seat foundations became loose in service⁴⁹, and photographs taken after the accident of one seat foundation⁵⁰ suggest that at one stage some of the seat screws have pulled out and could not be replaced, and consequently a small steel plate was connected to the deck with four new screws and to which the seat was then attached. In other examples the screws appear to have pulled out at some stage and have been put back very close to the previous hole⁵¹. It was only in the abnormal condition where the vessel had excessive stern trim and the weight of the seated person generated an abnormal tipping force that the foundations finally failed. Nevertheless the arrangement of screwing seats into GRP foam sandwich in my opinion could not be considered as adequate.

This sketch is drawn to scale from the construction drawings, using two of the actual screws remaining on the upper deck.

Only the black part marked as “Woven Roving” makes a structural connection with the screws, the plastic foam having no strength to resist “pull-out”.

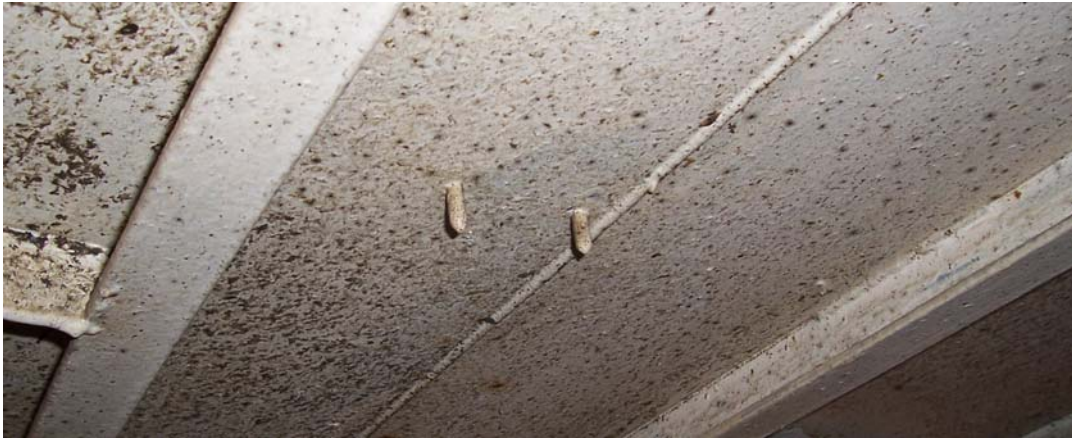
App IV - 12. Seat foundation screws in the aluminium main deck

Photograph taken from underneath the aluminium main deck, showing undisturbed seat screws encased in paint. As far as I could see this was typical of them all, without cracked paint.

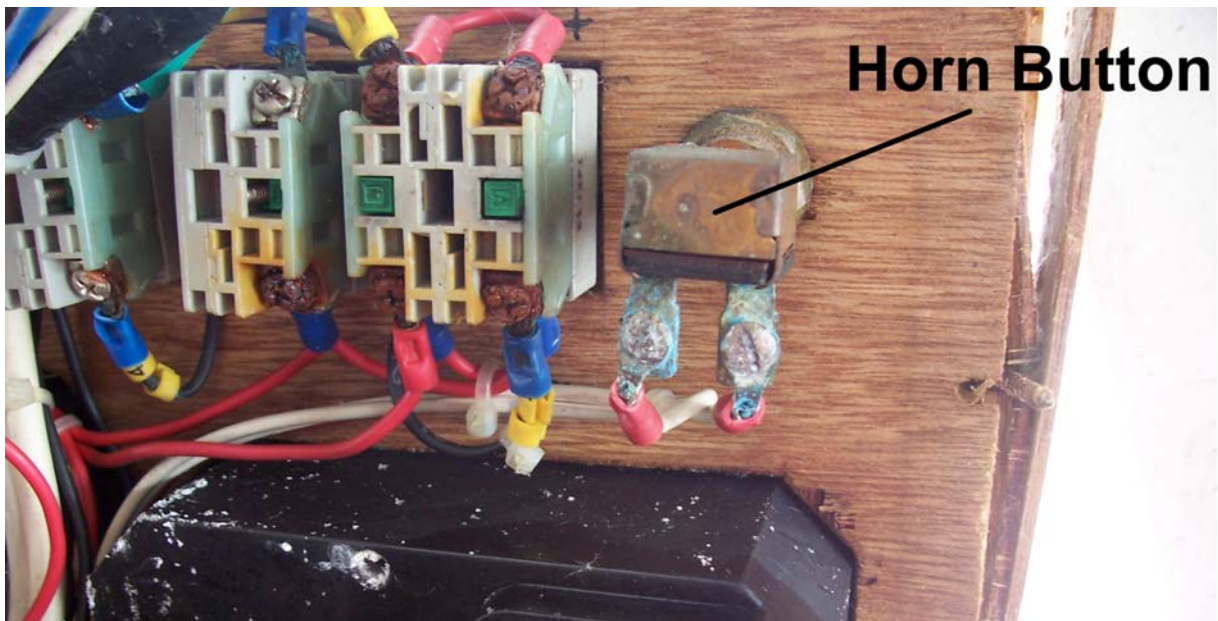
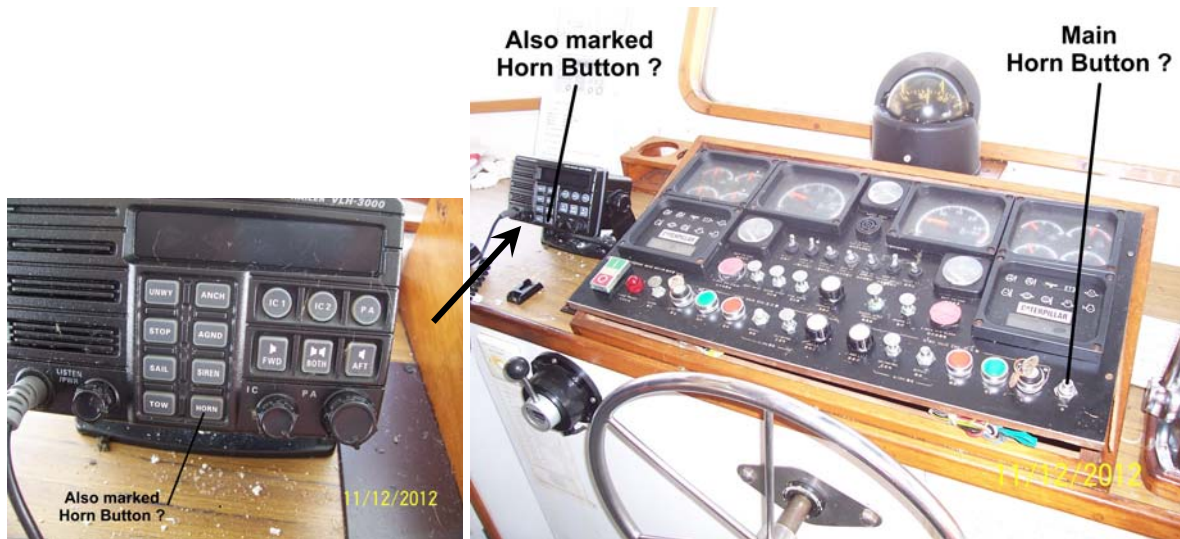
App IV - 13. Horn Whistle

The following photographs were taken in the wheelhouse of Lamma IV, and show the corroded connections of the wiring to the Horn button, as well as two alternative horn buttons in the lower picture.
