SUPPLEMENTAL EXPERT REPORT

Expert Witness appointed by the Commission of Inquiry
into the Collision of Vessels
near Lamma Island on 1 October 2012

16 January 2013

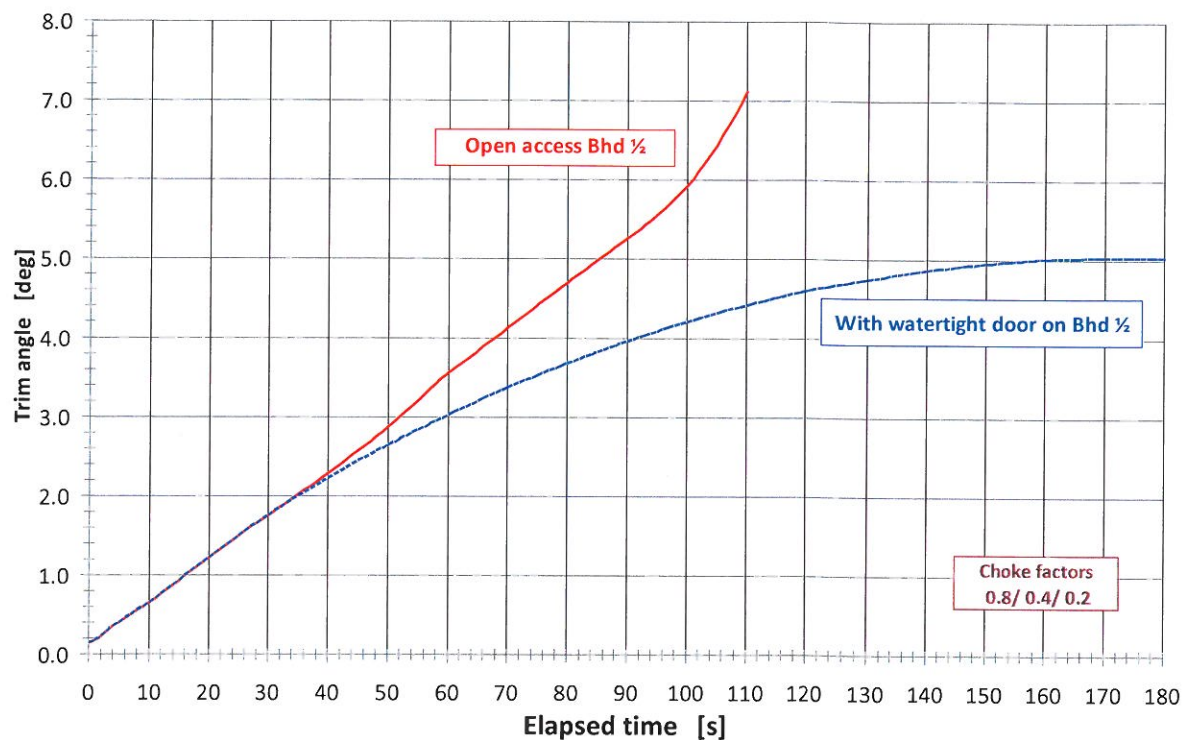
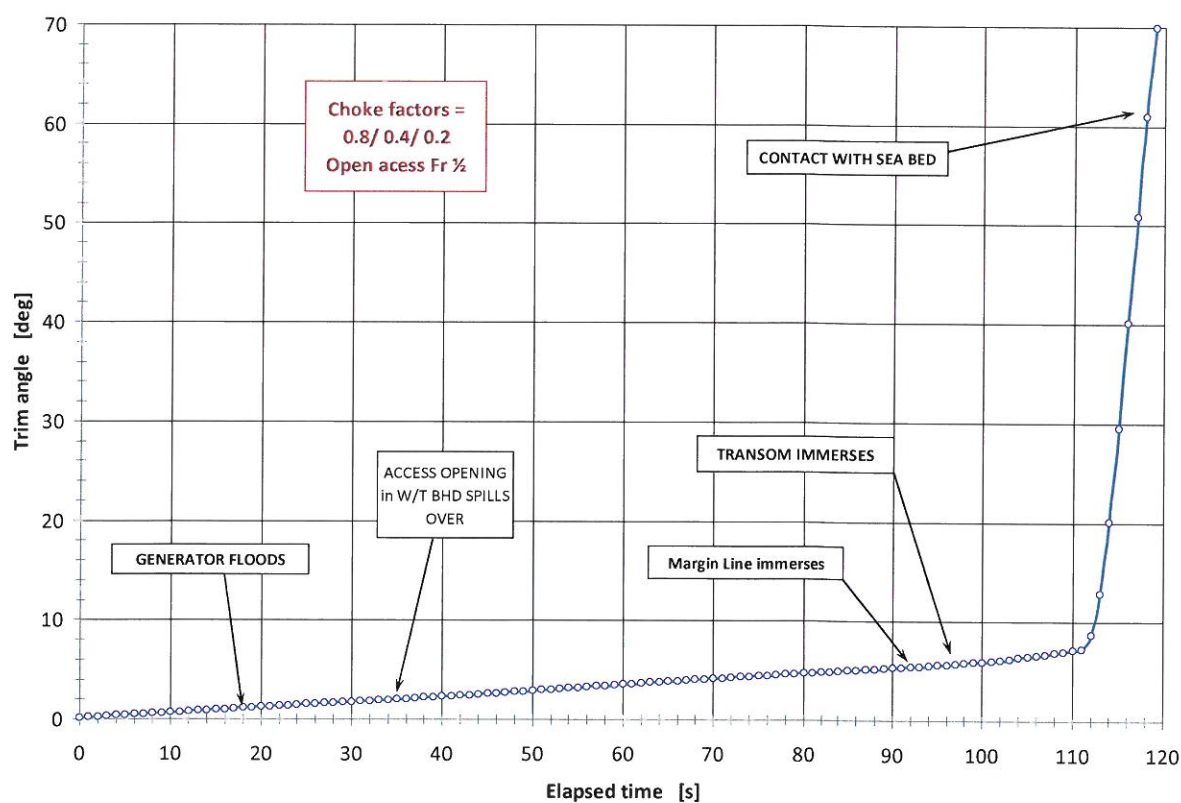
Appendix IV, Item 15. Elapsed time and trim angle, estimated choke factors

6. The revised timeline is given in Appendix IV, Item 15. The time to sink, given in my original Report at Paragraph 38-3 of about 87 seconds from initial contact to the deck at the stern going below the water, has extended to 96 seconds. The time of 102 seconds from the initial contact to assuming a position of 70° to the horizontal, given in my original Report at Paragraph 40, is amended to 118 seconds.

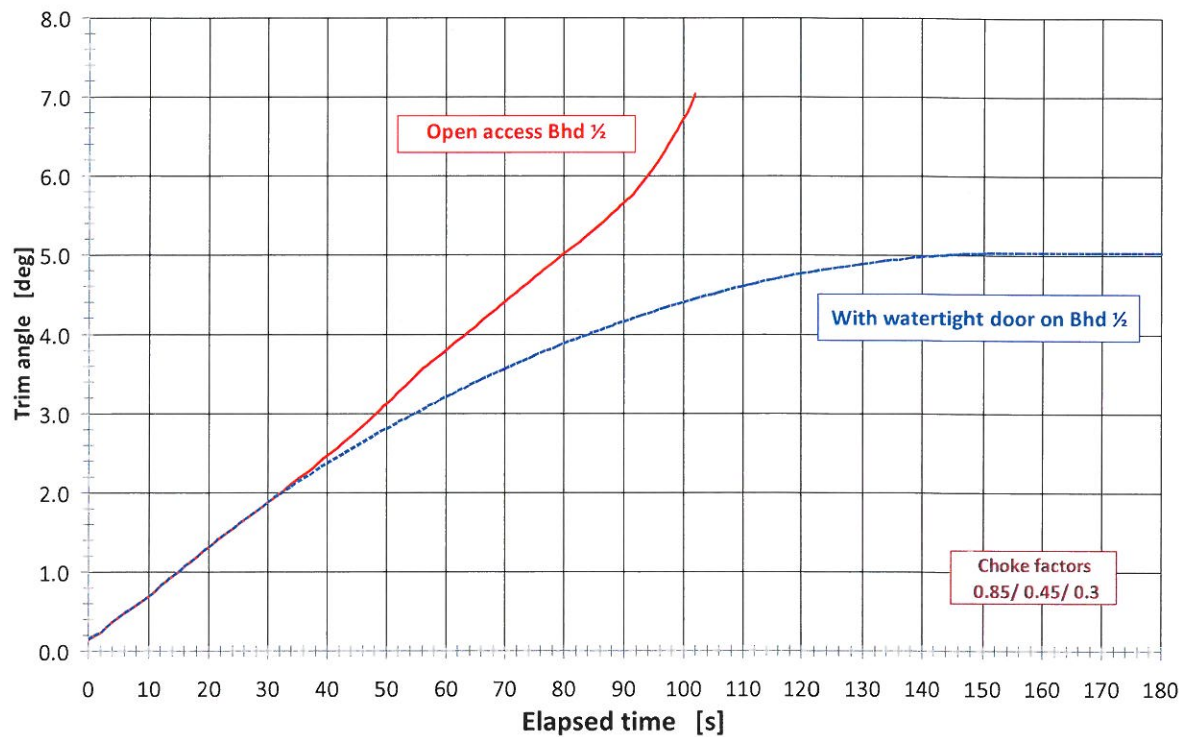
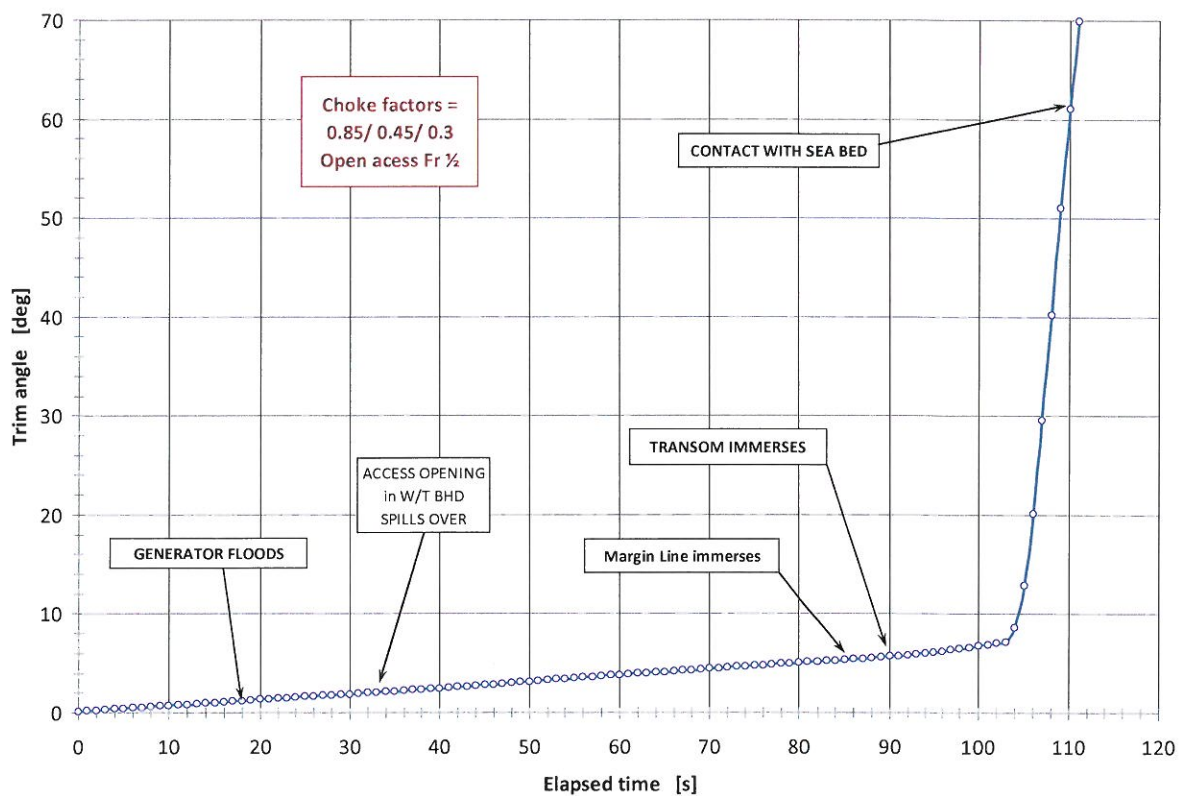
Appendix IV, Item 16. Elapsed time and trim angle, alternative choke factors (higher flow rate)

7. As the calculation of the timeline is dependent upon the arbitrarily-chosen "choke factors" which represent the effects of debris from *Sea Smooth* remaining within the holes in the hull, I have also included a second timeline in Appendix IV Item 16 which indicates the effect of choosing other choke factors. In this case the vessel is at

70° to the horizontal and resting on the sea bed in about 111 seconds, indicating a possible range error owing to the amount of debris in the holes of about 7 seconds.

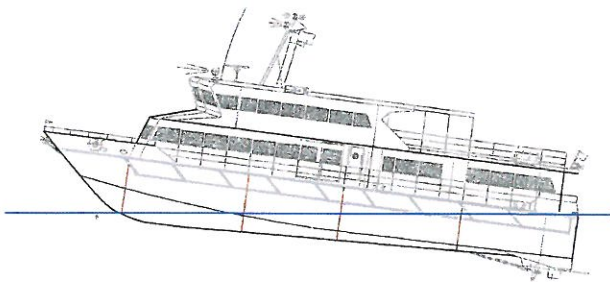
End of Phase 1: Transom immersed at 6.5°

Phase 1: Consequent to the flooding, *Lamma IV* sank by the stern until the deck edge on the transom went below the waterline. When this happened there was no further reserve of buoyancy and the vessel could only sink further. The trim angle at this point was a little more than 6½°, and this occurred at about 97 seconds after the collision.

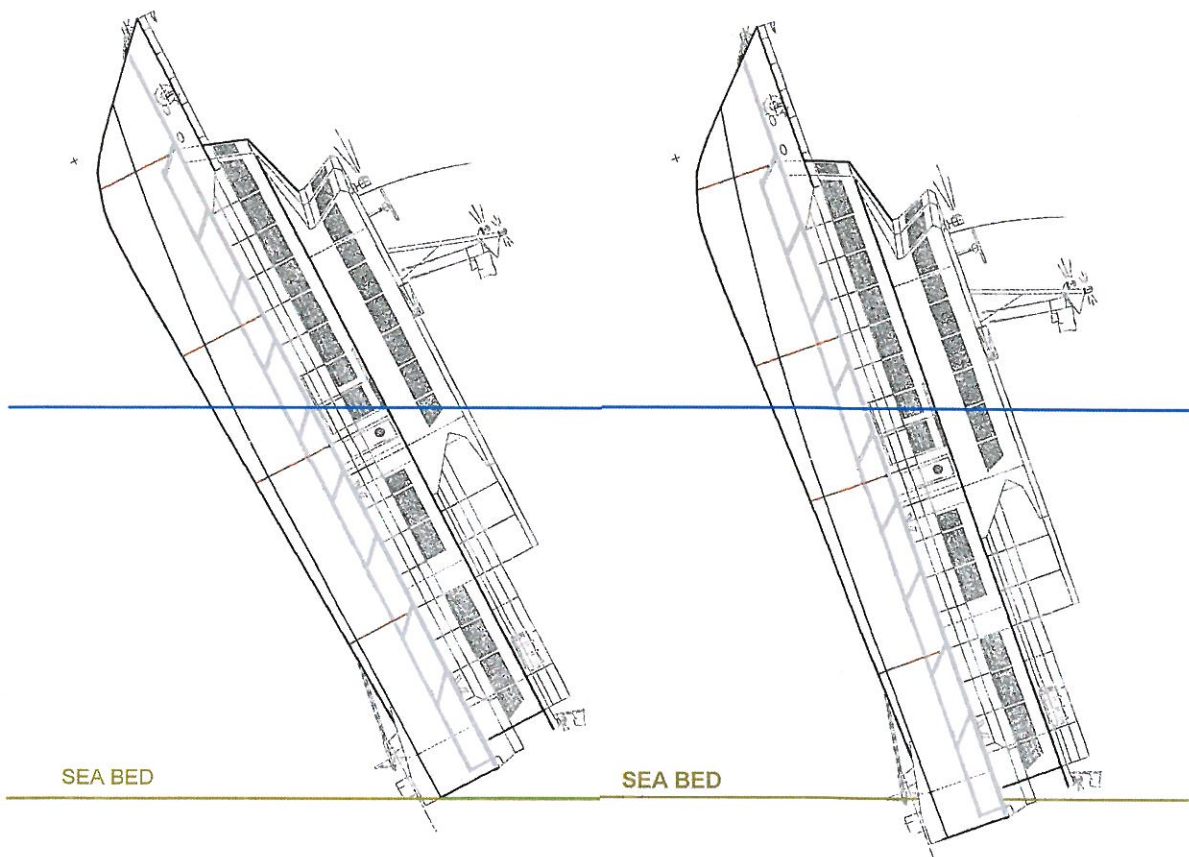
Phase 2: The vessel continued to rotate by the stern until the transom hit the sea bed at approximately 118 seconds at an angle of 62°. There are two witnesses^{3 4} who comment about a heel to starboard during the descent. This may have been the result of hydrodynamic forces generated around the hull whilst sinking, or from the rudders which were most likely positioned to one side, or even from the initial contact with the soft mud.

Phase 2a: The vessel settled in the mud to some unknown extent, but I have estimated this as initially 70° based on the depth of water and an assumption as to the depth of mud, supported by the attitude of the vessel illustrated in a photograph owned by the South China Morning Post⁵, which shows the initial stages of the rescue by the Fire Services Department.

End of Phase 2: Transom in contact with sea bed.

End of Phase 2a: Vessel settles into the mud on the sea bed.

Phase 3 is similar to the first diagram illustrated Exhibit 3, Witness Statement of Yau Wai Keung (31.12.2012).

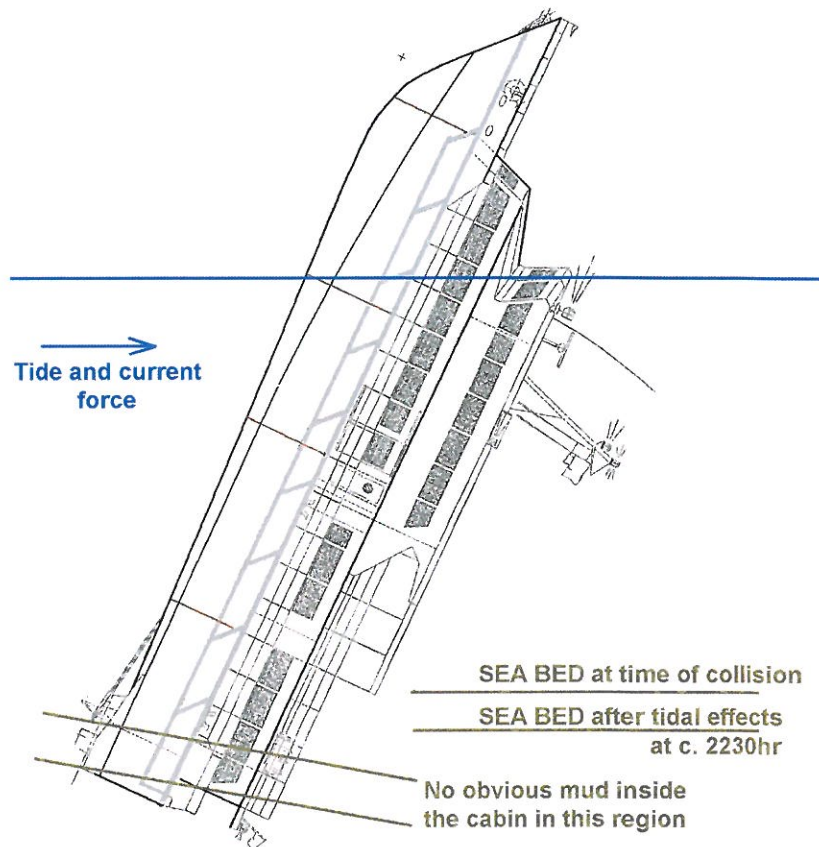
Final Phase 4.

Phase 4: Pushed by the current and with a receding tide, the vessel was trapped at an angle of greater than 90°, estimated from photographs as approximately 110°~115°. This attitude is widely presented in the media, but by this time I believe that all practical rescues of passengers had been completed. It is not known how much of the vessel was supported by the mud at this time, as the inside of the cabin has little obvious mud within it when it was inspected and there was little damage in the cabin area and upper deck from lying at the bottom. I can only assume that the vessel had dug a hole in the mud during the previous hours whilst it lay at lesser angles.

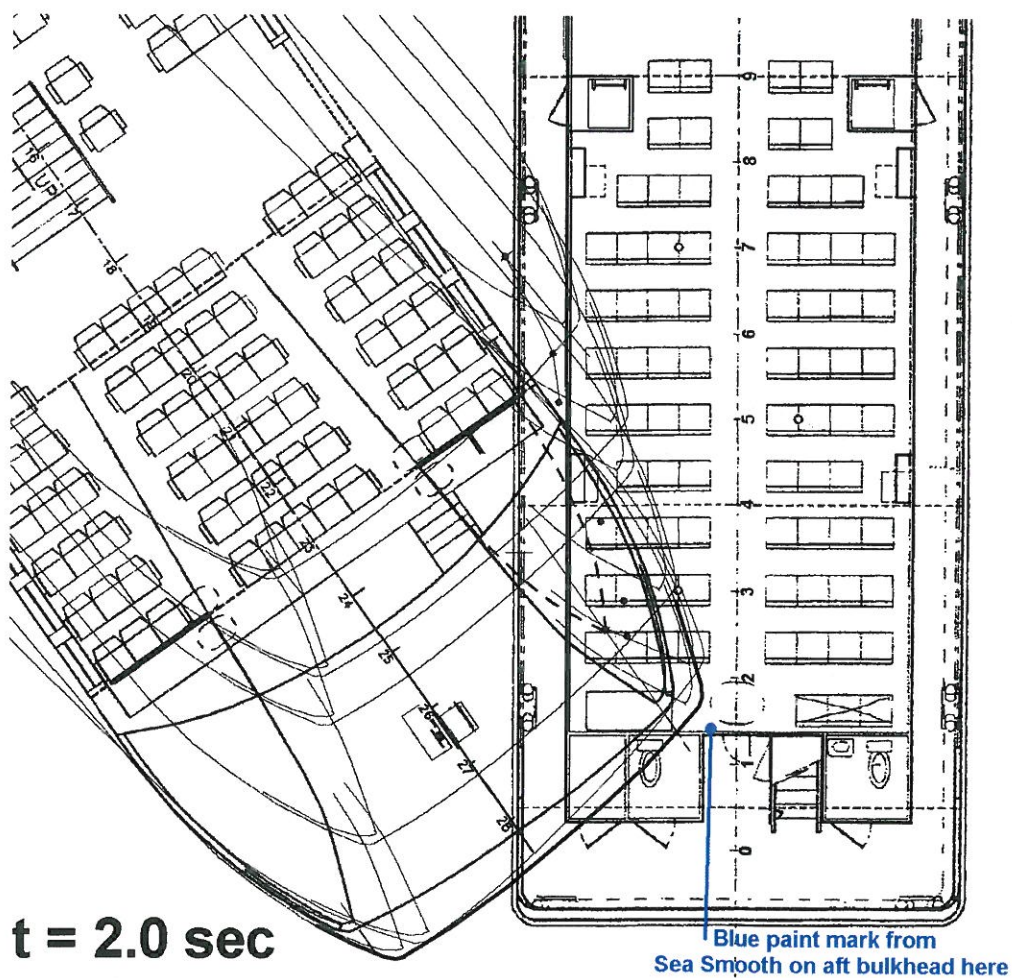
Appendix IV, Item 18. Forensic evidence of length of penetration of *Sea Smooth* into *Lamma IV*

- b) The blue paint smear referred to in paragraph 3.4.4 of Dr Cheng's report, and illustrated in his photograph 20, provides excellent correlation with the sketch included in my Report in Appendix IV on Page 64, being the plan view of the two collided craft at an elapsed time of 2.0 seconds and showing the calculated maximum extent of penetration of *Sea Smooth* into *Lamma IV*. This sketch is reproduced in Appendix IV Item 18, showing the location of the blue paint smear from *Sea Smooth* within the cabin of *Lamma IV*, and thus representing the maximum penetration of one craft into the other

The following diagram is taken from my initial report, Appendix IV Item 5 after a time of 2.0 seconds from the initial contact. I have superimposed the location where the Forensic Scientist noted a mark matching the paint of *Sea Smooth*, which shows good correlation with the extent of hypothesized penetration.

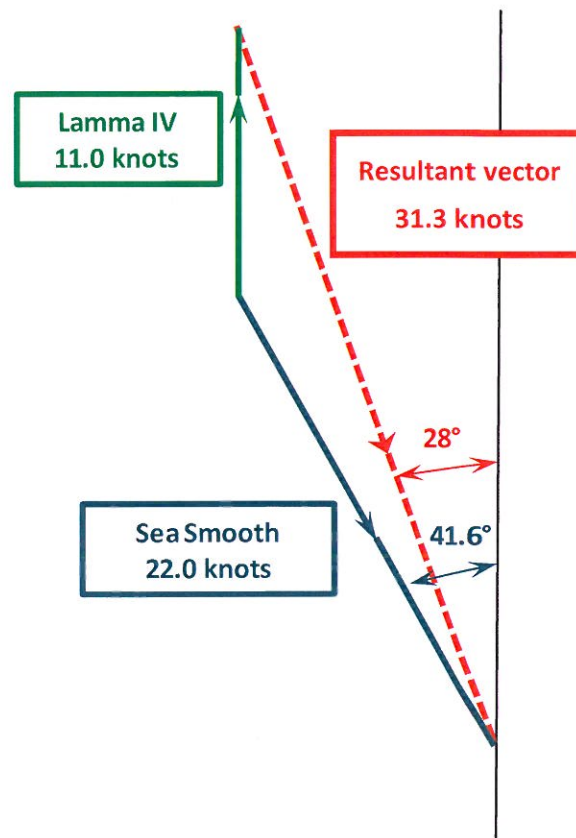
Appendix IV, Item 19. Difference in true heading angles of the two craft at the moment of the collision

- d) In paragraph 5.2 and in his summary at paragraph 6.1 of his report, Dr. Cheng comments that the two boats met at an angle of approximately 30°. I would like to clarify that the measured angle of 30° is not the angle at which the two craft met, because a geometric correction needs to be applied to allow for the relative speed of the two craft. According to my measurements, the angle of the gash in the deck in *Lamma IV* was 30° when taken down the centre of the gash, and at the inboard edge of the gash the angle was 28°. These angles, when considered with the relative speed of the two craft, show that the two boats met at a difference in true heading angle of approximately 41.6°, as discussed in my report in paragraph 15, and not at 30°. The vector diagram is illustrated in Appendix IV Item 19, with *Lamma IV* moving at 11 knots "up the page" and *Sea Smooth* moving at 22 knots from the top left towards the bottom right at an angle of 41.6°. In this case they meet at a combined speed of 31.1 knots and an apparent relative angle of 28°, but the true heading difference was 41.6°.

The following diagram is based on a speed of 11 knots for *Lamma IV* and a speed of 22 knots for *Sea Smooth*, and results in a difference in true heading of 41.6° . Other speeds can be solved using simple geometry to give alternative heading angles as listed in my Report of 3 January 2013.
