# **ASSESSMENT OF THE ELECTRICAL ASPECTS OF LAMMA IV**

***Prof. S.L. Ho***

**DEPT. OF ELECTRICAL ENGINEERING  
HONG KONG POLYTECHNIC UNIVERSITY**

**6 March, 2013**

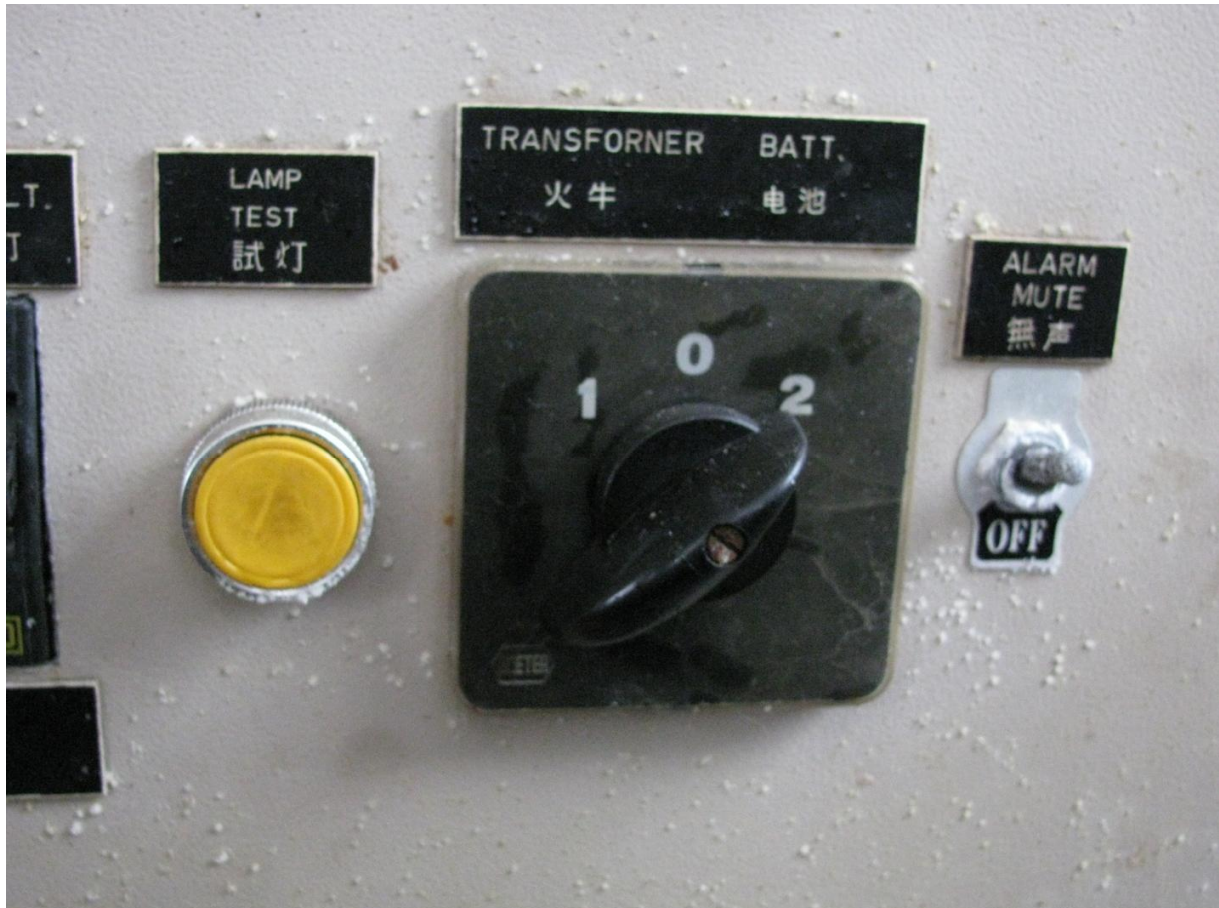
- 1) The power to the various circuits could be obtained from either the generator (designed as 010 or 0Transformer) or from the Batteries (designed as 020 or 0Batteries0). When the selector is in the middle position, there is no power supply to the light circuits.

Photo 1 Power to the various light circuits can be obtained either from the Generator or from the Batteries Pack. There should be no differences in the functionality of the circuits no matter where the supply was derived. However the power from the generator would be more stressful to the components (such as lamps) if the voltage rises above a certain threshold value. For example, if a 24 V lamp is fed from a 26 V source, there is more power pumped into the lamps, thereby shortening the life expectancy of the lamps.

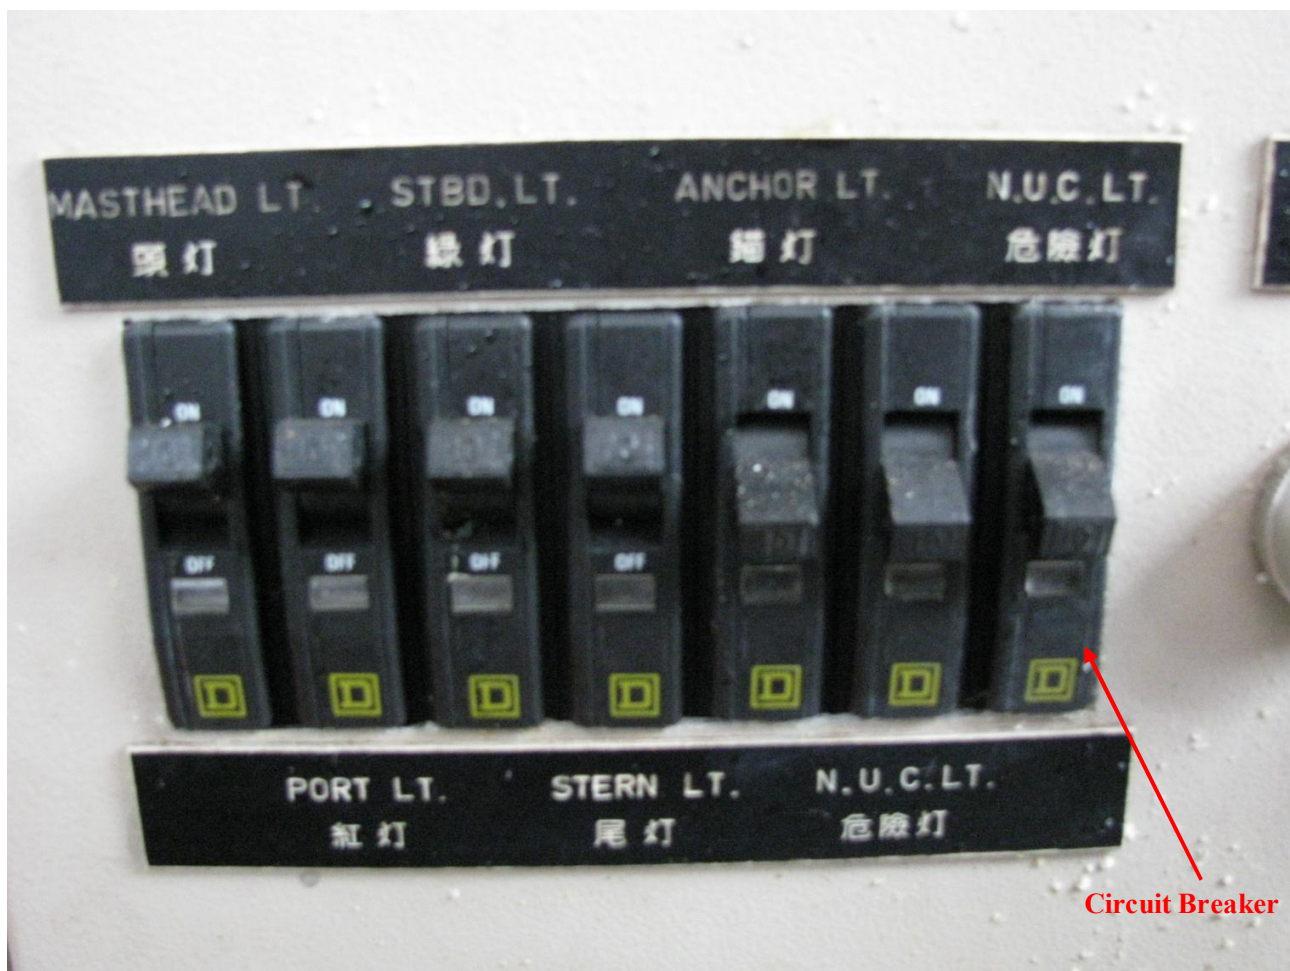
Photo 2 Circuit Breakers controlling the various lighting circuits

It is noted that the Circuit Breakers for the Masthead Light, Port Light, Starboard Light and Stern Light were seen to have been clicked to the ON position at the material time of the visit on 2<sup>nd</sup> March, 2013. If the observed Circuit Breaker status were the same as that at the material time of the accident, then all the four navigation lights as mentioned earlier would be energized, unless there is no power connected to that particular circuit or the light bulbs were blown. If, however, there was NO power feeding into the Distribution Board in Photo 2, then the light bulbs would remain to be DARK even if its associated Circuit Breaker was switched ON (and remains ON regardless of whether power was fed to the Distribution Board, as Circuit Breakers can be clicked to either ON or OFF positions manually) because, for example, we can click the light bulb switches in our flat to the ON position but the light bulbs will remain DARK if the power company has cut off the power supply to the flat. The last three Circuit Breakers, namely those for the Anchor Light and the two N.U.C. Lights were clicked to the OFF position in Photo 2 and these Lights had therefore been switched OFF altogether (if these Circuit Breakers were clicked to the OFF position prior to the accident).

It is further noted that the Circuit Breakers for the Masthead Light, Port Light and Starboard Light were functioning normally as they could be set positively to either the ON or OFF position. The Circuit Breaker for the Stern Light was however malfunctional and this is indicative that this Circuit Breaker had previously been tripped to the OFF position by a heavy current. In other words, this Circuit Breaker should not stay at the ON position as seen in Photo 2. The fact that the Circuit Breaker was clicked to the ON position was probably because it could have been clicked to such position by an unknown person (as the Circuit Breaker would not return to the ON position automatically after being tripped to the OFF position) during inspection and investigation, for example.

6. The seven Circuit Breakers as shown in Photo 2 (and Photo 6) controlled the powering of the Light Circuits. It can be seen in the Photo that the Circuit Breakers for the Masthead Light, Port Light, Starboard Light and Stern Light were all switched to the ON position. Hence these four light should be energized and lit up if the light bulbs were healthy. It

should also be noted that Circuit Breaker that controlled the power to the Stern Light was damaged (i.e. malfunctional) and this, when viewed together with the damaged Relay as shown in Photo 7, is a strong indication that there were power supplied to the Stern Light circuit. Whether the Stern Light was lit at the material time of the incident would depend on whether the Stern Light Bulb was healthy or not.

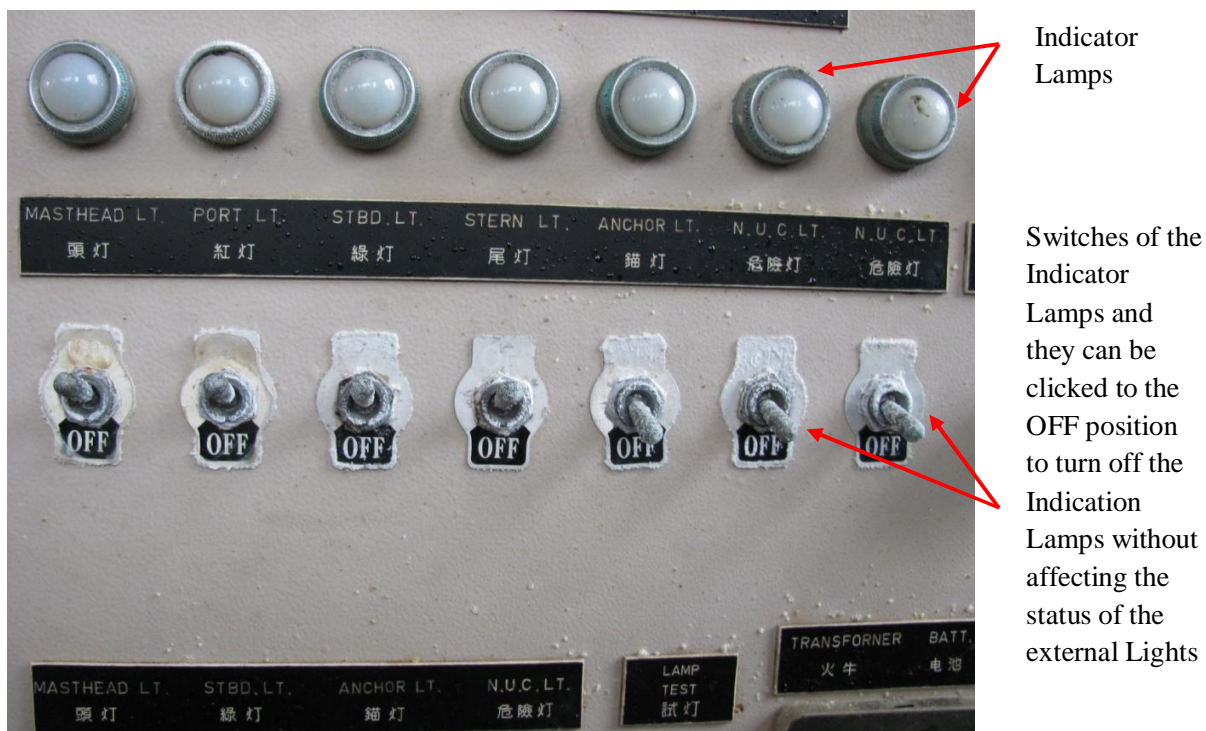
Photo 3 The indicators of the Lights can be switched off without affecting the actual lighting circuit outside. The light intensity can be controlled by a dial as shown in Photo 4.

7. There were seven switches that controlled the Indicator Lamps as shown in Photo 3. The first four (counted from the left) were all switched to the ON position and these four lamps were the Lamp Indicators for the Masthead Light, Port Light, Starboard Light and Stern Light. The remaining switches were in the OFF position which means the Indicator Lamps of the Anchor Light and the two N.U.C. Lights were turned OFF. Hence the status of the Anchor Light and the two N.U.C. Lights could not be seen by the Officers inside *Lamma IV*.

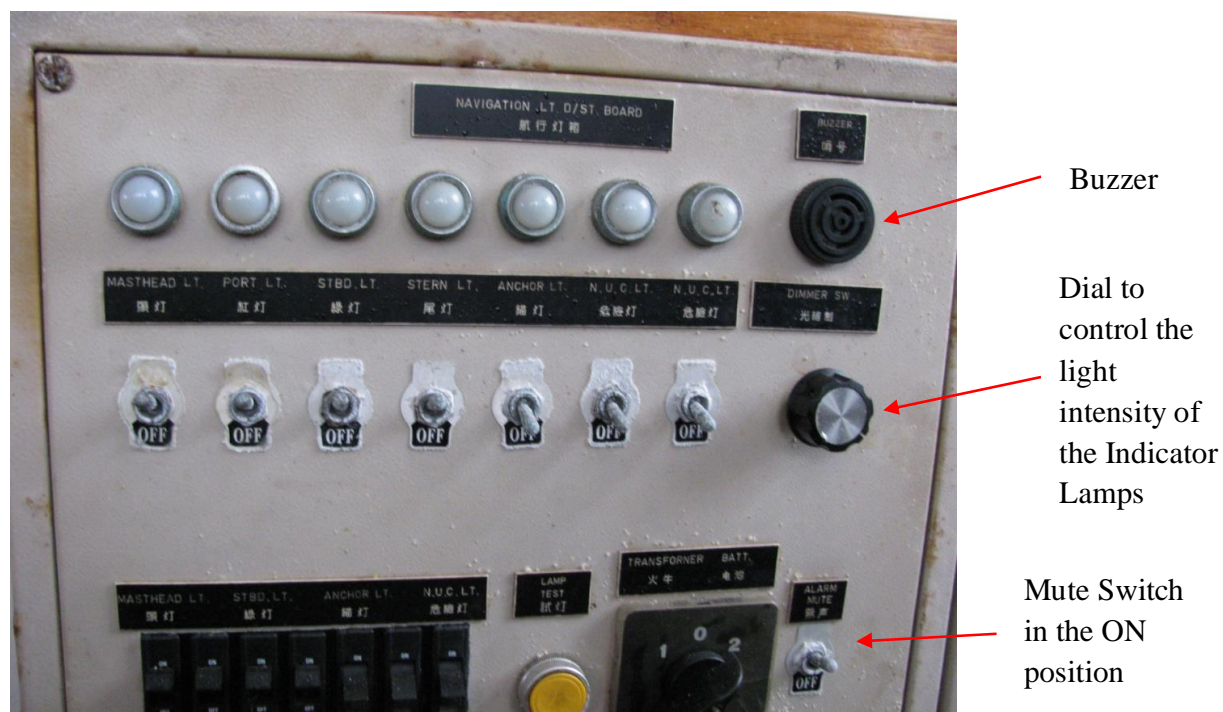
Photo 4 The intensity of the Indicator Lamps can be controlled by the dial as shown in the photo

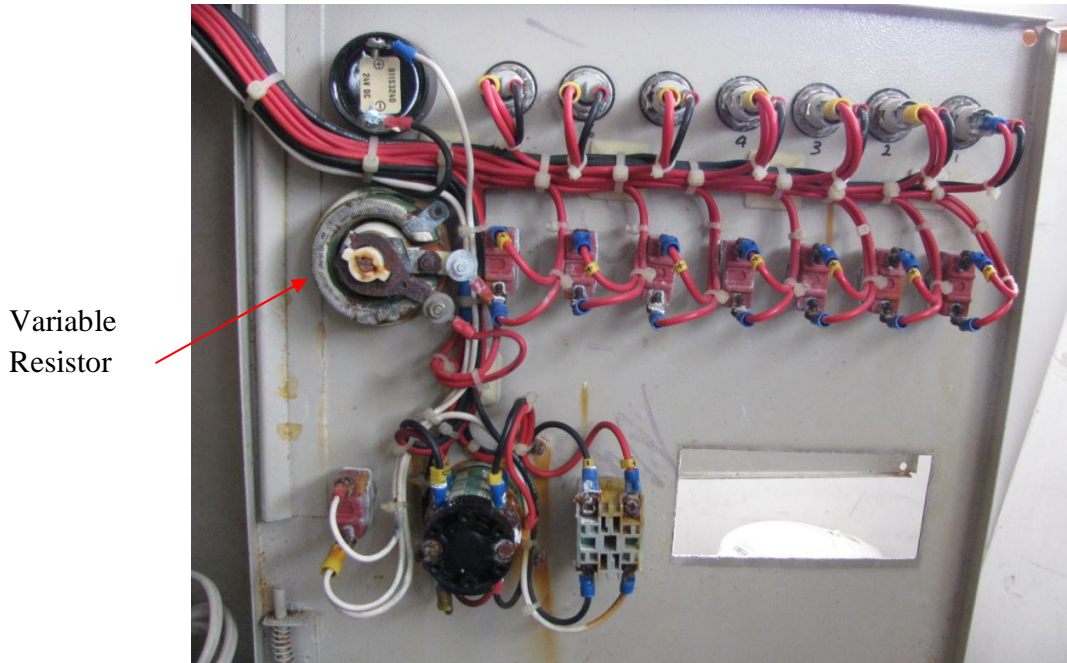
Photo 5 Upon removal of the cover, one can see the wiring of the Indicator Lamps together with the Switch for each Light Indicator.

The Dial as shown in Photo 5 actually is a variable resistor which controls the current that flows into the Indicator Lamps. Basically, the supply circuit to the Indicator Lamp is as shown below:

The undersigned had tried to measure the resistance of  $R_1$  during the site visit on 2<sup>nd</sup> March, 2013. However it was found that because of rust formed on the surfaces of the variable resistor, it was difficult to measure  $R_1$ . It was subsequently found on 4<sup>th</sup> March, 2013 that there were so much rust on the variable resistor that it was difficult to measure the resistance after the rusts were cleaned by sandpaper. It is likely that the variable resistor needs to be taken back to the University for further cleaning before one can measure the resistance more accurately.

Notwithstanding the fact that  $R_1$  had not been measured, it is estimated that the light intensity of the Indicator Lamp will be less than half of its full intensity when  $R_1$  was set to its maximum value.

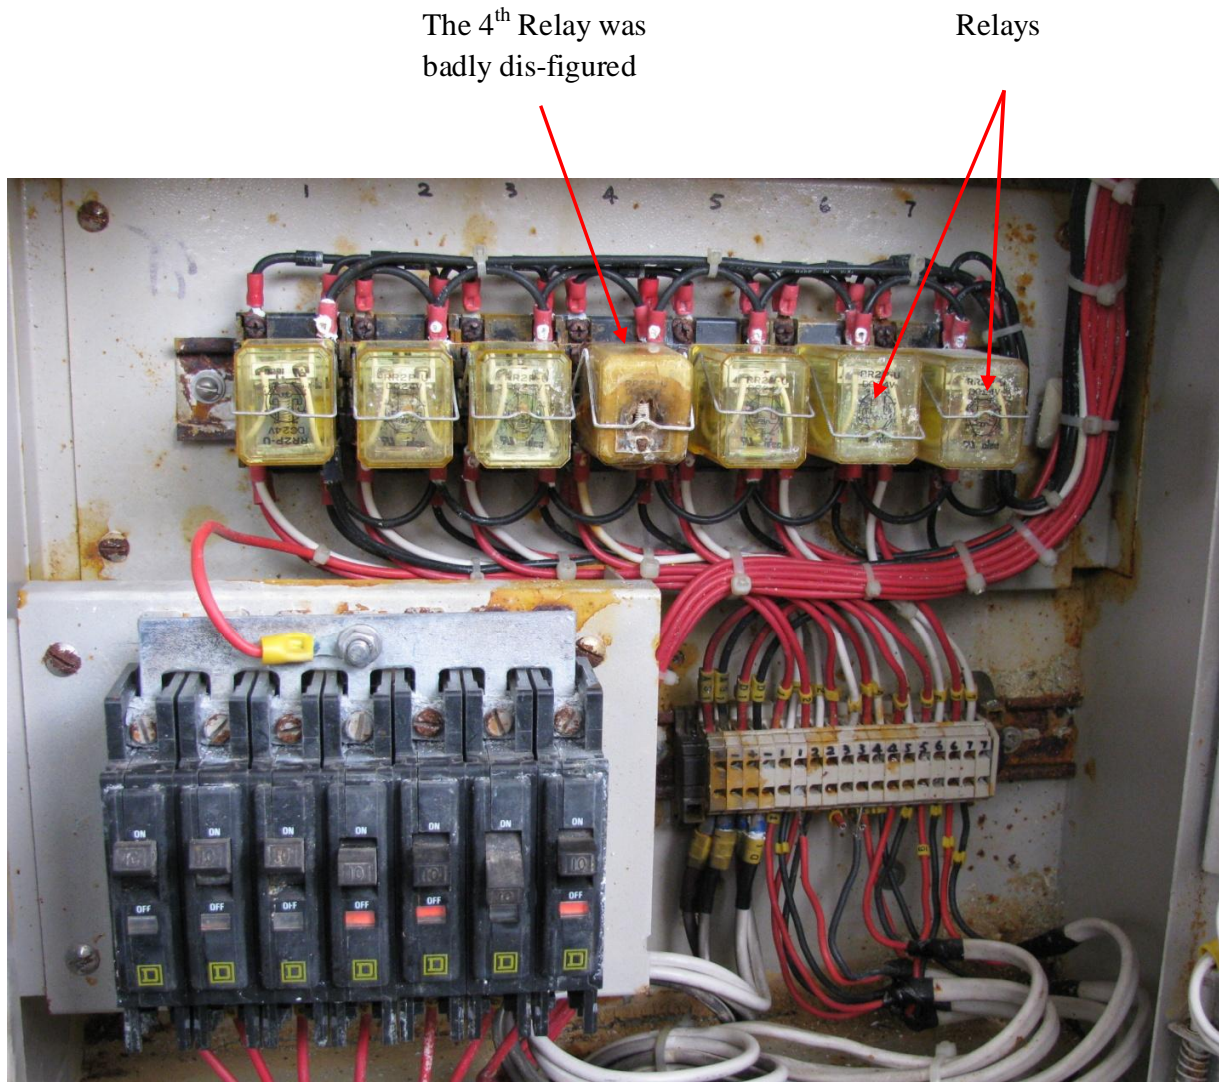
Photo 6 The relays of the seven Lighting Circuits are as shown in the Photo. All Relays, with the exception of the 4<sup>th</sup> Relay counted from the right hand side, appeared to be normal.

It is noted that there are red flags in Circuit Breakers No. 4, 5 and 7 (when counted from the left) in Photo 6. This is typical in Circuit Breakers indicating the status of the Circuit Breaker being in the ON state. An example from a Circuit Breaker being used at the University is as shown in Photo 9.

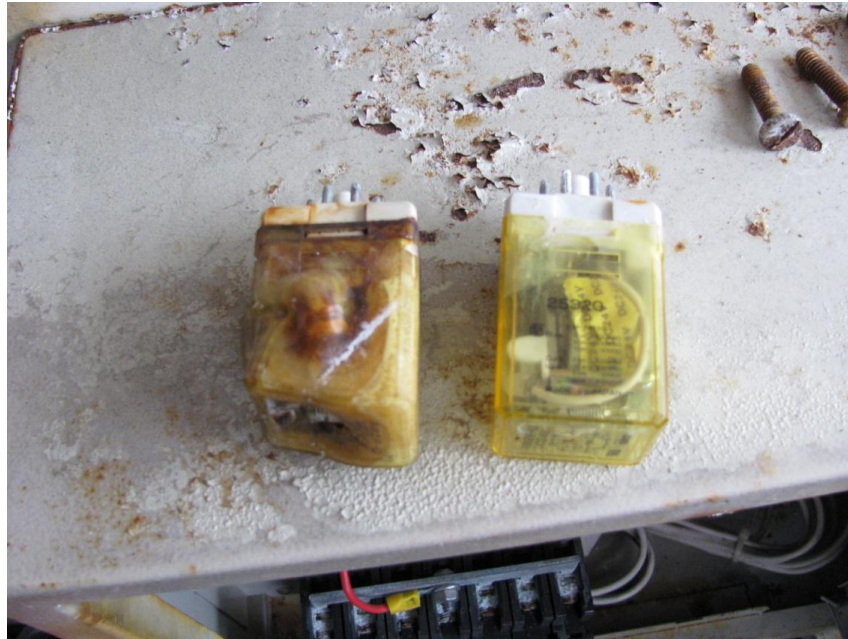
Since the 4<sup>th</sup> Relay as shown in Photo 6 was found to be badly disfigured, it was taken down and compared with a healthy relay as shown in Photo 7.

Photo 7 A badly disfigured relay (on the left) together with a ðhealthyö relay (on the right)

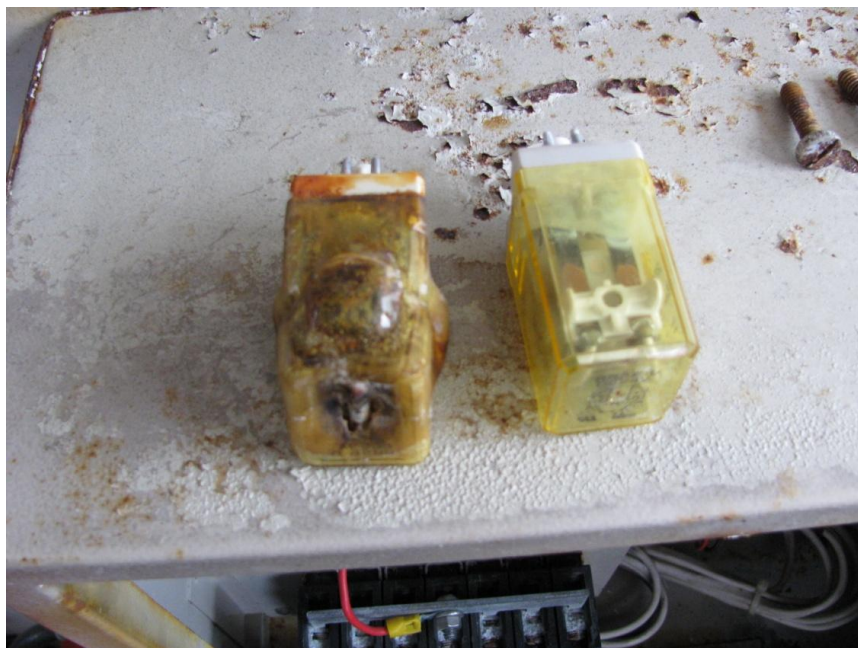
Photo 8 Another view of the disfigured relay and ðhealthyö relay. From the outside appearance of the dis-figured relay, one can confirm that high current had been flowing through the Coil inside the Relay for a prolonged period, of the order of at least several minutes. The reason for such high current was possibly because the devices in series with the Coil inside the Relay had been short-circuited.

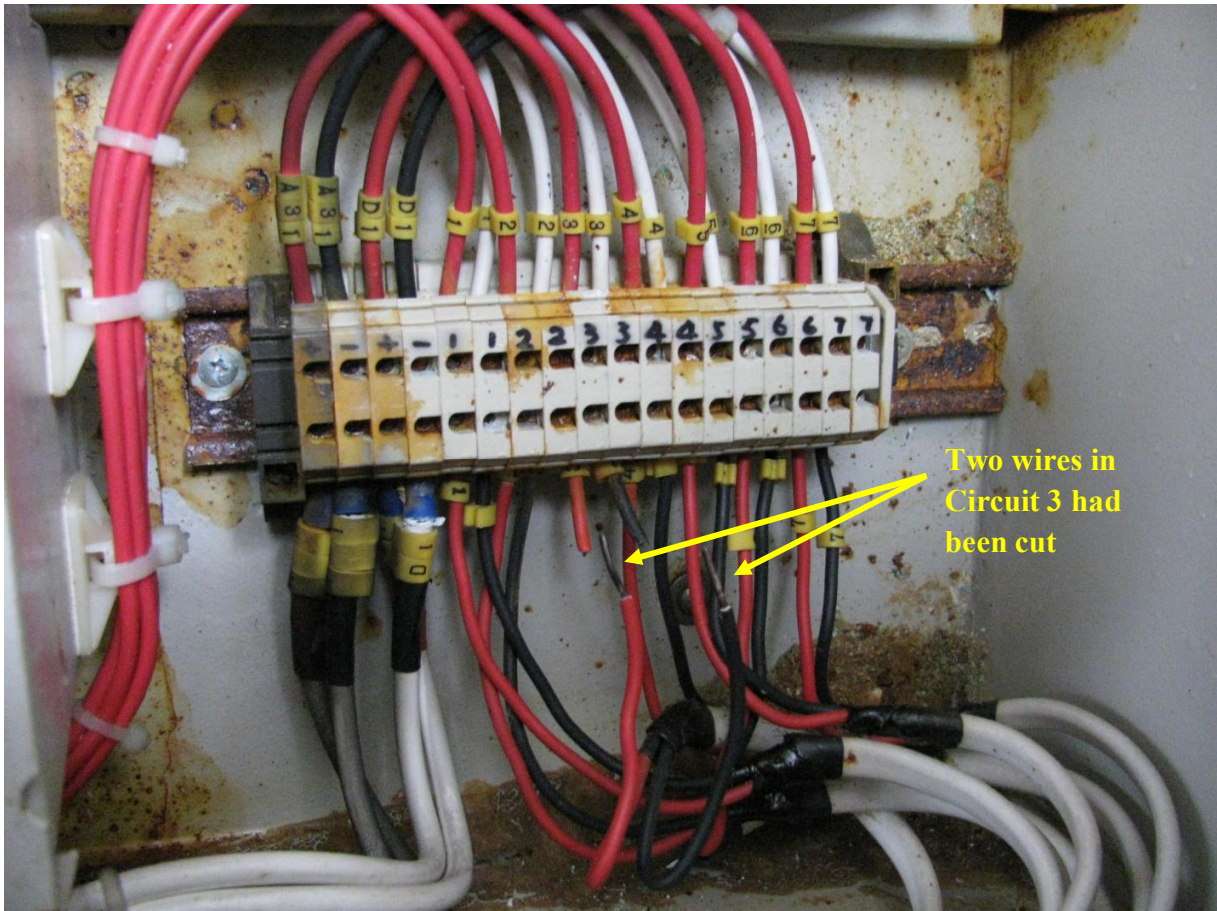
Photo 10 Two wires in Circuit 3 (believed to be in the circuit of Starboard Light Circuit) were found dangling in air after the cover of the Distribution Board was removed. If the circuit for the Starboard Light Circuit had indeed been cut, then there should be no power to the Starboard light bulb and hence it would not be lit. However it was confirmed subsequently that the wires were cut by Mr Szeto Yiu Kuen of Mardep for the purpose of marine accident investigation.

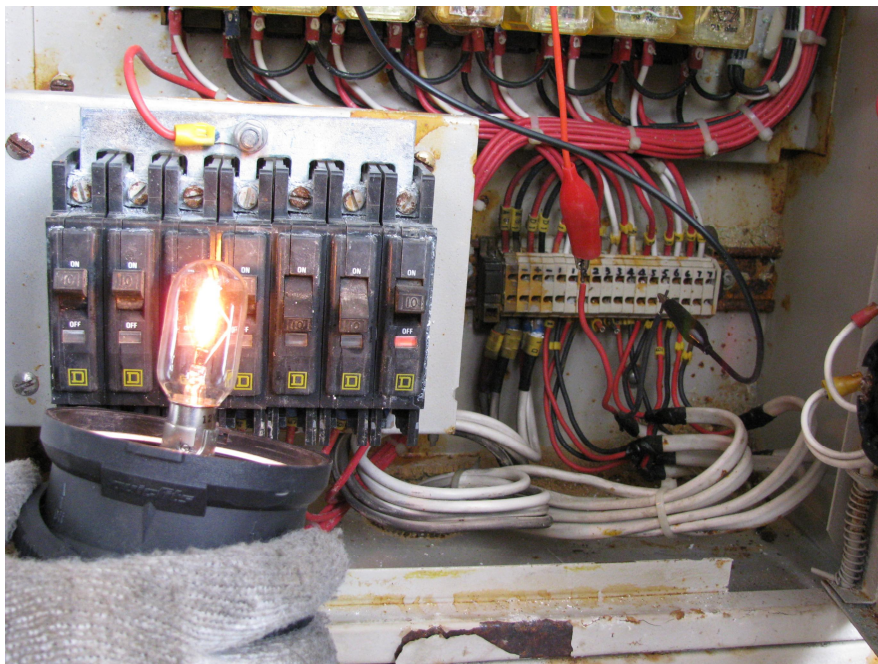
Photo 11 When a 12 V power supply is connected to the two cut wires identified as Circuit 3 and with the light bulb connected to the holder terminals of the Starboard Light, the Test Light Bulb was lit up, thereby confirming the cut wires were connected to the Starboard Lighting Circuit.

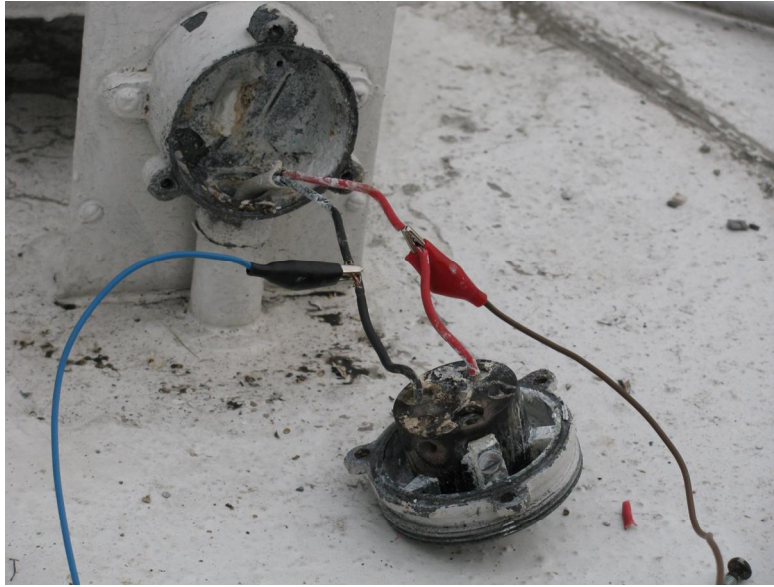
Photo 12 Two crocodile clips were used to connect two wires from the Test Light Bulb to the Starboard wires. It was found that the two wires (marked as Circuit 3) which have been cut in the Distribution Board were wires of the Starboard Light.

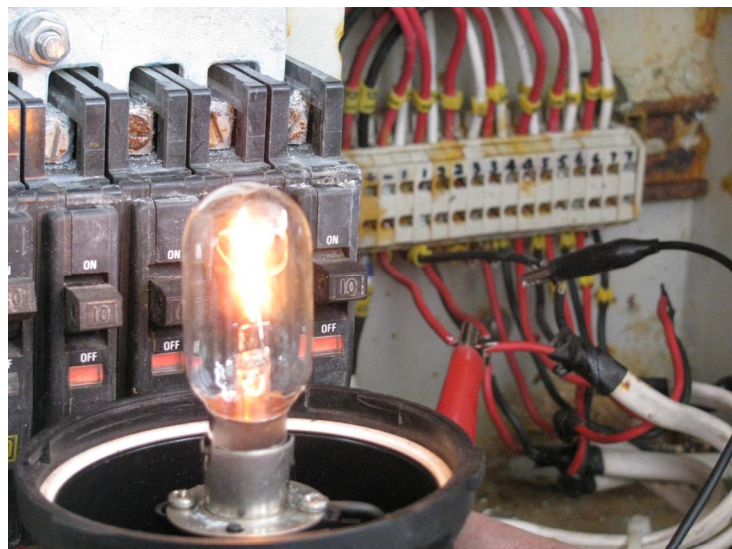
Photo 13 The insulation of wires in Circuit 2 was stripped to allow the connection of the 12 V power supply to the test circuit. Upon connecting the Test Light Bulb to the Port Light circuit, the Test Light Bulb lit up to confirm positively that this circuit is the circuit for the Port Light.

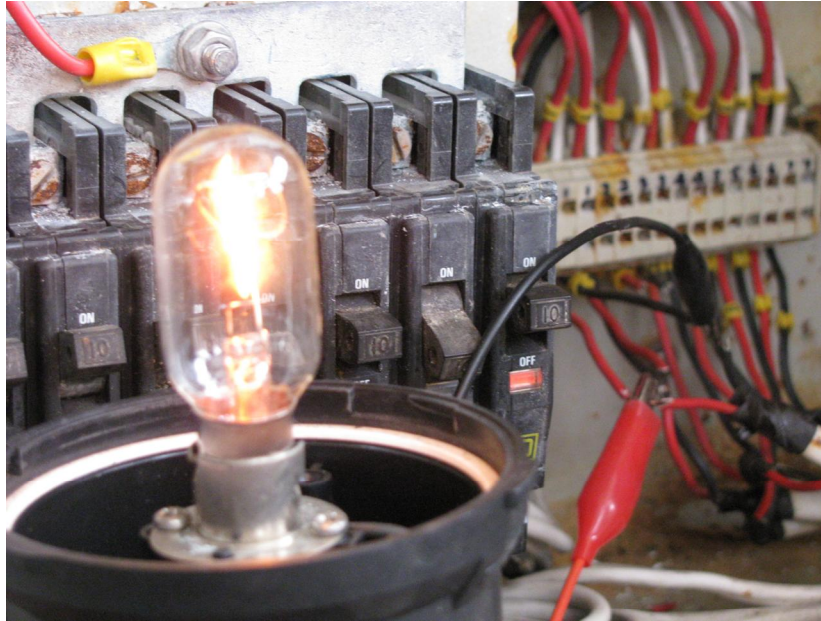
Photo 14 The insulation of wires in Circuit 1 was stripped to allow the connection of the 12 V power supply to the test circuit. Upon connecting the Test Light Bulb to the Masthead Light circuit, the Test Light Bulb lit up to confirm positively that this circuit is the circuit for the Masthead Light.

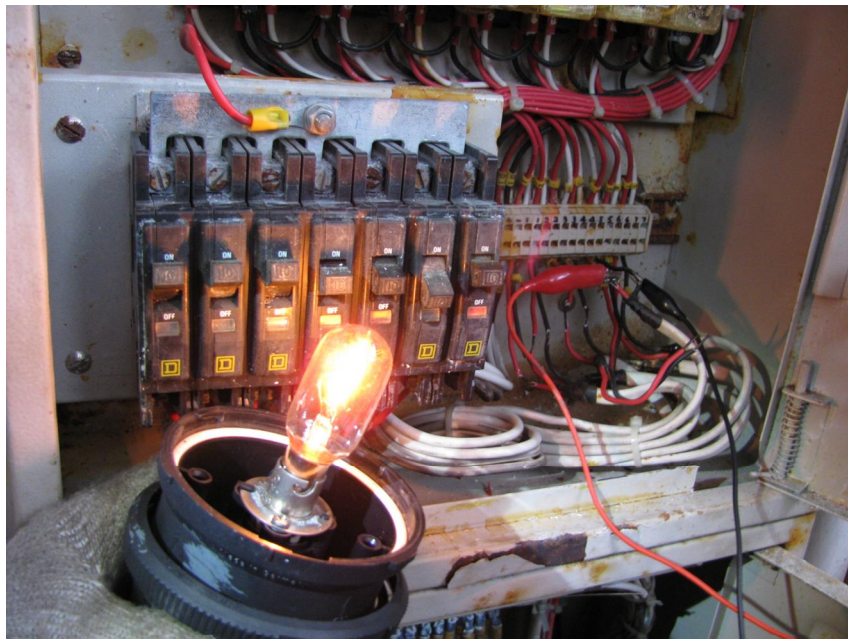
Photo 15 The insulation of wires in Circuit 4 was stripped to allow the connection of the 12 V power supply to the test circuit. Upon connecting the Test Light Bulb to the Anchor Light circuit, the Test Light Bulb lit up to confirm positively that this circuit is the circuit for the Anchor Light.

However the circuit to the Stern Light was found to be discontinuous as the Test Light Bulb could not be lit up. This however is understandable as the Stern sank to the seabed and one would not be surprised to see that the wirings were broken and discontinuous.

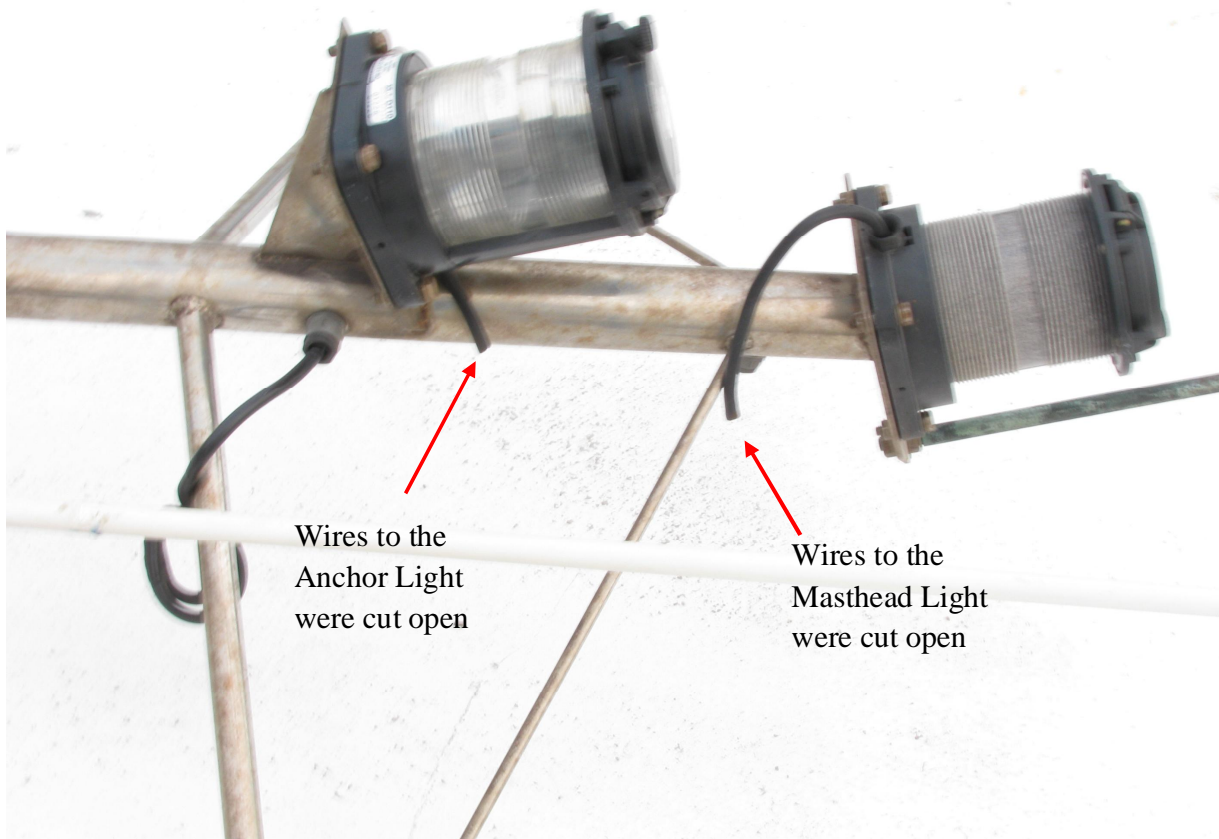
Photo 16 Wires connecting to the Anchor Light and Masthead Light were found to be cut open during the second inspection on 4<sup>th</sup> March, 2013. However it was confirmed from Photographs 45 to 61 (pp.300-316) of Police Photo Album V dated 15<sup>th</sup> October 2012 that the wirings were intact, hence ascertaining that there was nothing untoward in the wiring connections for the Anchor Light and Masthead Light.

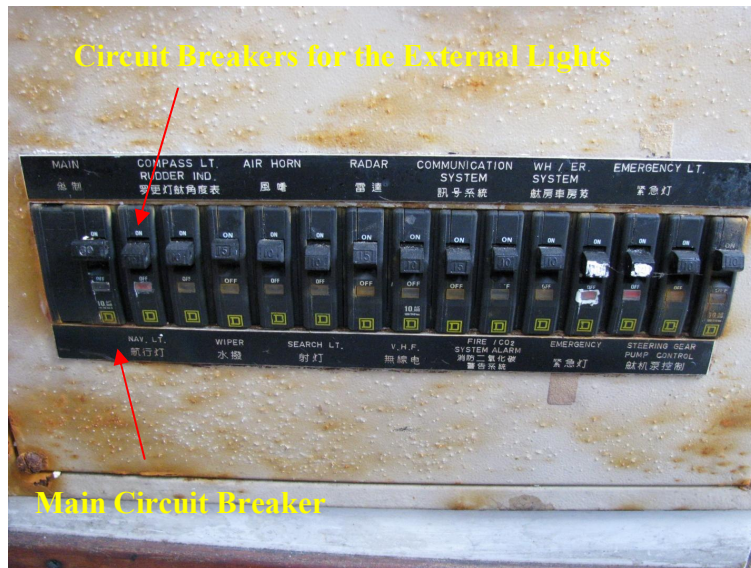
Photo 17 All the circuit breakers, with the exception of the Main Circuit Breaker (the first Circuit on the left) and the two marked with white paint on the handle were malfunctional, indicating that large current had flowed and tripped the circuits. The Circuit Breaker for the external Lights controlled the power supplied to the Seven Light Circuits and hence the turning off of this Circuit Breaker would cut off the power supply to all the external Lights Bulbs (including the corresponding Indicators)

5. The Circuit Breaker on the Panel shown on Photo 17 was the ðmasterö switch to control whether power is available to the Panel of Circuit Breakers shown in Photo 6. The turning OFF of the ðmasterö Circuit Breaker on Photo 17 would not however affect the set position of the Circuit Breakers in Photo 6 as all Circuit Breakers mentioned in this report were mechanical Circuit Breakers which could only be set manually.

9. It is noted that some of Circuit Breakers had a red flag and some had no red flag, even though they all appeared in the ON position in Photo 17. It is likely that those Circuit Breakers that had a red flag were those that were switched to the ON position. Those which do not have a red flag, even though they were in ON position, were probably because they had been damaged. Since it is difficult to buy the same model of Circuit Breakers from the market, one can confirm the above information through a visit to a similar vessel such as *Lamma II*.

10. The Circuit Breakers shown in Photo 17 were mostly damaged as they could not be tripped positively one way or the other. It is likely that these Circuit Breakers were tripped because of short-circuits which occurred on 1<sup>st</sup> Oct., 2012. However one could not rule out the possibility that some of the Circuit Breakers had been damaged before the accident.

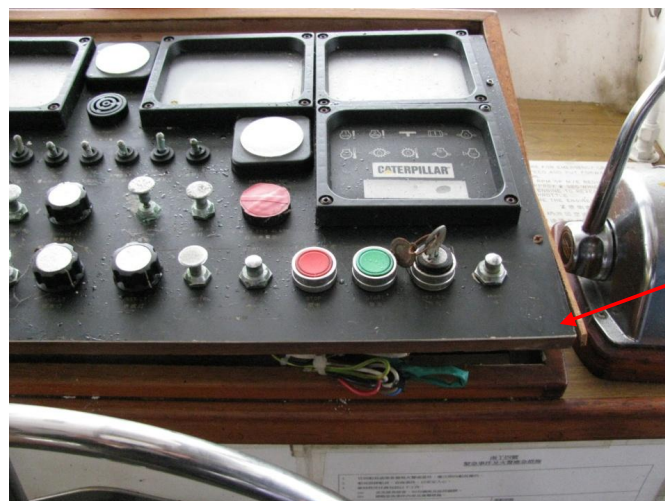
Photo 18 The controls of the various circuits, including the one marked with the description of "HORN". It is understood that by pressing the "HORN" button, a loud HORN would be produced to alert other vessels.

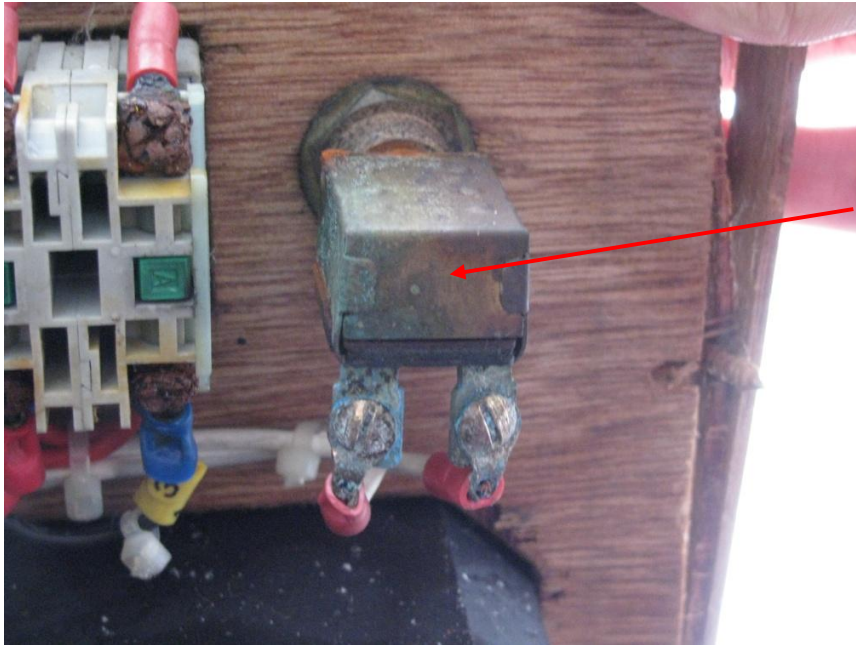
Switch associated  
with the ðHORNö  
button

It was however found that there were some rust on the switch associated with the ðHORNö button as shown in Photo 19. It could cast doubts as to whether the switch could function normally to emit a loud warning to other vessels.

Photo 19 Rusts of copper oxide were observed on the switch associated with the ðHORNö button.

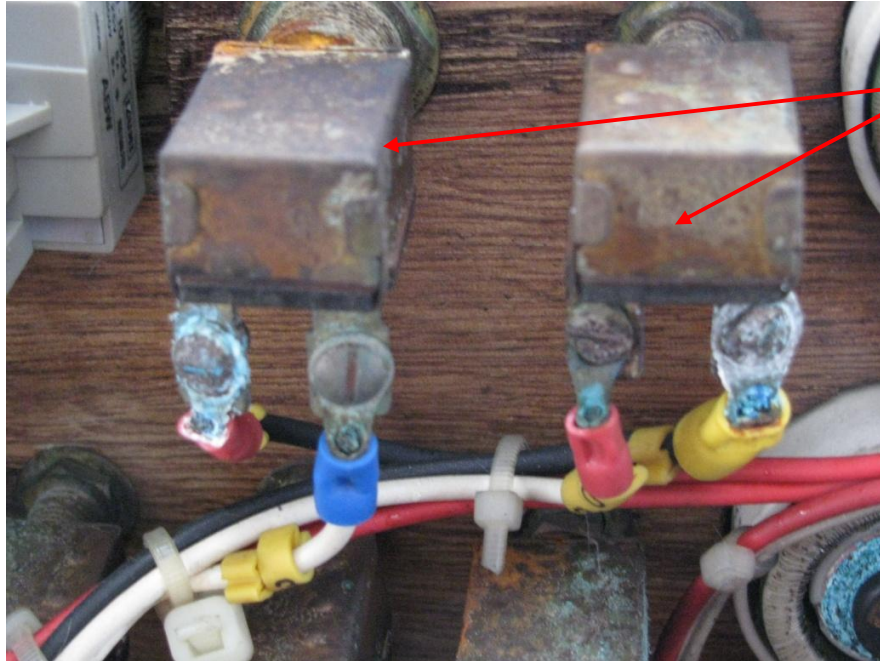
Switches on the  
same console of  
the HORN  
button

It is also noted that there were lots of copper oxides in the other switches or even on the plastic cables as shown in Photos 20 and 21. Hence one could not conclude whether the rusts were there before the accident in issue.

Photo 20 Rusts were found on other switches on the same console

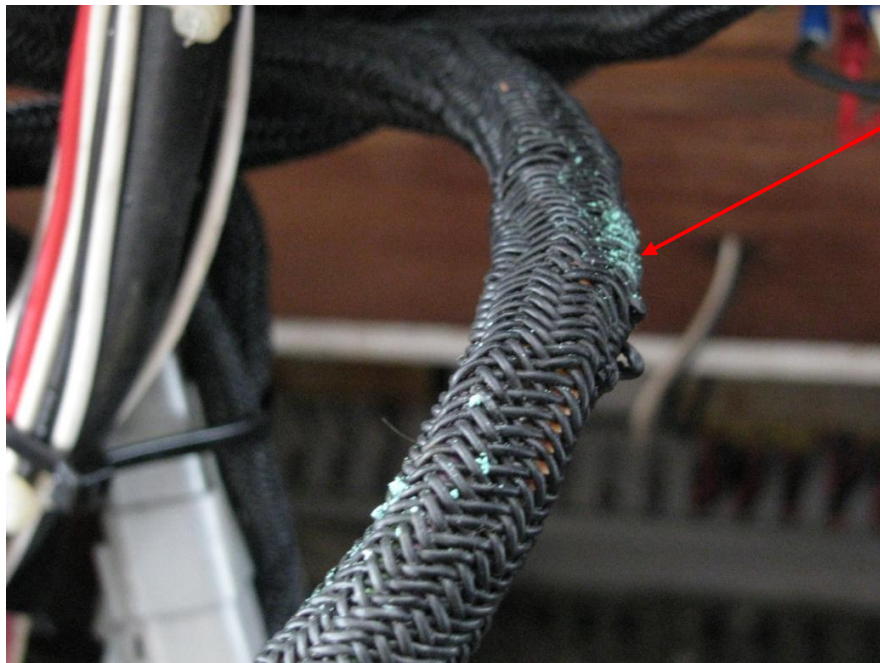
Rusts on nylon  
cable

Photo 21 Rusts were found on nylon cables
