**GOVERNMENT LABORATORY**  
**STATEMENT OF WITNESS**

**Forensic Investigation Report**

- 1.1. On 1 October 2012 at about 2020 hours, a Hongkong Electric Company Limited (HKE) pleasure boat "Lamma IV" were conveying HKE employees and their relatives/friends, a total of 127 passengers and 3 crew members, from the HKE Power Station at Lamma

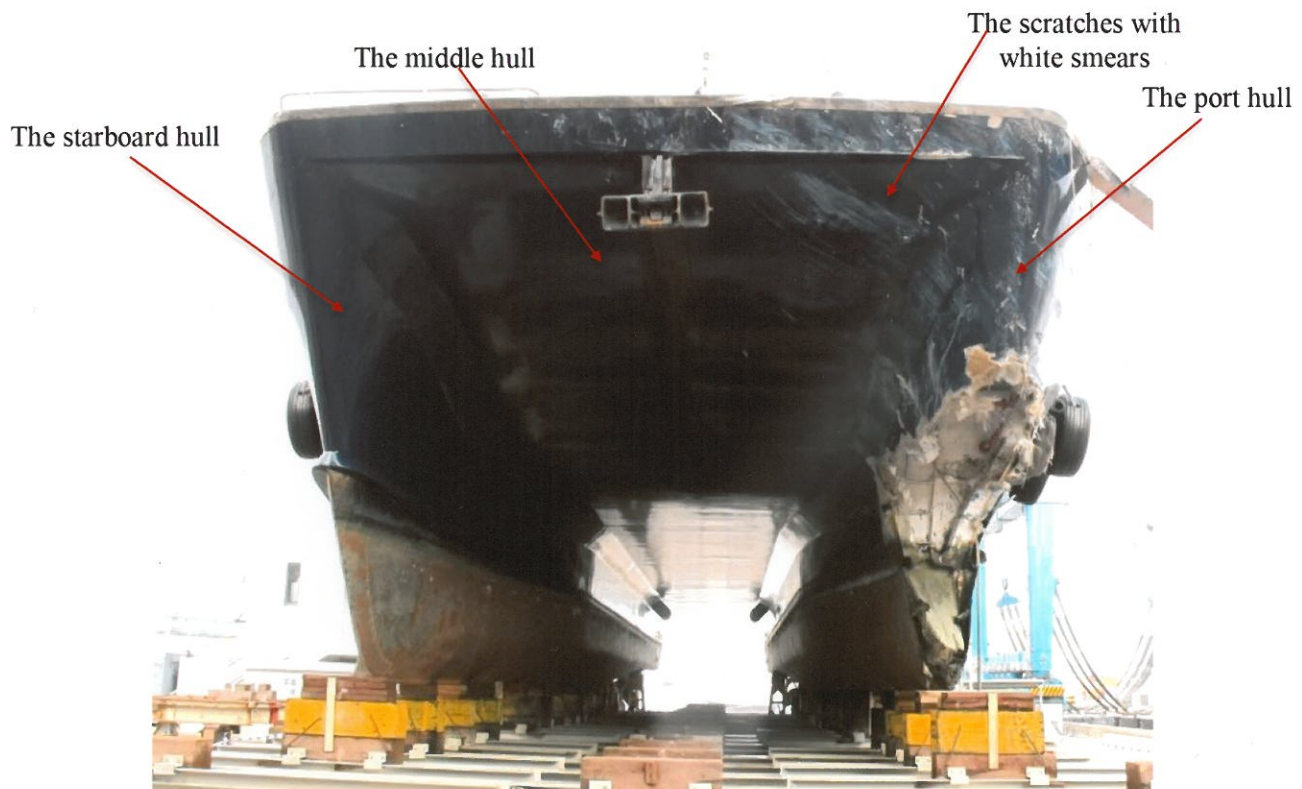
- 2.3. Contact damage to Sea Smooth was confined to the port hull and the foredeck. The bow of the port hull was badly damaged and its planking was missing, leaving a breach with a maximum extent of about 2.4 metres high, 4.3 metres long by 1.5 metres wide. The structural members reinforcing the fibreboard planking near the breach were broken and bending inwards (see Photo 4). Scratches with white smears were found on the bow of the middle hull, the open section between the two hulls above the water (see Photo 2). These scratches started from the top of the breach on the starboard side of the port hull, travelled upwards and aft, crossed to the middle hull and ended at the bow near the centreline<sup>4</sup>. The scratches were continuous and mostly travelling at a single direction.

Photo 2: The front view of Sea Smooth showed the scratches with white smears on its port hull and middle hull.

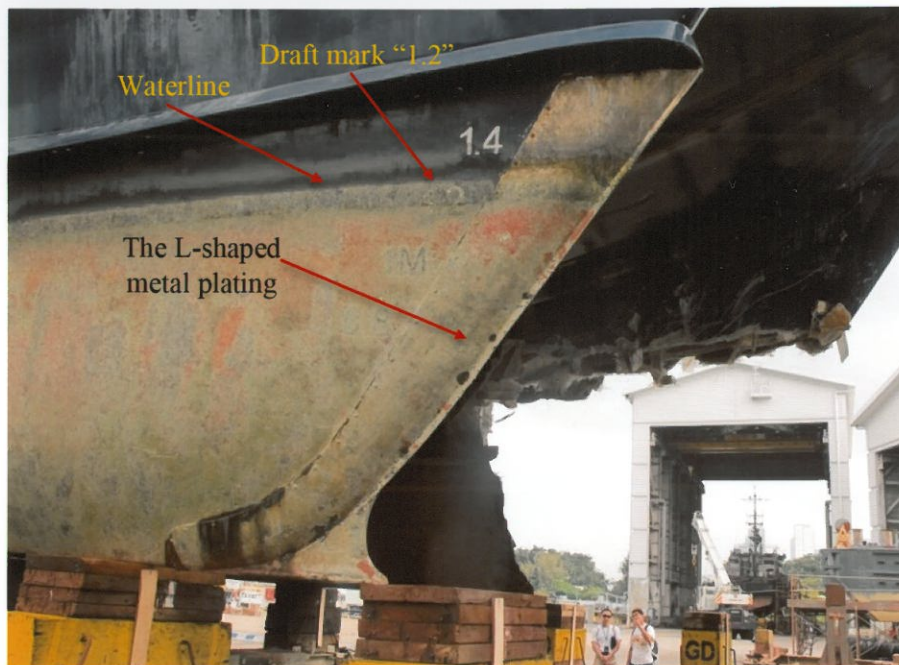
- 2.2. The hulls of Sea Smooth were mainly composed of strong fibreboard. The bow of the starboard hull was found to have been protected by additional L-shaped metal plating near the waterline, measuring about 1.6 metres high by 0.8 metres wide and having a pointed protrusion at its corner (see Photo 3). The paintwork of the hulls above the waterline was deep blue and below was brown.

Photo 3: The L-shaped metal plating on the bow the starboard hull

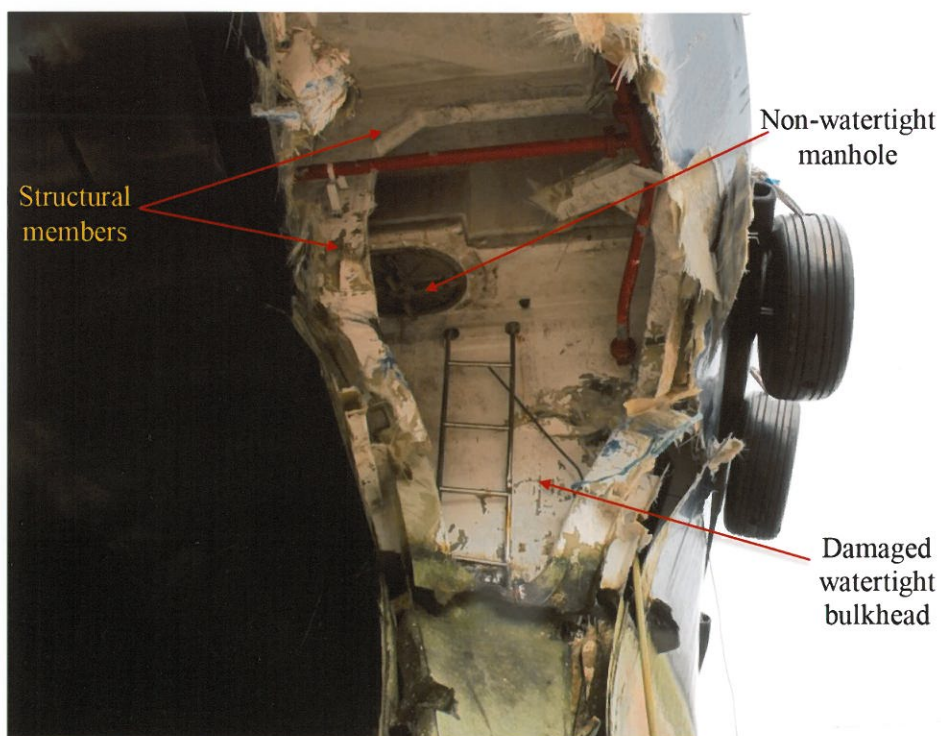
Photo 4: The structural members reinforced the fibreboard planking near the breach of the port hull of Sea Smooth. This area was a void belonging to Compartment 1 of the port hull in the under deck.

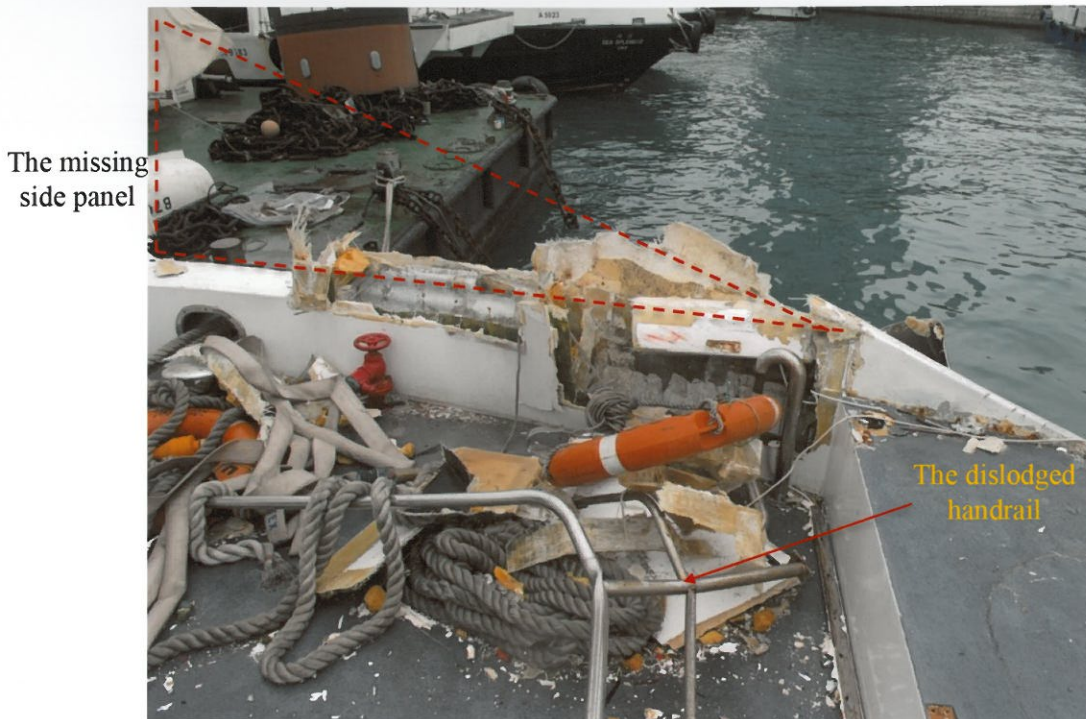
- 2.4. The foredeck of Sea Smooth also sustained severe impact damage to its port bow, including the damage and missing of a triangular side panel and dislodgement of the handrail (see Photo 5). The missing side panel measured about 1.5 metres high by 2.7 metres wide. Debris, including the panel of Sea Smooth and some foreign white, blue and red paint fragments, was scattered on the foredeck. In addition, fresh scratches with white and red paint smears were found on the leading edge of the foredeck at the bow; the direction of the scratches ran aft towards the port side.

Photo 5: This showed the foredeck of Sea Smooth on the port bow. The side panel at the port bow was missing and the handrail was dislodged.

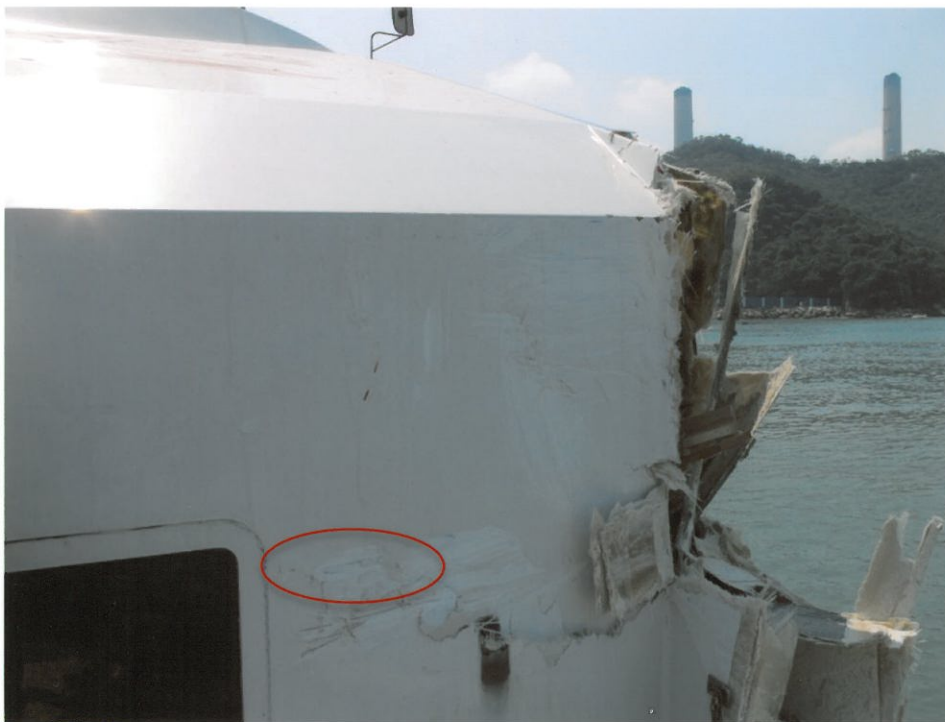
- 2.5. Behind the foredeck, about 3.5 metres from the bow, was the front panel of the main-deck cabin. Fresh horizontal scratches with blue smears were found on the front panel at a height of about 0.9 metres from the deck and about 1.3 metres from the port side end (see Photo 6).

Photo 6: The blue smears (red circled) on the outer front panel of the main-deck cabin of Sea Smooth at the port side.

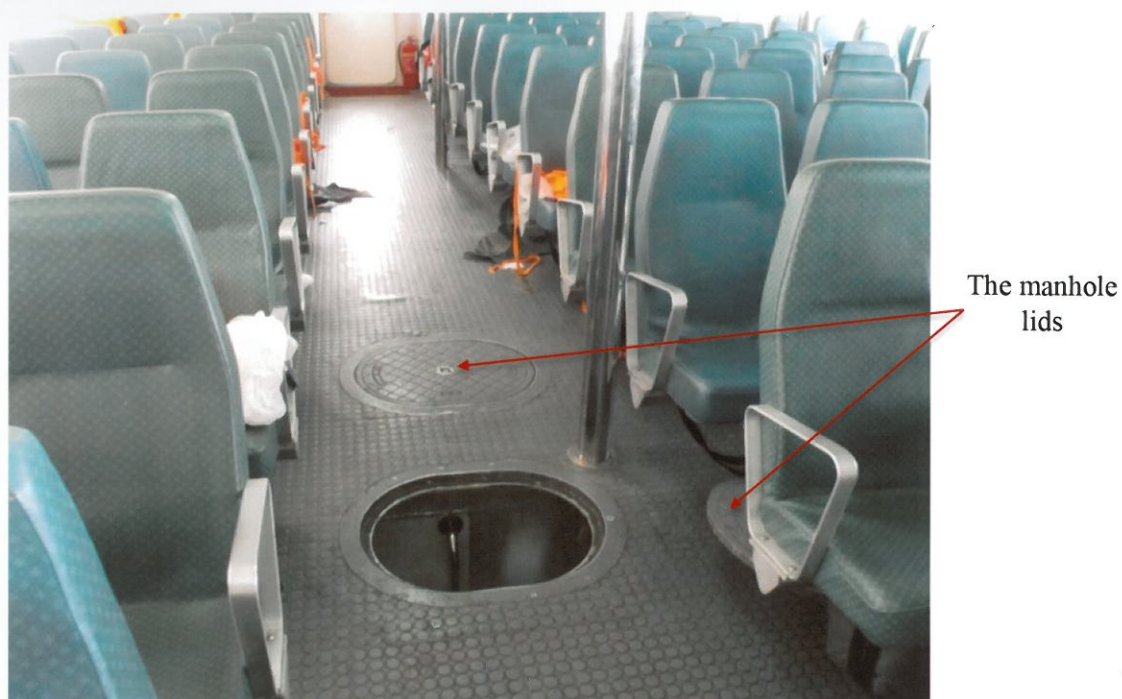
- 5.11. After the collision, the port hull of Sea Smooth had totally lost its first watertight compartment below the foredeck, causing flooding of the second compartment as well. Therefore, the non-watertight manholes in the main-deck cabin to these two compartments were exposed, and were about 1.5 metres above the water. Therefore, water splashing onto them, probably by either the movement of the vessel or waves, could have leaked into the main-deck cabin.

Photo 7: The manholes in the main-deck cabin of Sea Smooth access to Compartments 4 and 5 of the port hull.

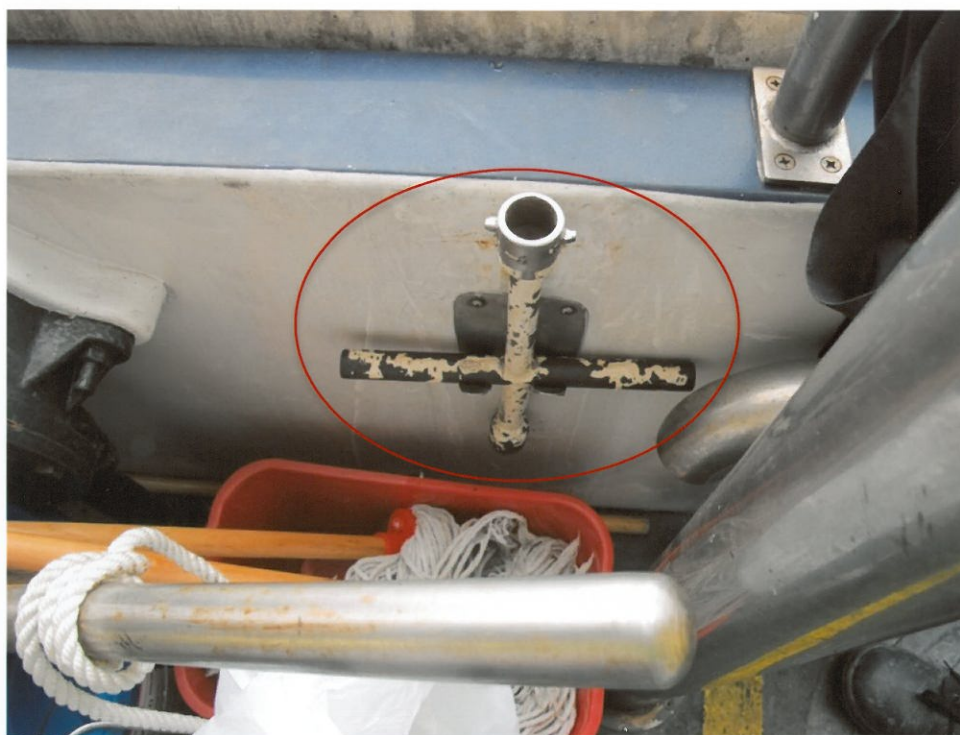
- 5.13. After the collision, crew of Sea Smooth could access and check the damage to the under deck, the compartments, via the manholes in the main-deck cabin, using either cross wrench, respectively kept near the stern and a storage space under the stairs in the middle of the main-deck deck. It would take a crew member about 5 minutes to check all the first ten compartments for any damage or leakage.

Photo 8: The cross wrench (red circled) at the stern of Sea Smooth for opening the manholes in the main-deck cabin for access to the compartments in the under deck.

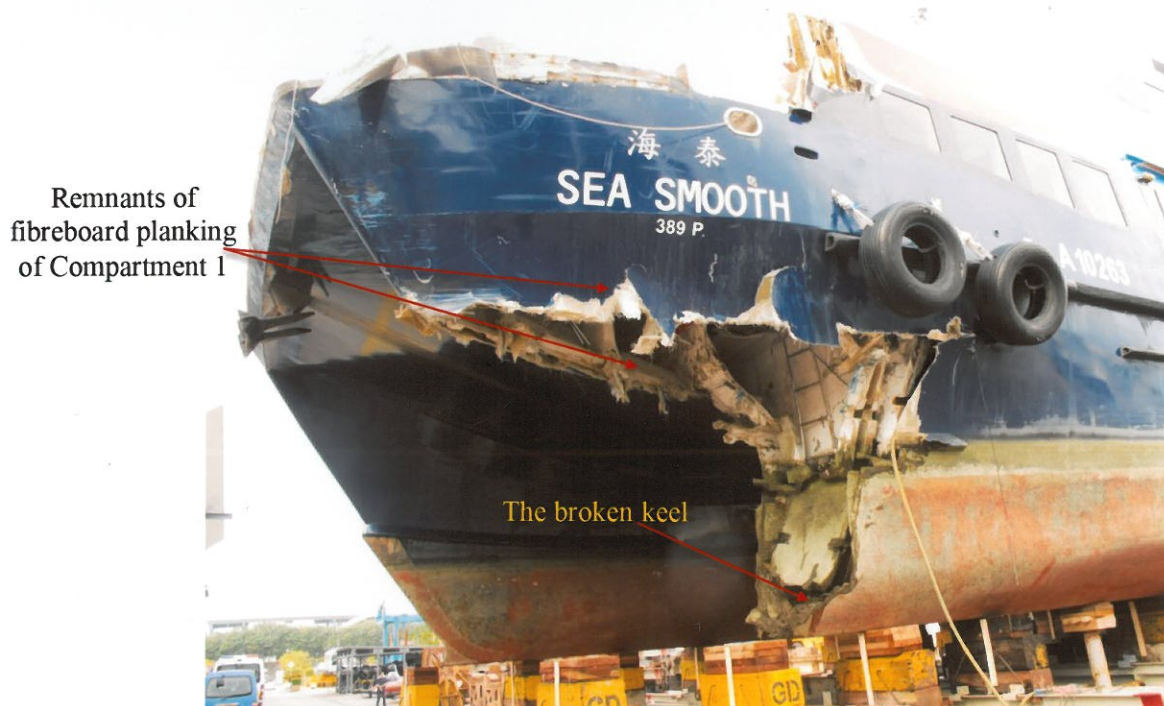
- 2.8. Examination revealed no damage to or water ingress into any of the first five compartments of the starboard hull. However, Compartment 1 of the port hull was found badly damaged and almost lost; only a small section of the keel and few fibreboard planking at the top remained (see Photo 9). The bulkhead between Compartments 1 and 2 was also damaged, causing flooding in Compartment 2 of the port hull. Compartments 3 and 4 of the port hull showed no visible damage but some water estimated roughly 10-20 cm deep was found in the bilges<sup>5</sup>. No damage and water ingress were noted in Compartment 5 of the port hull.

Photo 9: The damage to Compartment 1 of the port hull of Sea Smooth

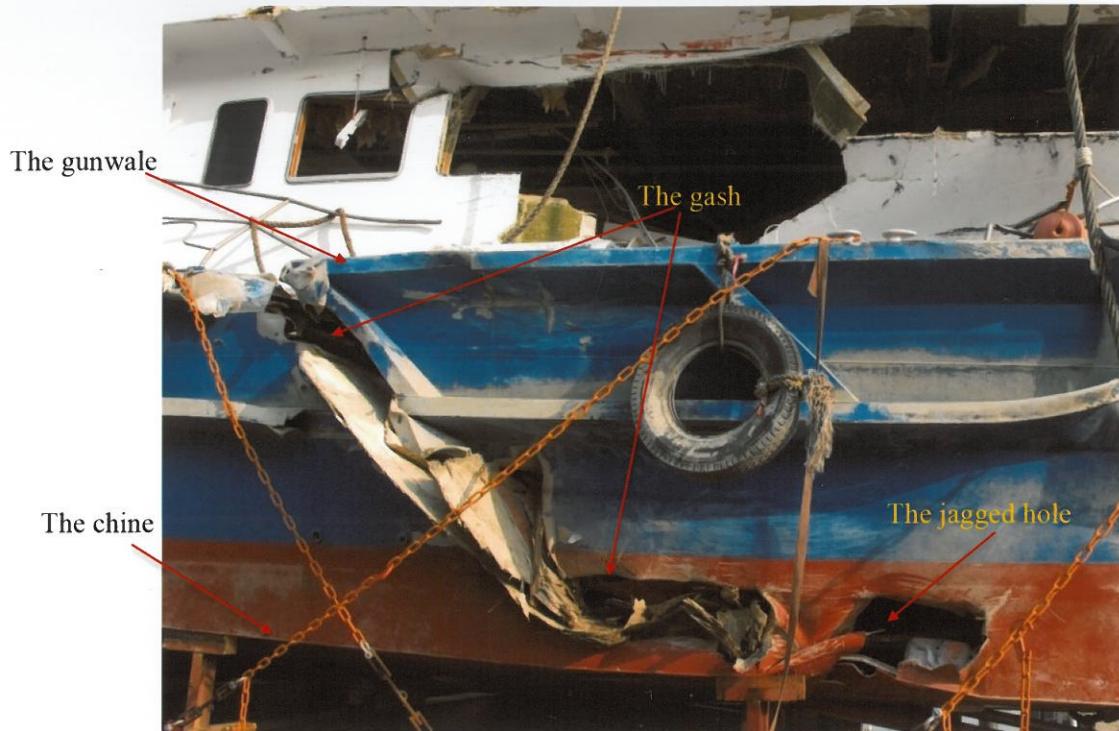
- 3.2.3. A gash and a jagged hole were found on the port side of the hull (see Photo 11). The gash on the hull, measuring about 0.3 metres wide, extended from the gunwale at a position of about 10 metres from the transom<sup>9</sup>, running about 3.3 metres aft towards the chine (a slanted gash). When the gash reached the chine, it ran parallel to the chine for a distance of about 1.1 metres and ended at a position about 6.1 metres from the transom, where the hull was reinforced by a bulkhead separating two watertight compartments (see paragraphs 3.3). Horizontal scratches, some with deep blue smears, running aft were found on the hull behind the gash (see Photo 12). Of these scratches, those on the brown-painted hull were the deepest, running towards the hole and ending there. These scratches appeared smoothly and uninterrupted, suggested that an object, which was subsequently confirmed to be the broken keel of the port hull of Sea Smooth, had moved from the gash towards the hole in a single swipe.

Photo 11: The gash and the jagged hole on the port side of the hull of Lamma IV

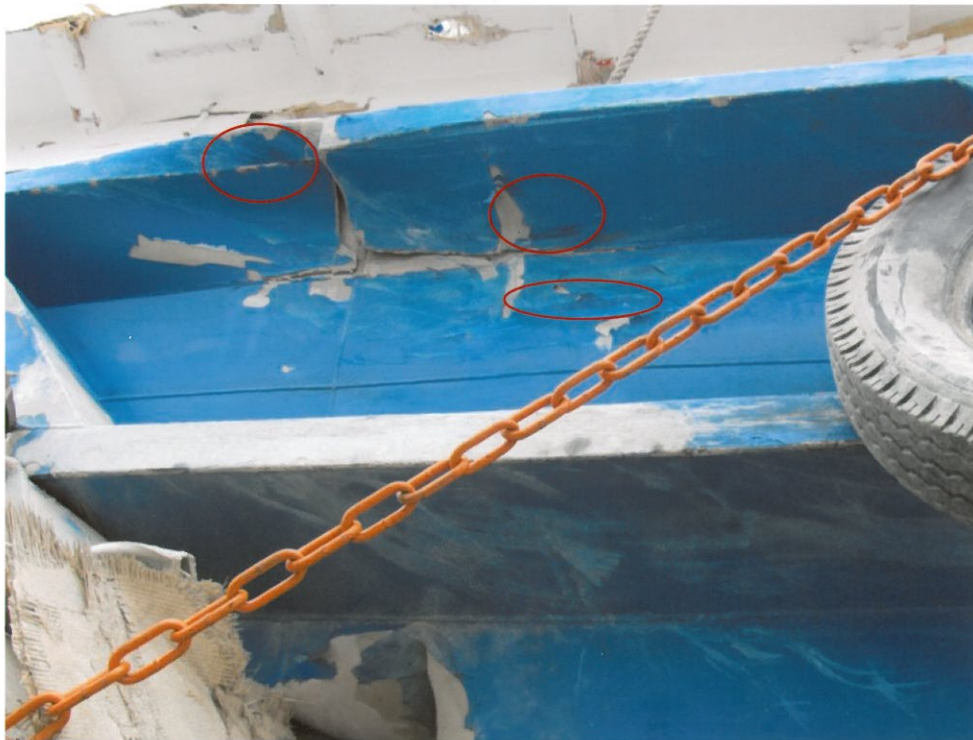
4.5.2. The recovered deep blue smears (GPW 12843) from Lamma IV were found to agree in colour and chemical composition with the control paint sample (GPW 12839) taken from Sea Smooth, indicating that the respective samples could have originated from the same source.

Photo 12: The horizontal scratches with deep blue smears (red circled) on the port side of the hull of Lamma IV

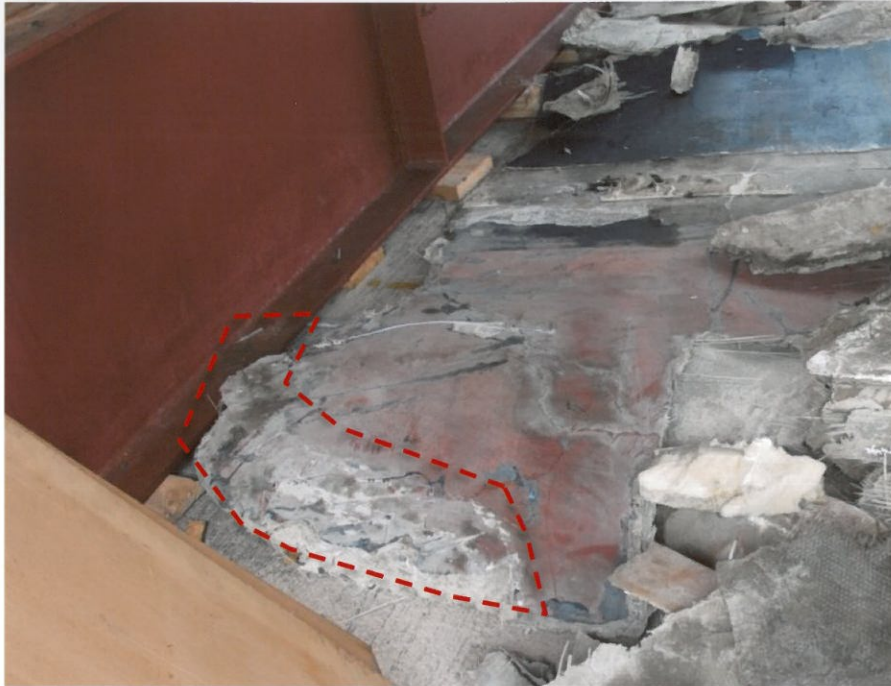
Photo 13: The imprint, marked by dotted line, on the fibreboard fragment belonging to the bow of the port hull of Sea Smooth

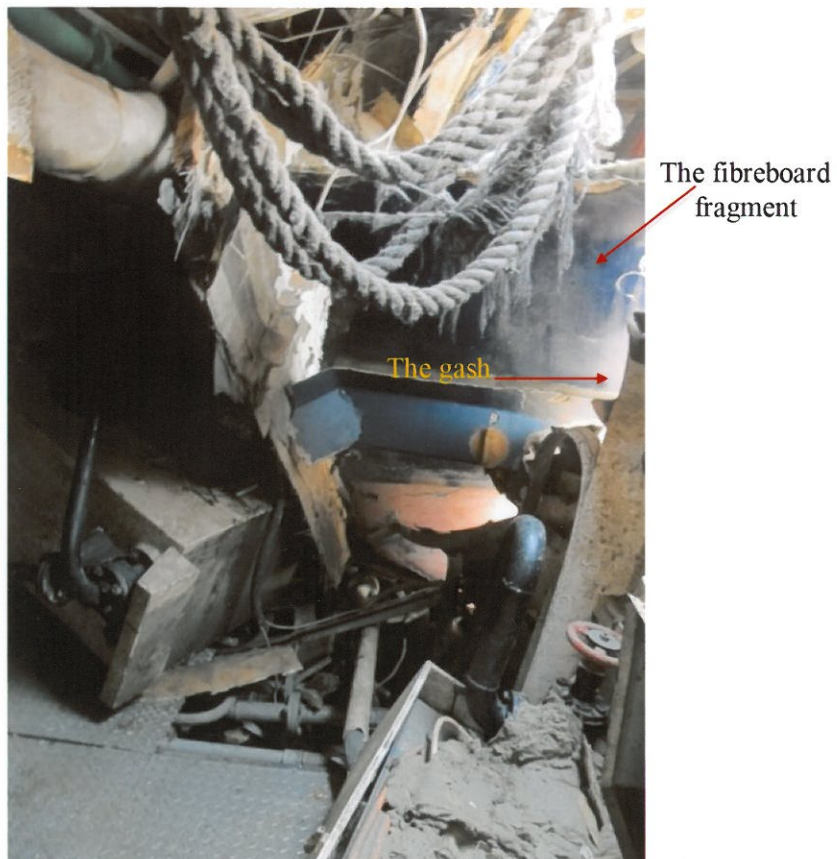
- 3.3.5. Compartment D was the engine room and the entire compartment, including the engine, was covered in a layer of mud. The identified gash was found in Compartment D (see Photo 14). The piece of fibreboard wedged in the gash had deeply penetrated into the interior of hull, reaching a thick tube from the port side engine. The bulkhead separating Compartment D from Compartment E appeared to be watertight as well.

Photo 14: The fibreboard fragment wedged in the gash of the engine room of Lamma IV

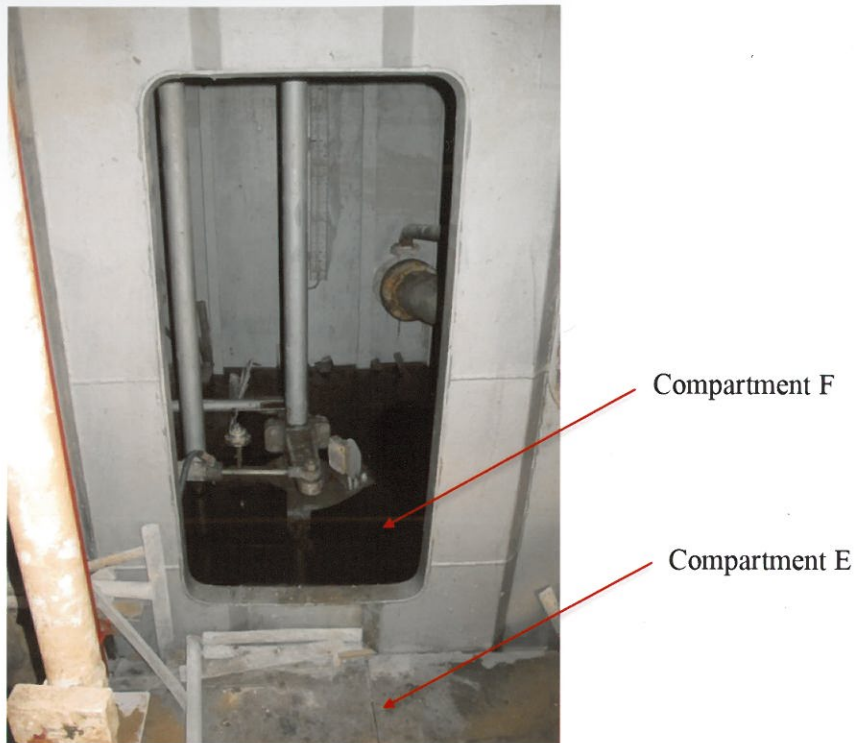
3.3.7. The substantial damage to the port side of Compartments D and E suggests that water ingress into them was sudden and unstoppable. As the bulkhead between Compartments E and F was not watertight, three out of six compartments in the under deck could have flooded rapidly after the vessel sustained the damage.

Photo 15: The non-watertight bulkhead between Compartments E and F with an opening

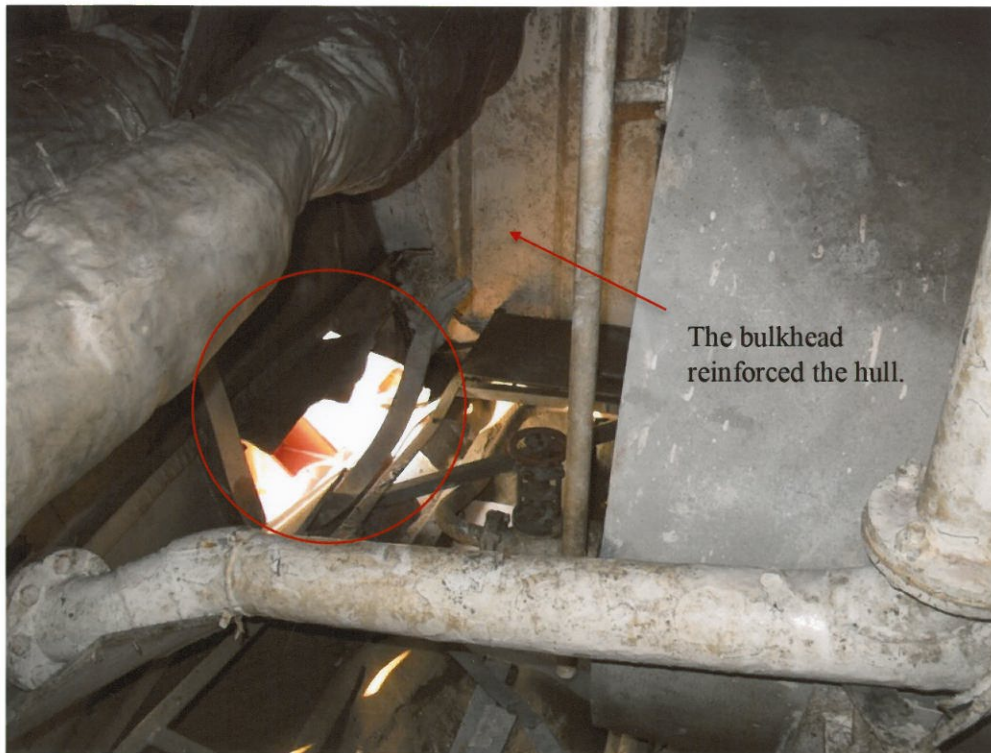
Photo 16: The jagged hole (red circled) in the tank room (Compartment E) of Lamma IV

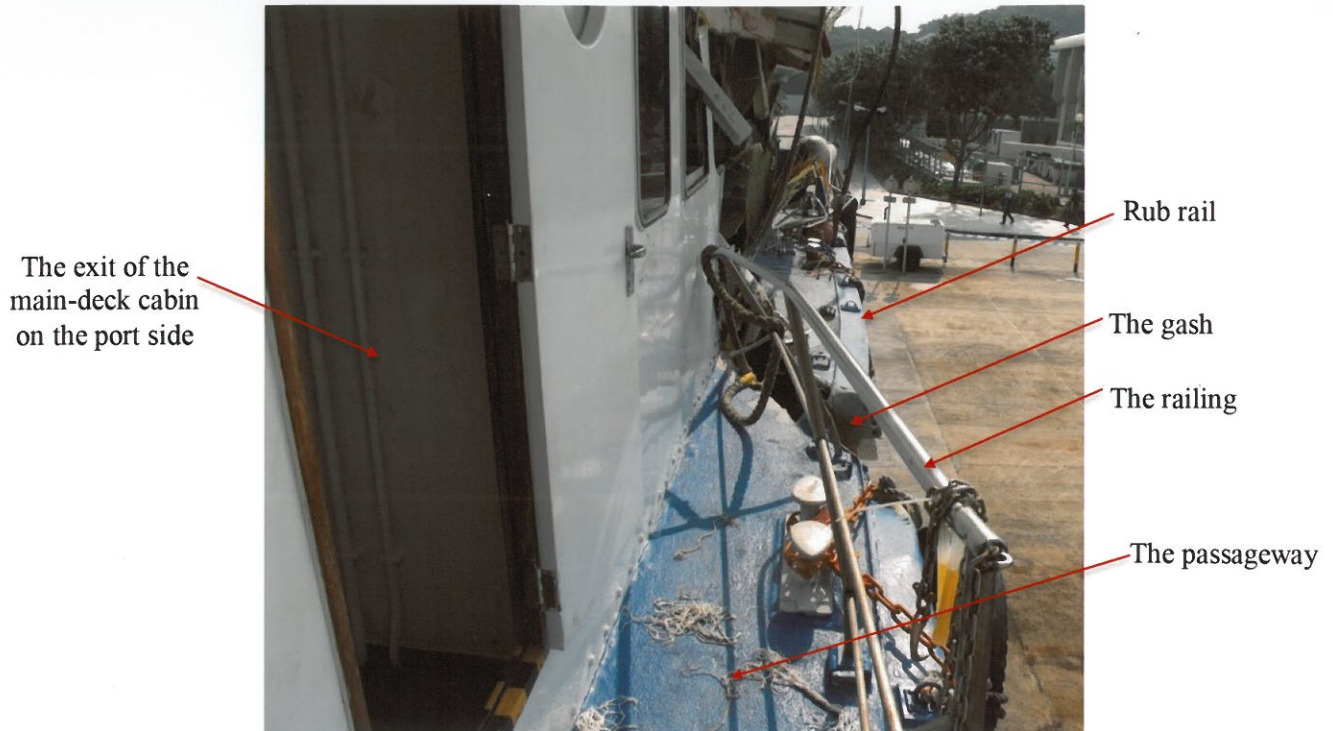
3.4.5. The gash on the port side of the hull could be observed on the passageway amidships, which existed as a straight cut of about 50 cm wide and ended by the side panel of the main-deck cabin. The angle of the gash on the passageway was found to be about 30 degrees from the bow (see Photo 17).

- 5.2. The gash on the port side passageway of Lamma IV suggests that the centrelines of the two vessels against each other at the moment of collision were at an angle of approximately 30 degrees. The foredeck of Sea Smooth had breached the side panel of the main-deck cabin of Lamma IV, and went in and reached the centreline of the main-deck cabin, crushing the seats and the central unit of the air-conditioning system on the port quarter and causing collapse of a large piece of ceiling frame. At the same time, the bow of the port hull of Sea Smooth had pierced open the hull of Lamma IV, causing the slanted gash in the engine room at Compartment D. The strong force of collision had torn the fibreboard planking of the port bow of Sea Smooth apart. Then, Sea Smooth remained its forwards momentum and the broken keel, which was hardest part of the hull, further sideswiped the port side hull of Lamma IV so the gash on the hull of Lamma IV changed direction, running along the chine, leaving the set of smooth and continuous scratches on the hull of Lamma IV. When the broken keel of Sea Smooth reached the position of the bulkhead between the engine and tank rooms of Lamma IV, the gash on Lamma IV ended and replaced by deep scratches on the hull surface, probably due to the hull having been reinforced by the bulkhead. Without reinforcement of the bulkhead, the hull of Lamma IV at the tank room yielded again and the broken keel of Sea Smooth ripped it open and left the hole there. At that moment, the foredeck of Sea Smooth had probably reached the air-conditioning unit at the rear of the main-deck cabin of Lamma IV, while the port side of the weather deck of Lamma IV had come into contact with the front panel of the main-deck cabin of Sea Smooth. Therefore, the impact between the main-deck cabins stopped Sea Smooth moving forwards after ripping the hole in the tank room of Lamma IV, probably resulting in the disengagement of the two vessels.

Photo 17: The passageway along the rub rail of Lamma IV on the port side.

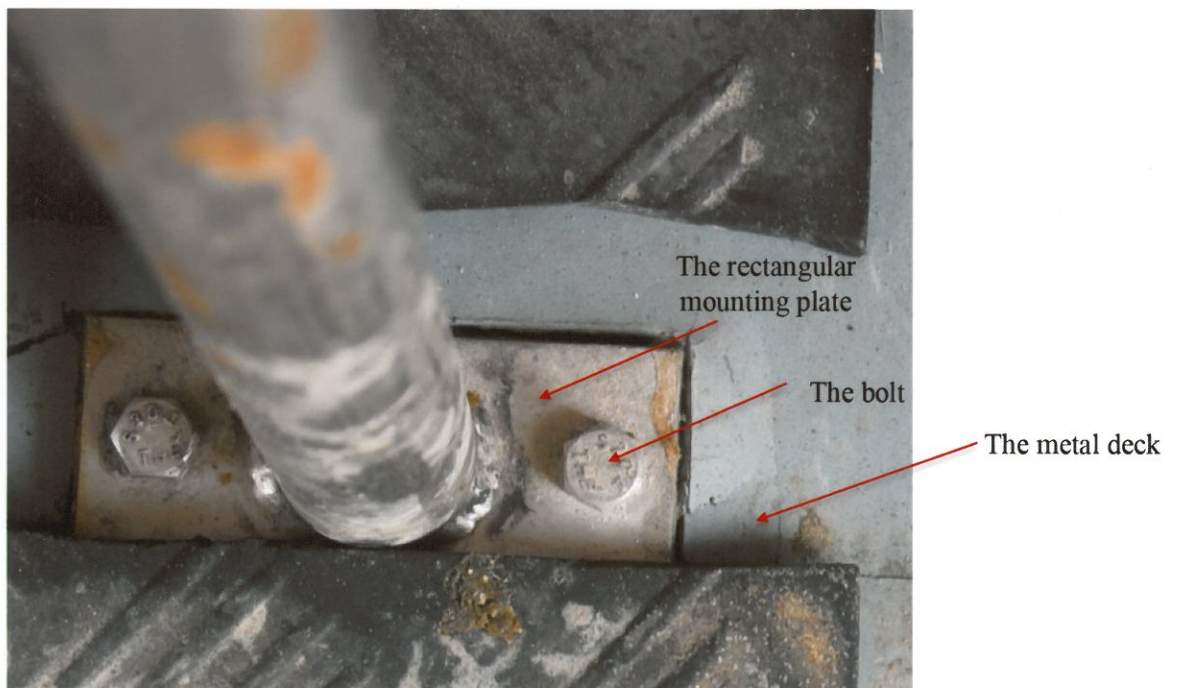
3.4.1. The main-deck cabin was encircled by a passageway of 0.9 metres wide along the rub rail, and the passageway was further enclosed by railing (see Photo 17). The cabin had 8 rows and 11 rows of seats respectively situated at the front and the rear. In addition, there were two rows of seats amidships. Each leg of the seats had a rectangular mounting plate, which was found to have been secured on the metal deck with a pair of 2.7-cm bolts (see Photo 18).

Photo 18: The rectangular mounting plate at the base of each leg of the seat in the main-deck cabin of Lamma IV. A pair of bolts was used to secure it to the metal deck.

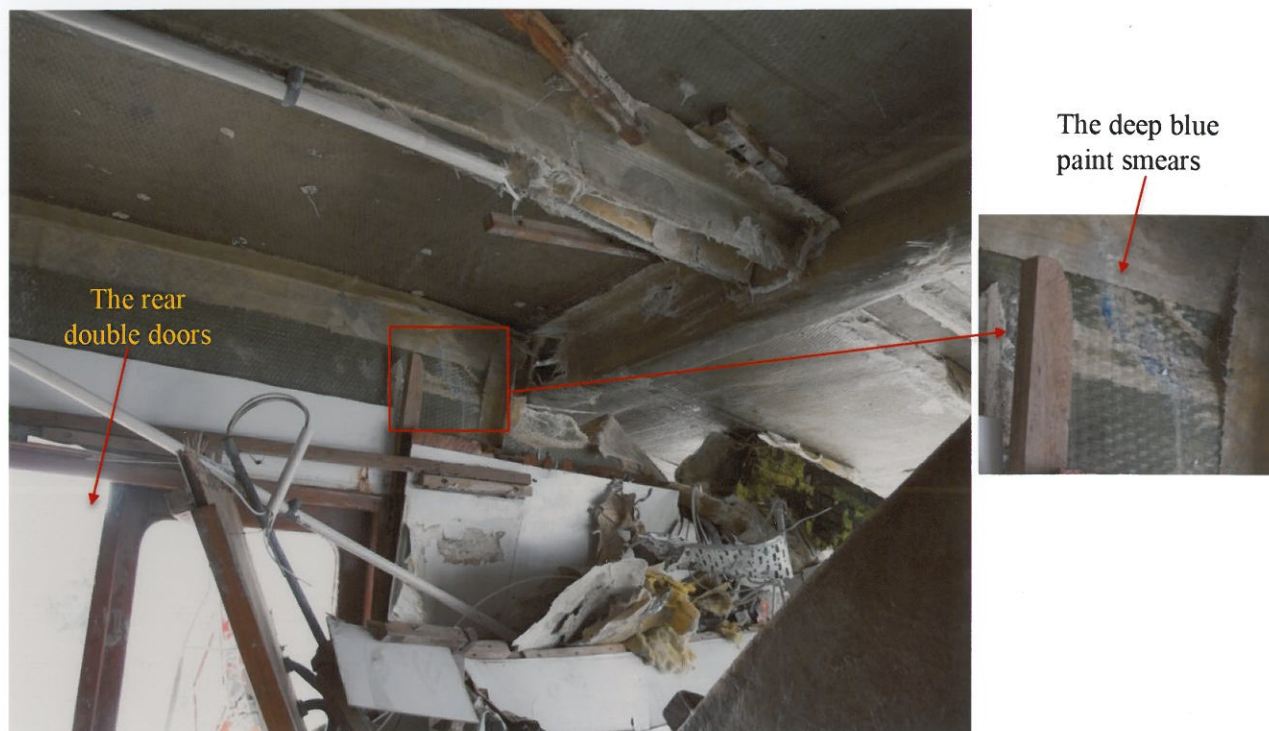
Photo 19: The deep blue paint smears found at the ceiling frame above the rear doors of the main-deck cabin of Lamma IV near the centreline

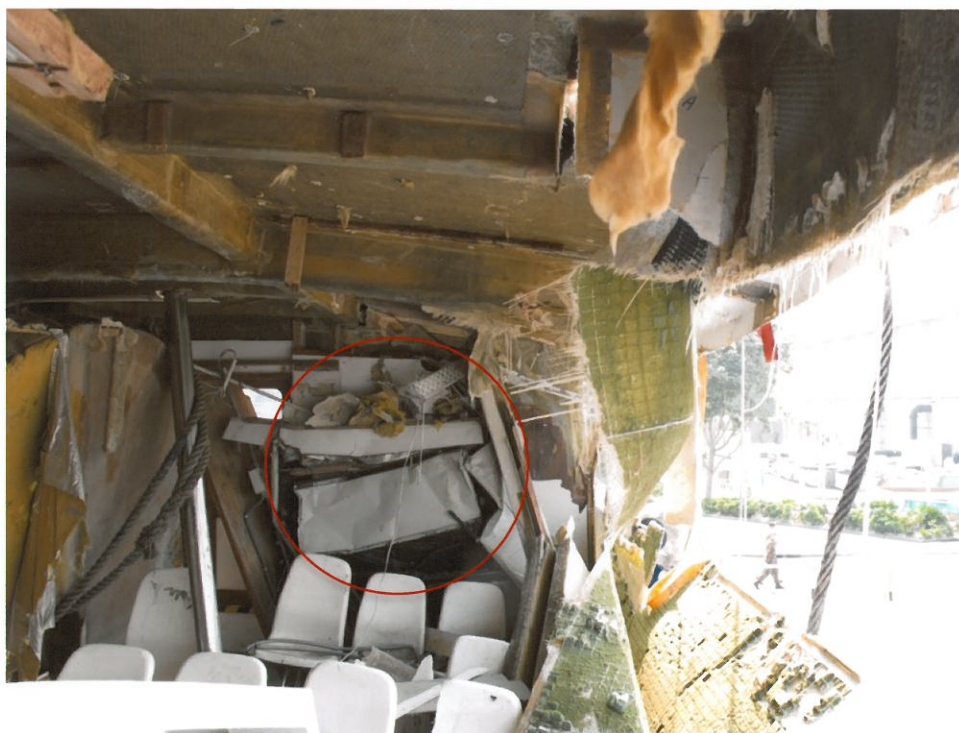
3.4.4. The side panel of the main-deck cabin was made up of fiberboards sandwiched with a layer of foam in the middle. The port quarter of the main-deck cabin had sustained severe impact damage, causing collapse of about 5.6-metre side panel and the nearby ceiling frame as well as crushing of the last five rows of seats. The impact damage to the ceiling frame had reached a position near the centerline, where deep blue paint smears, agreeing in colour with the hull of Sea Smooth, were found (see Photo 19). The fallen ceiling frame was heavy and large, measuring about 4.8 metres long and 2 metres wide. Behind the last row of seats on the port side was the central unit of the air-conditioning system, of which the housing was badly deformed and collapsed rearwards (see Photo 20).

Photo 20: The crushed central unit of the air-conditioning system (red circled) and the collapsed seats at the port quarter of the main-deck cabin of Lamma IV

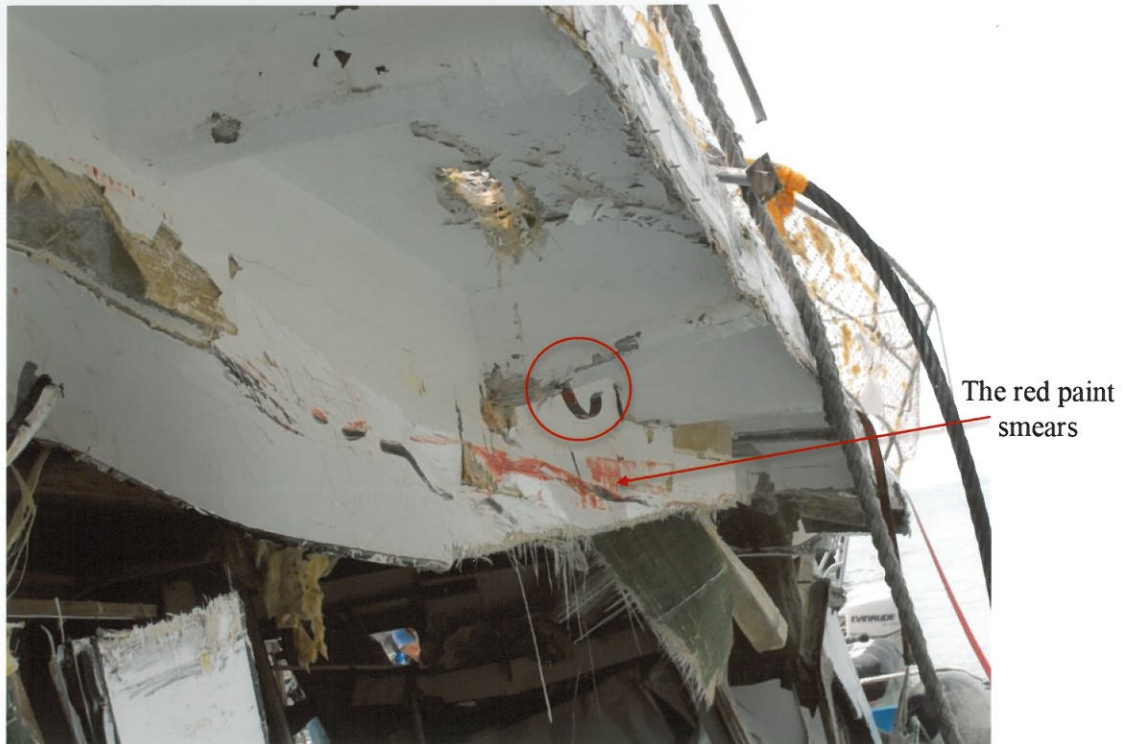
3.4.6. The passageway on either side was covered by porch. On the port side under the ceiling of the porch were U-shaped pipe mounting brackets, which were painted in red (see Photo 21). A horizontal strip of red paint smears was found on the top of the broken side panel. These findings suggest that a red pipe probably mounted below the porch on the port side could have been detached from its mounted and pushed towards the cabin before it was lost. The red paint fragments on the foredeck of Sea Smooth were found to agree in colour with the red paint of the U-shaped pipe mounting brackets.

Photo 21: The U-shaped pipe mounting bracket (red circled) under the porch of the passageway

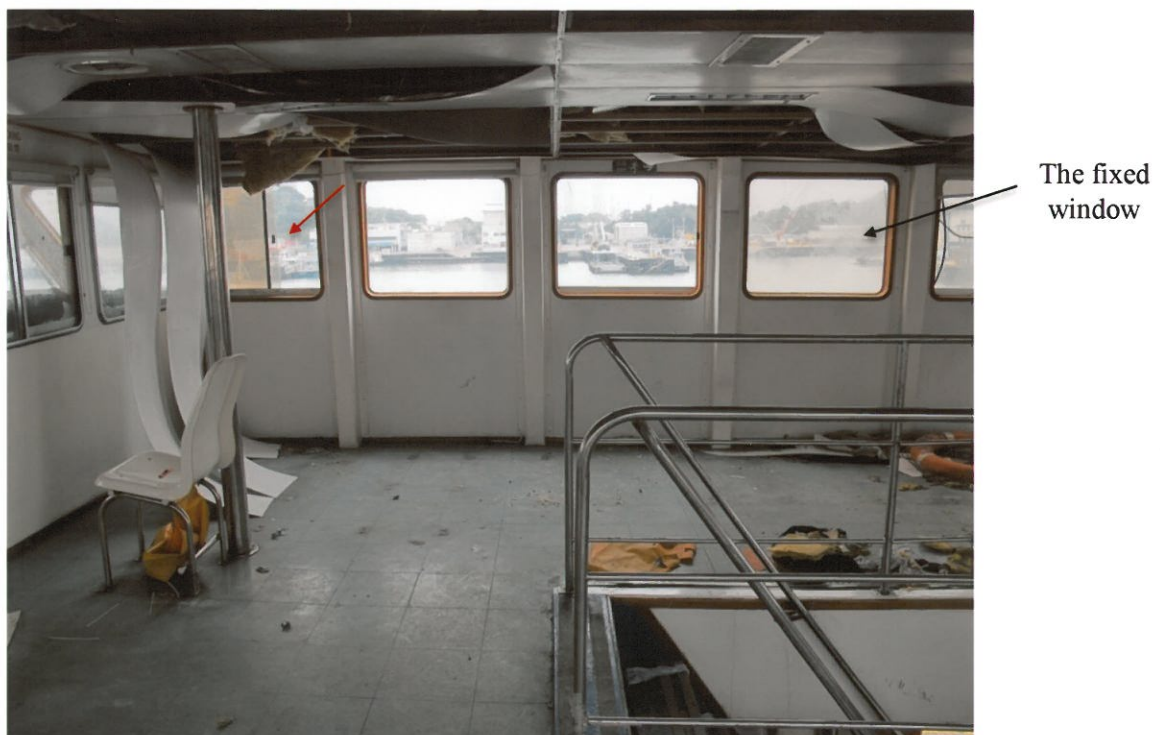
Photo 22: The only opened sliding window on the starboard side (red arrow). The upper-deck cabin was bare, and only one seat remained.

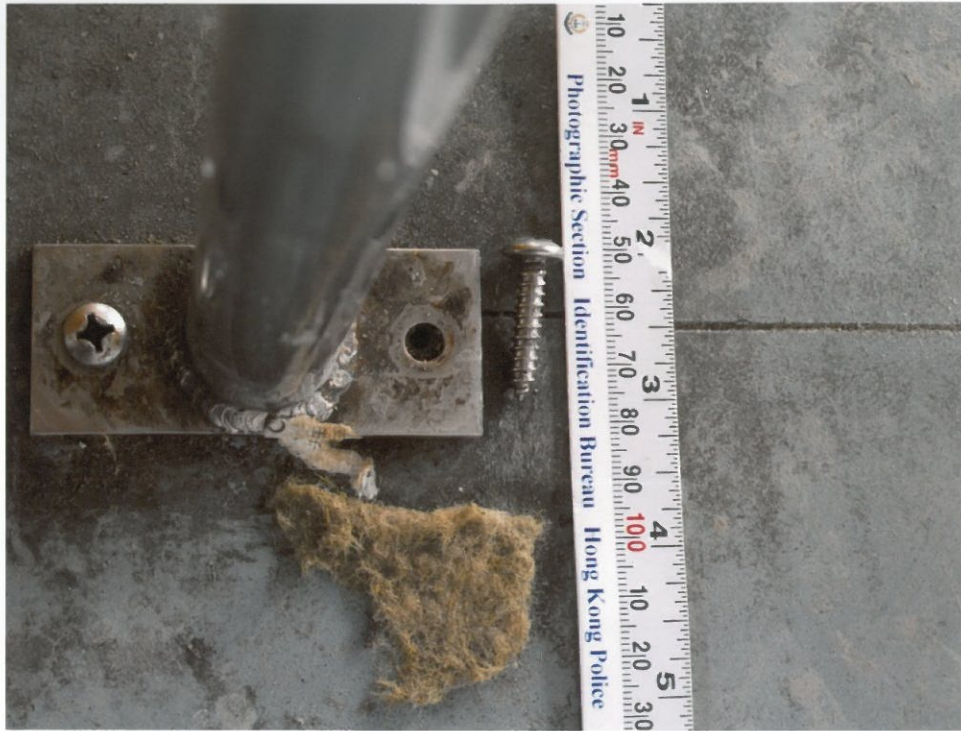
Photo 23: The rectangular mounting plate at the base of the leg of seat in the upper-deck cabin of Lamma IV and the screw for affixing the seat.

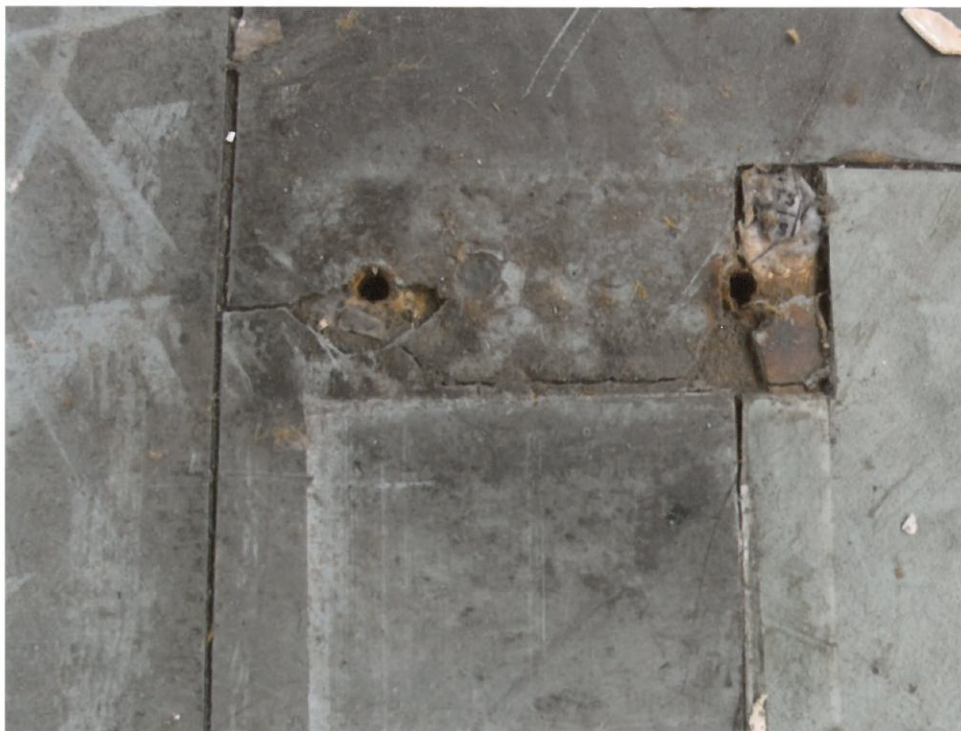
Photo 24: The rectangular imprint on the deck of the upper-deck cabin of Lamma IV

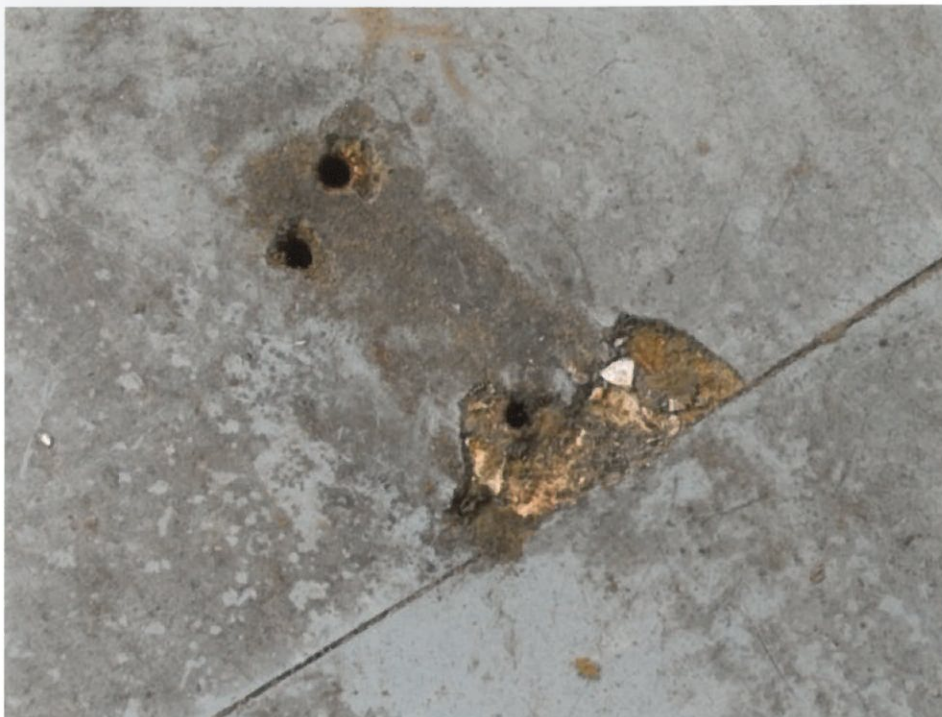
- 5.5. The findings in paragraphs 3.6.2-3.6.5, particularly more than two screw holes in one mounting position, indicate that the fibreboard deck of the upper-deck of Lamma IV was not strong enough to maintain the shape of the mounting holes to grip the screws tightly. The mounting holes could have been enlarged/deformed over time such that the grip of the screws would be reduced, and the screws would be loosened. Therefore, the loosened screws had to be re-mounted to the fibreboard deck at new positions, resulting in more than a pair of holes in some of the mounting positions of the seats in the upper-deck cabin.

Photo 25: The mounting place had more than a pair of mounting holes.

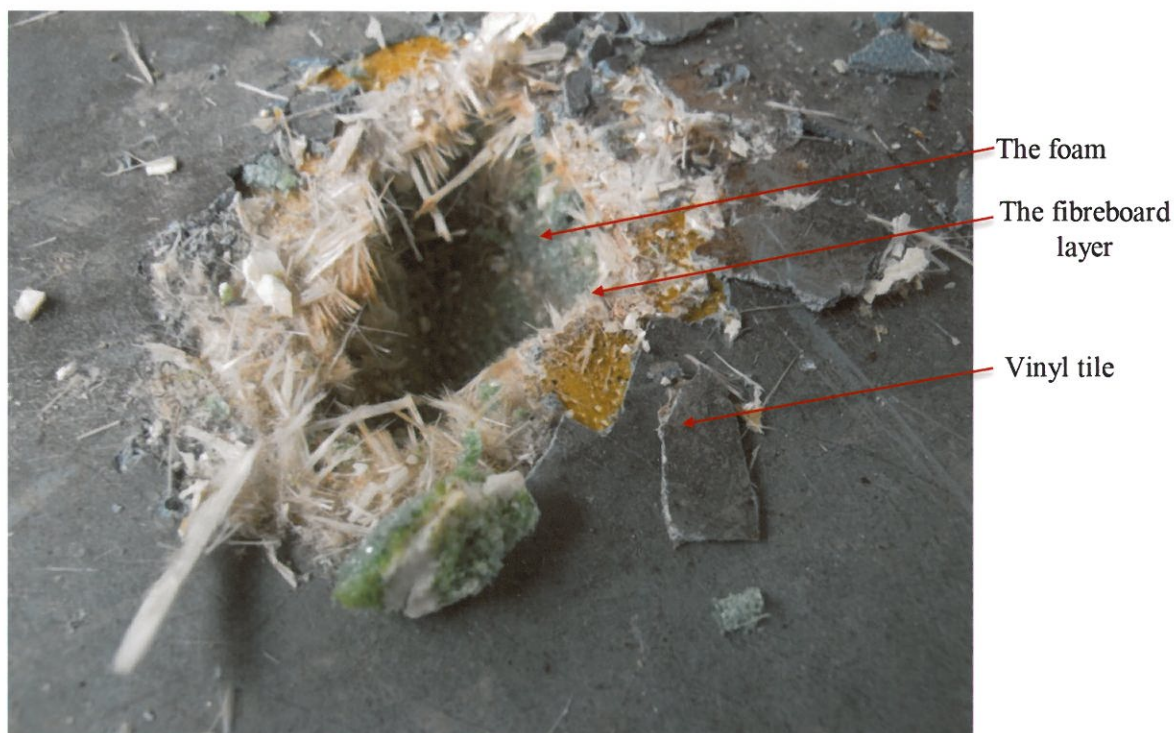
Photo 26: The construction of the fibreboard deck in the upper-deck cabin of Lamma IV

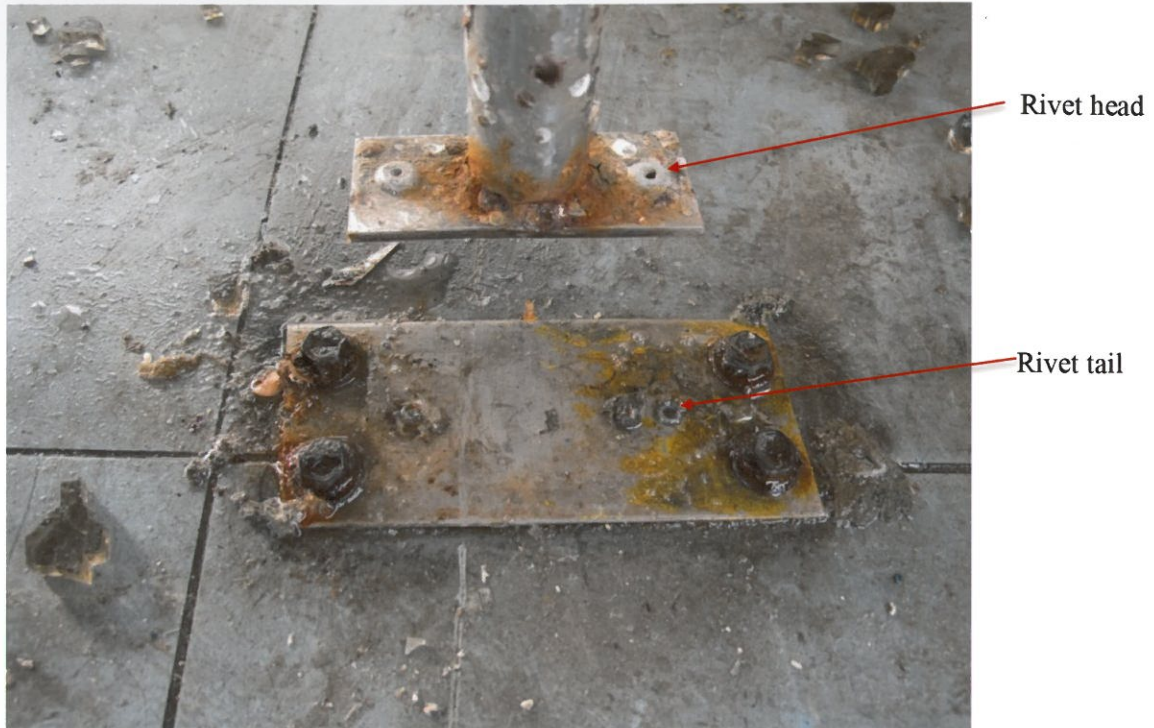
Photo 27: The mounting plate of the leg attached with heads of two rivets and the rectangular metal plate attached with rivets tail
