**GOVERNMENT LABORATORY**  
**STATEMENT OF WITNESS**

**Forensic Investigation Report**

- 1.1. On 1 October 2012 at about 2020 hours, a Hongkong Electric Company Limited (HKE) pleasure boat "Lamma IV" were conveying HKE employees and their relatives/friends, a total of 127 passengers and 3 crew members, from the HKE Power Station at Lamma

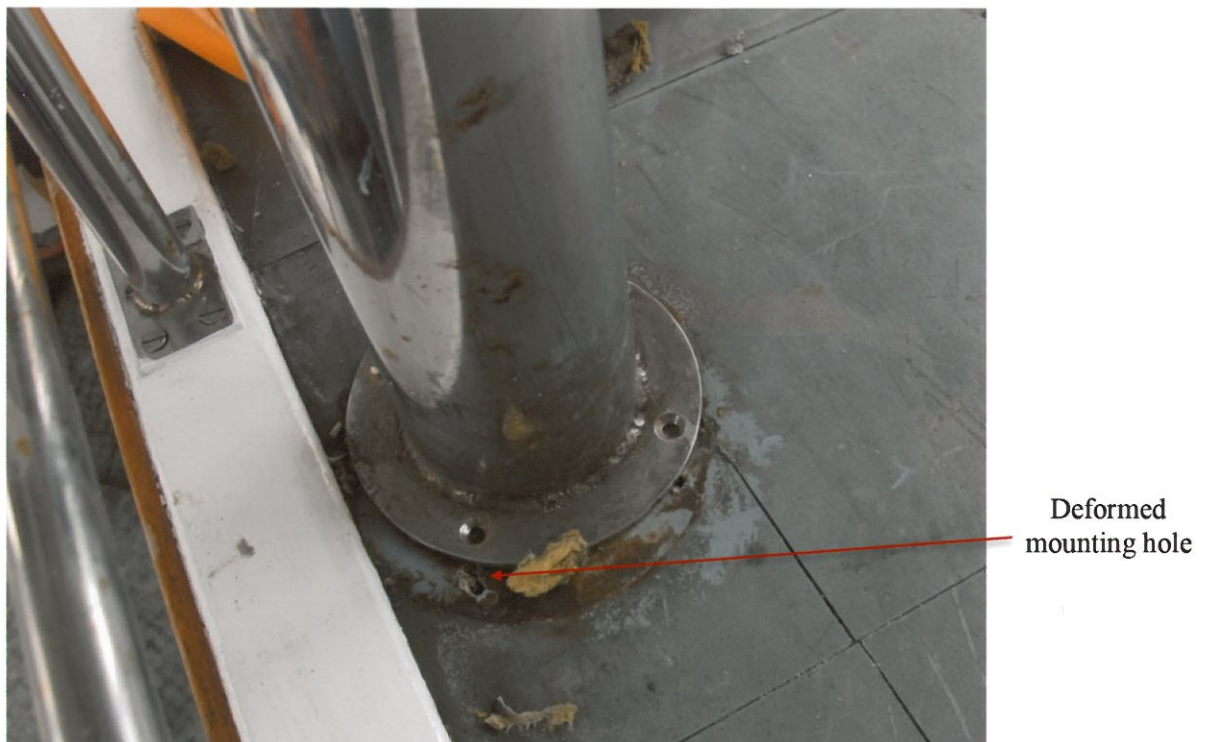
- 3.6.5. Near the centre of the cabin was a supporting column, of which the mounting holes of the base were empty with its bolts/screws missing (see Photo 28). The column was found to have been displaced from its original position, exposing the corresponding mounting holes on the deck. These mounting holes on the deck had deformed and elongated towards the displaced position of the column, which could have been made when its mounting bolts/screws were pushed aside, and the bolts/screws were loosen from their mounting holes.

Photo 28: The mounting holes of a support column in the upper-deck cabin of Lamma IV

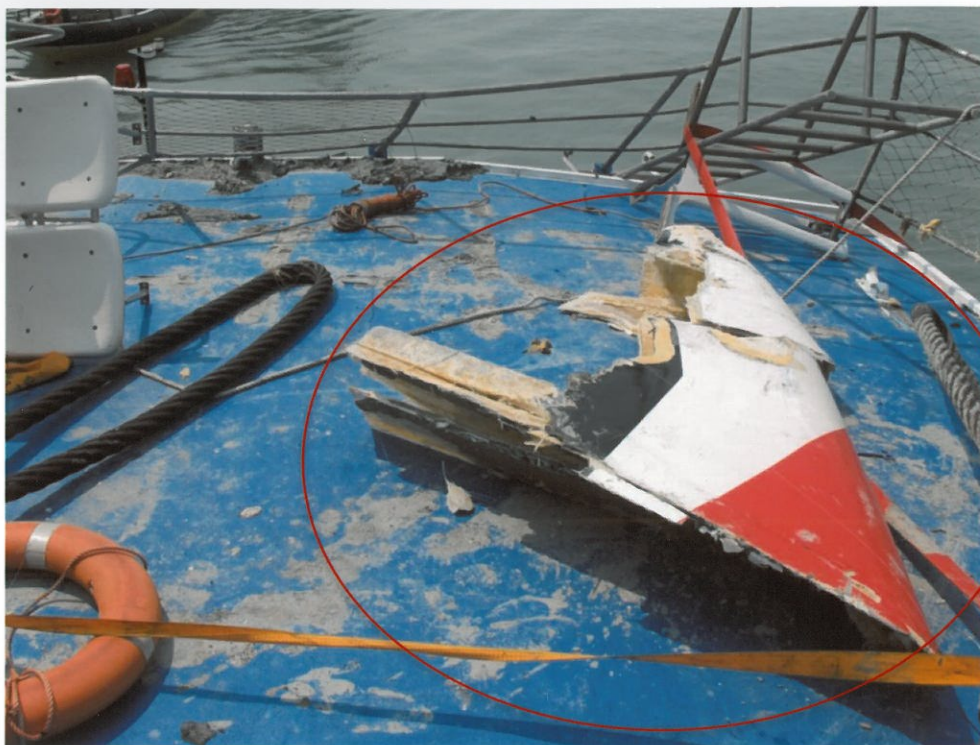
- 3.7.3. A piece of fibreboard fragment roughly triangular in shape, having deep blue, red and white paintwork and measuring about 1.6 by 2.4 metres, was found on the weather deck (see Photo 29). This fragment agreed in shape and dimension with the missing side panel on the port bow of Sea Smooth. Therefore, this fiberboard had originated from Sea Smooth.

Photo 29: The piece of fibreboard fragment (red circled) on weather deck of Lamma IV

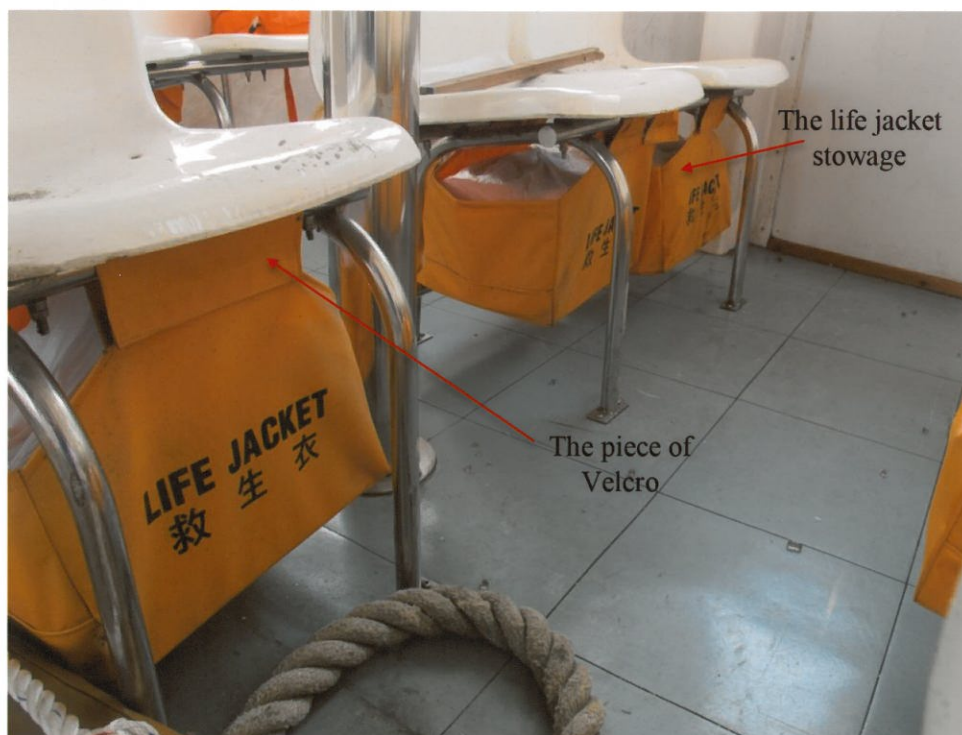
Photo 30: The life jacket stowage beneath the seats in the main-deck cabin of Lamma IV

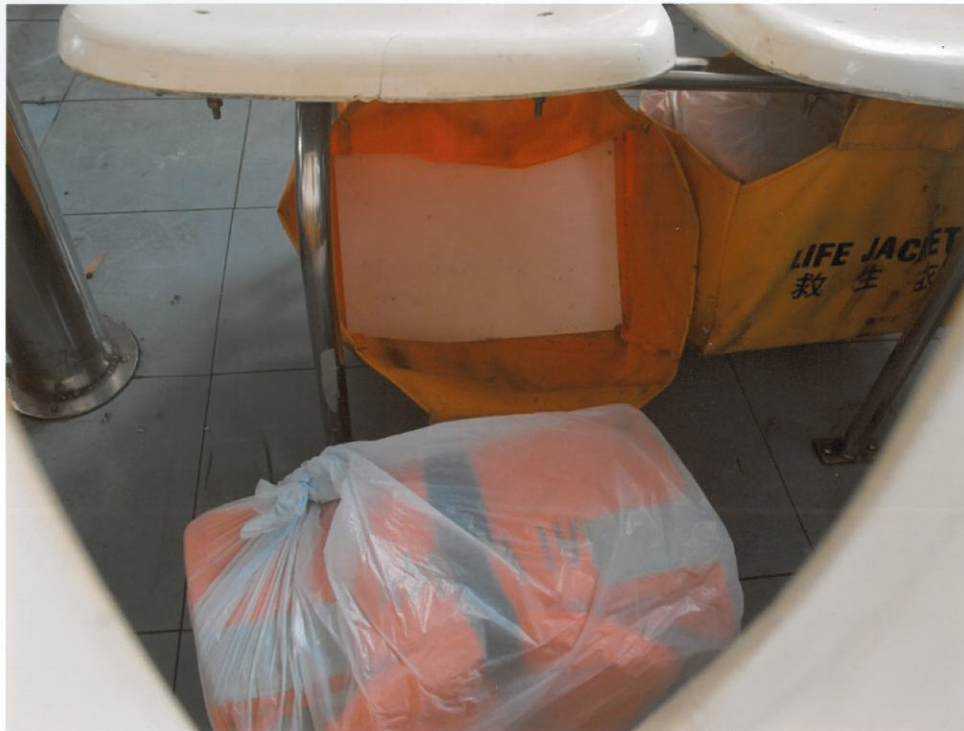
Photo 31: The white garbage carried the life jacket.

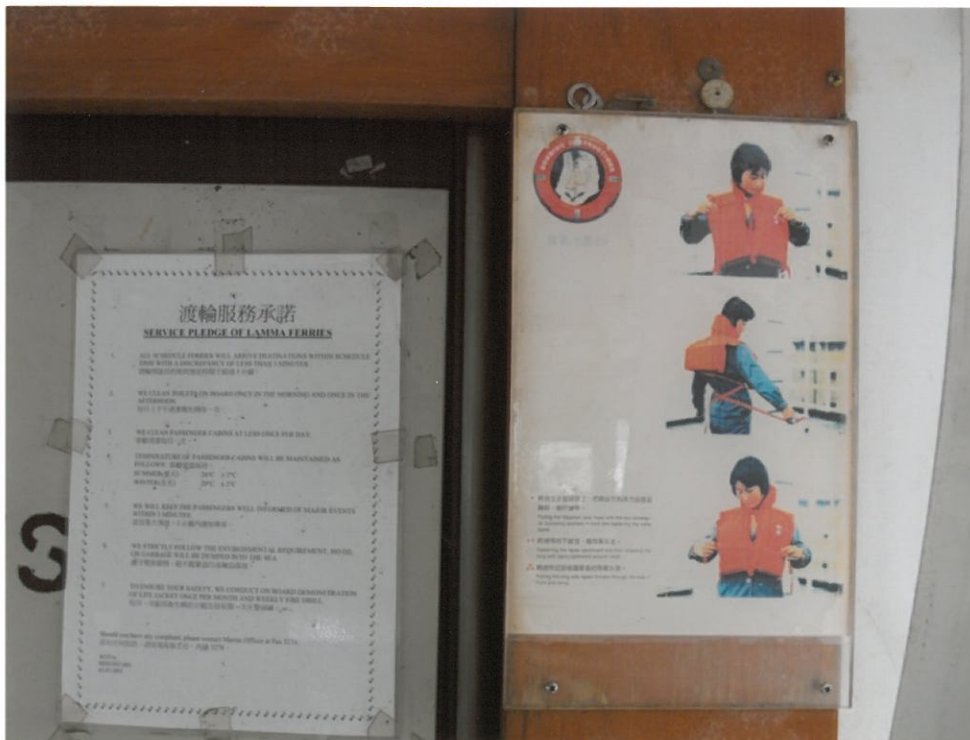
- 3.8.4. Only one type of life jackets was found in Lamma IV, which was the one shown on safety instruction notices for donning a life jacket. A total of three notices of donning instructions (see Photo 32), showing how to don a life jacket, were found inside the

Photo 32: The donning instruction sheet in the cabin of Lamma IV

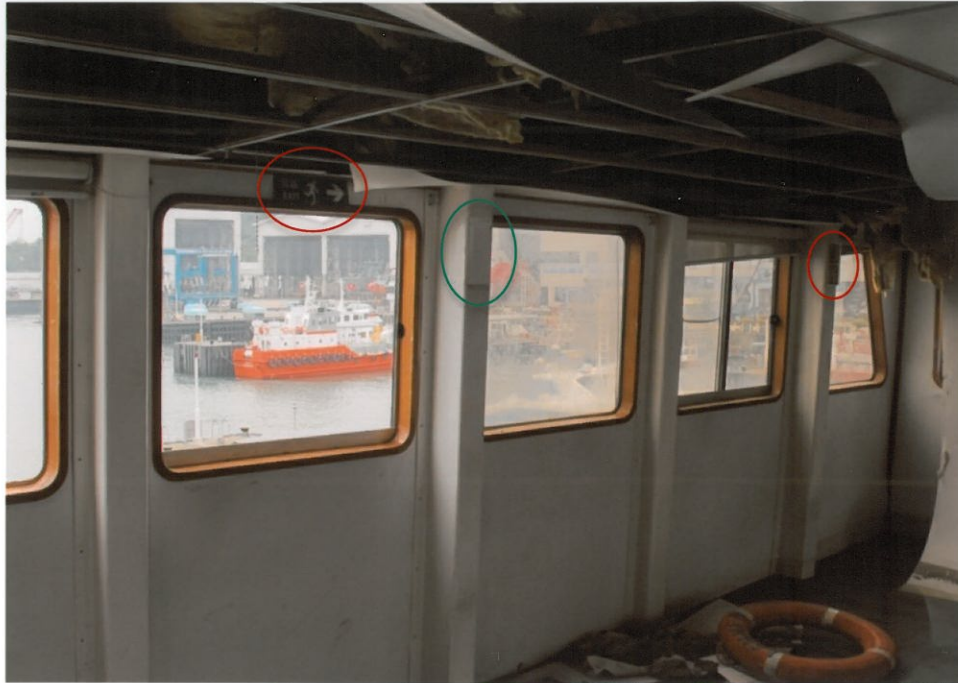
3.8.5. At least 6 and 4 exit signs (see Photo 33), denoting the location of the nearest emergency exit, were found in the main-deck cabin and the upper-deck cabin respectively. In addition, imprints, agreeing in size with the exit signs, were noted in the two passenger cabins, which suggests that some exit signs might have been posted on these positions but were detached.

Photo 33: The exit signs (red circled) in the upper-deck cabin of Lamma IV. An imprint agreed in size with an exit sign (green circled).

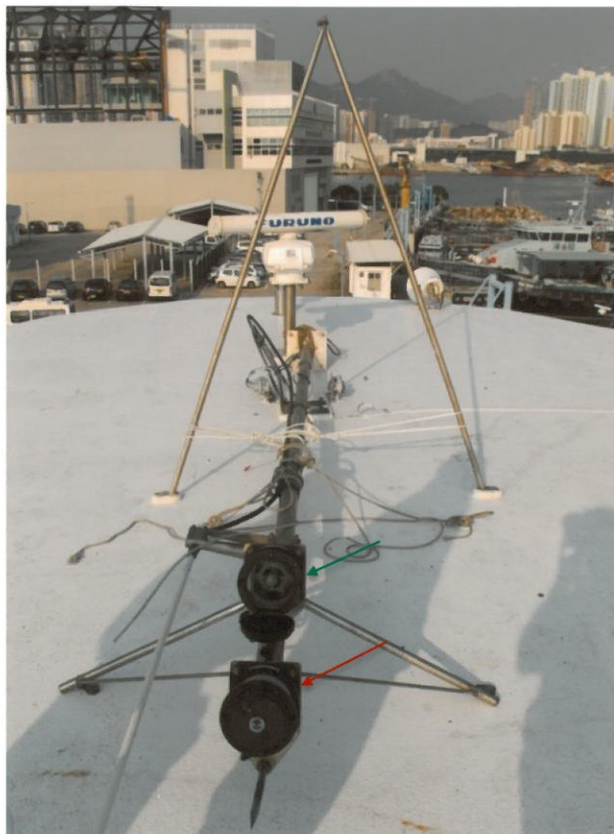
3.9.1. Lamma IV had a pair of sidelights installed on the roof of the upper deck; the sidelight on the starboard side was green and that on the port side was red. The mast on the roof was found detached from its anchorage point. The mast had an all-round navigation light<sup>11</sup> and a masthead light<sup>12</sup> (see Photo 34).

3.9.3. The housing of the masthead light was wet and its light bulb was found snapped. The housing of the all-round navigation light was found jammed and the light bulb inside could not be examined further.

- 4.9.2. No damage to the light bulb (GPW 13414) from the all-round navigation light was found. The filament was intact and the light bulb was found to be functional. I could neither confirm nor disprove whether the filament of the light bulb was illuminated at the time of the accident.

Photo 34: The all-round navigation light (red arrow) and the masthead light (green arrow) on the mast
