# **ASSESSMENT OF THE ELECTRICAL ASPECTS OF LAMMA IV**

***Prof. S.L. Ho***

**DEPT. OF ELECTRICAL ENGINEERING  
HONG KONG POLYTECHNIC UNIVERSITY**

**6 March, 2013**

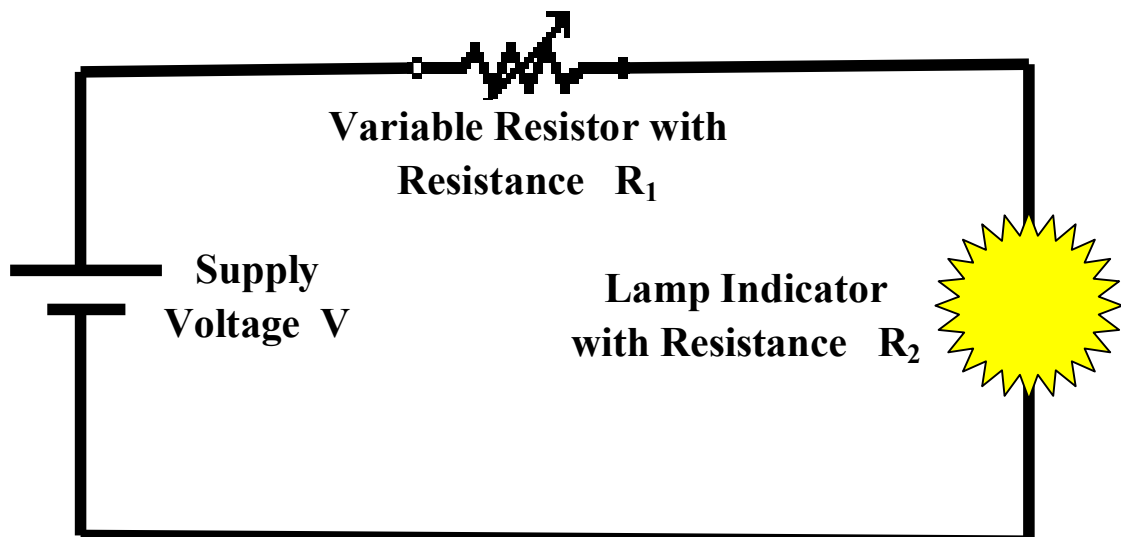
Fig. 1 Schematic circuit diagram of the Lamp Indicator

The Dial as shown in Photo 5 actually is a variable resistor which controls the current that flows into the Indicator Lamps. Basically, the supply circuit to the Indicator Lamp is as shown below:

Basically, the Supply Voltage (V) is 24 V for the Lamp Indicator circuit. The current that flows in the circuit is governed by Ohm's Law which states that

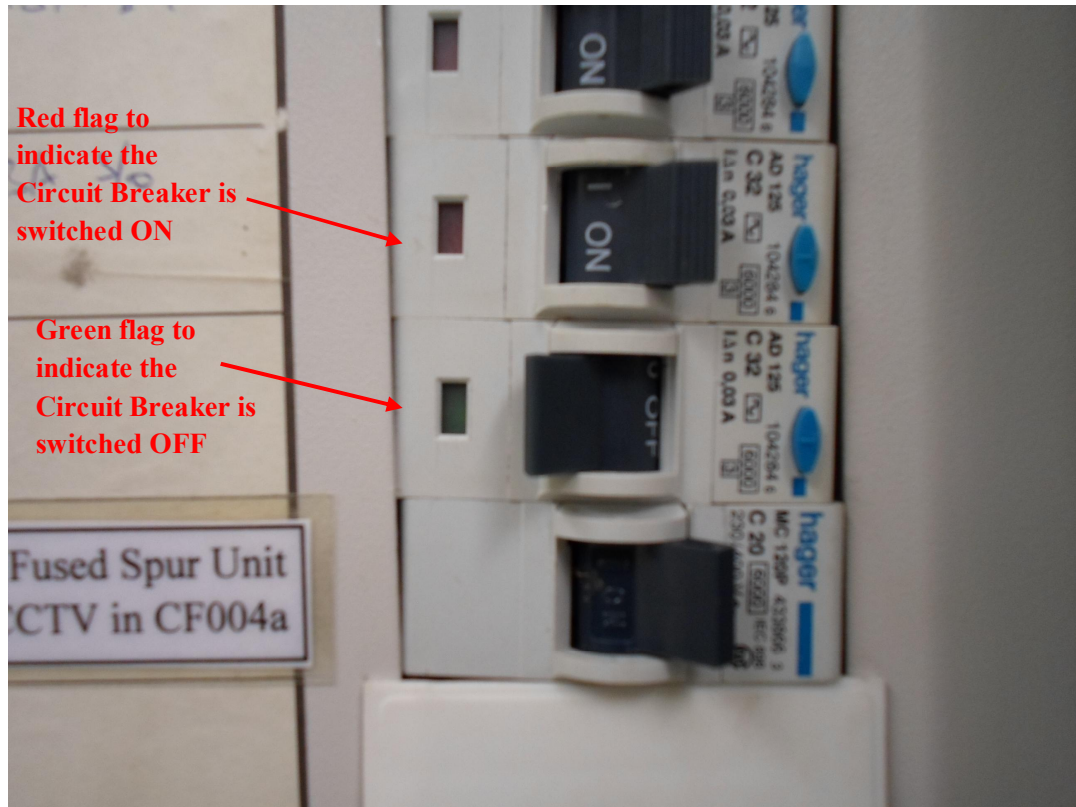
It is noted that there are red flags in Circuit Breakers No. 4, 5 and 7 (when counted from the left) in Photo 6. This is typical in Circuit Breakers indicating the status of the Circuit Breaker being in the ON state. An example from a Circuit Breaker being used at the University is as shown in Photo 9.

Photo 9 Flags are sometimes used to indicate the status of the Circuit Breakers

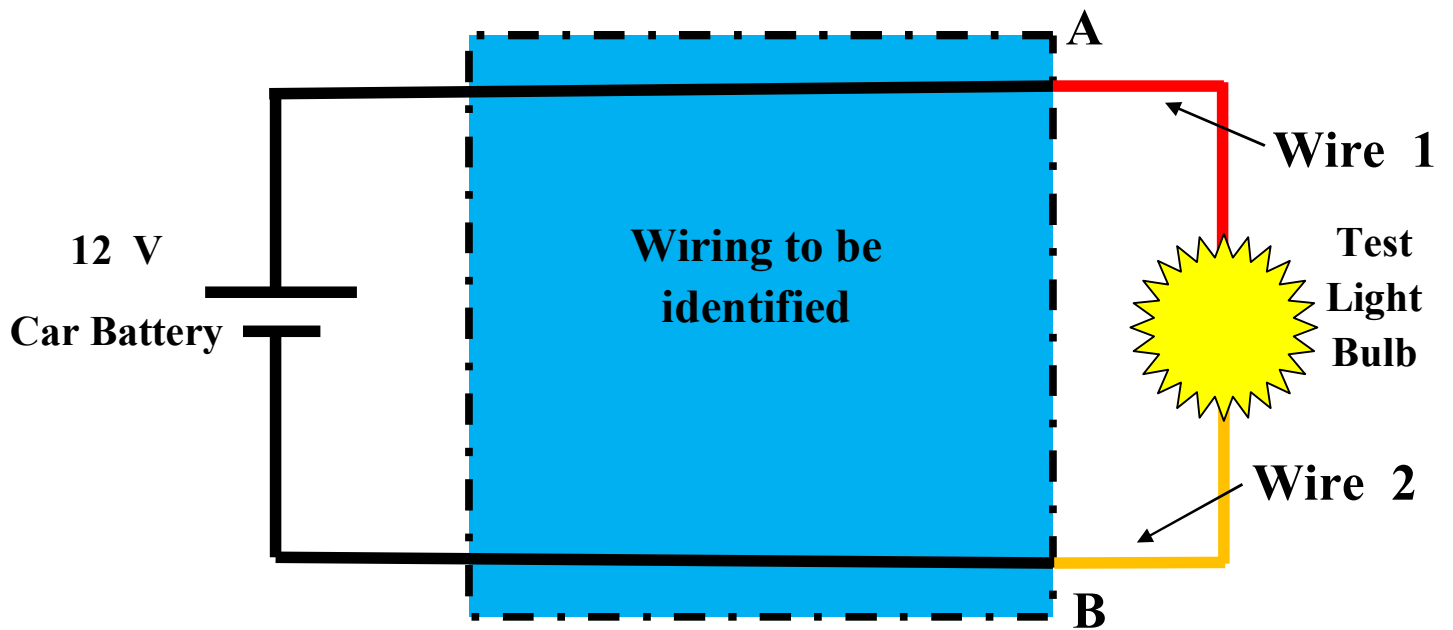
Fig. 2 Schematic circuit diagram of the Test Circuit to find the identity of the wires

- 7) In order to confirm the circuit, a further inspection of Lamma IV took place on 4<sup>th</sup> March 2013 with the assistance of 5 marine police officers. A simple test was carried out to identify the wiring of the circuits as shown in Fig. 2. In essence, if Circuit 3 in Photo 10 was marked as the circuit for the Starboard Light, then Wire 1 will be connected to point A as shown in Fig. 2. Similarly Wire 2 will be connected to location B. A 12 V battery was then connected to the wires at the Distribution Board as shown in Photo 11. If the markings on the wires are correct, then the Test Light Bulb would be lit up.

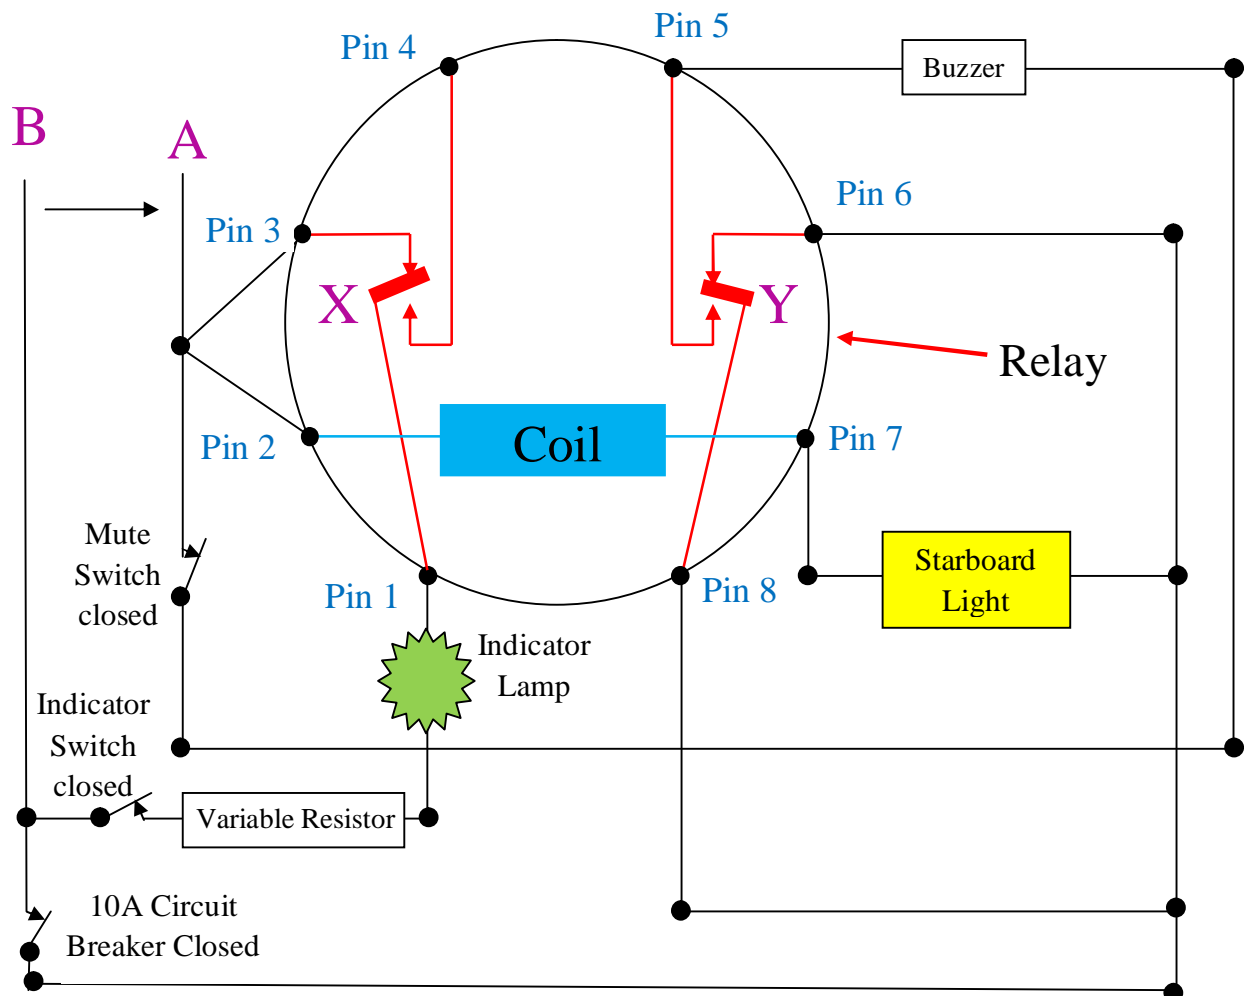
Fig. 3 The 10 A circuit breaker as shown in Photo 2 closes. Current flows from location A into the path comprising Pin 2, the Coil, Startboard Light via the closed 10 A Circuit Breaker to return to the power supply at B. As current flows through the Coil, the relay contacts at X and Y are as shown in Fig. 3. Electric current also flows from location A into another path comprising Pin 3, the Indicator Lamp, the Variable resistor and then back to the power supply at B. There is no current through the Buzzer as the circuit is broken at contact Y. Note here that if the Starboard Light Bulb had been short-circuited, then very high current would flow through the Coil inside the Relay.

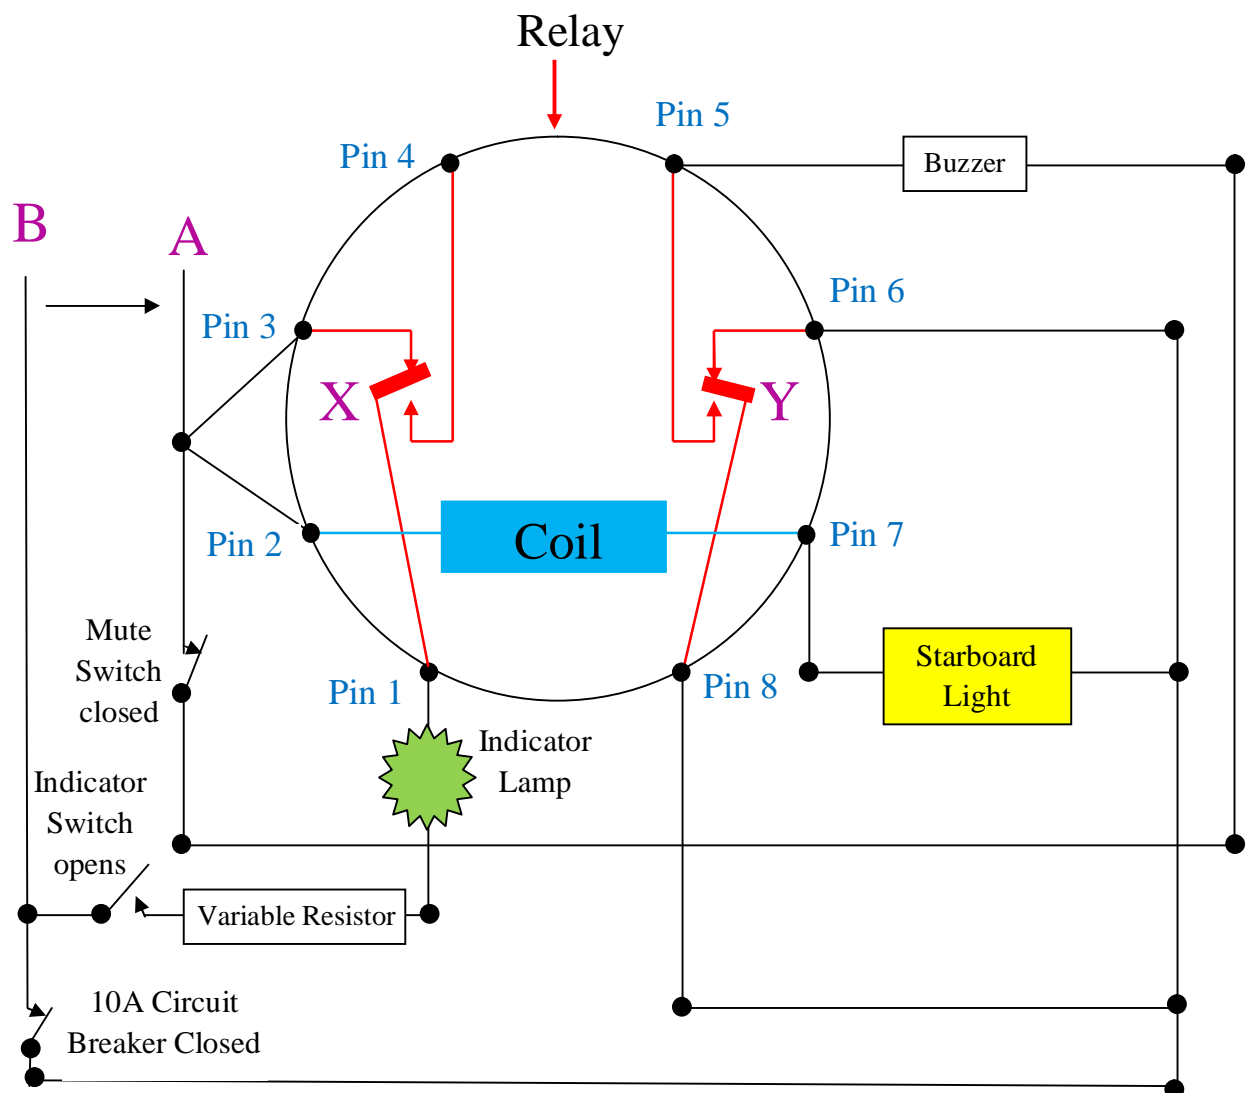
Fig. 4 The 10 A circuit breaker as shown in Photo 2 closes. Current flows from location A into the path comprising Pin 2, the Coil, Startboard Light via the closed 10 A Circuit Breaker to return to the power supply at B. As current flows through the Coil, the relay contacts at X and Y are as shown in Fig. 4. Electric current however cannot flow from location A into another path comprising Pin 3, the Indicator Lamp and the Variable Resistor because the Indicator Switch is opened. There is no current through the Buzzer as the circuit is broken at contact Y.

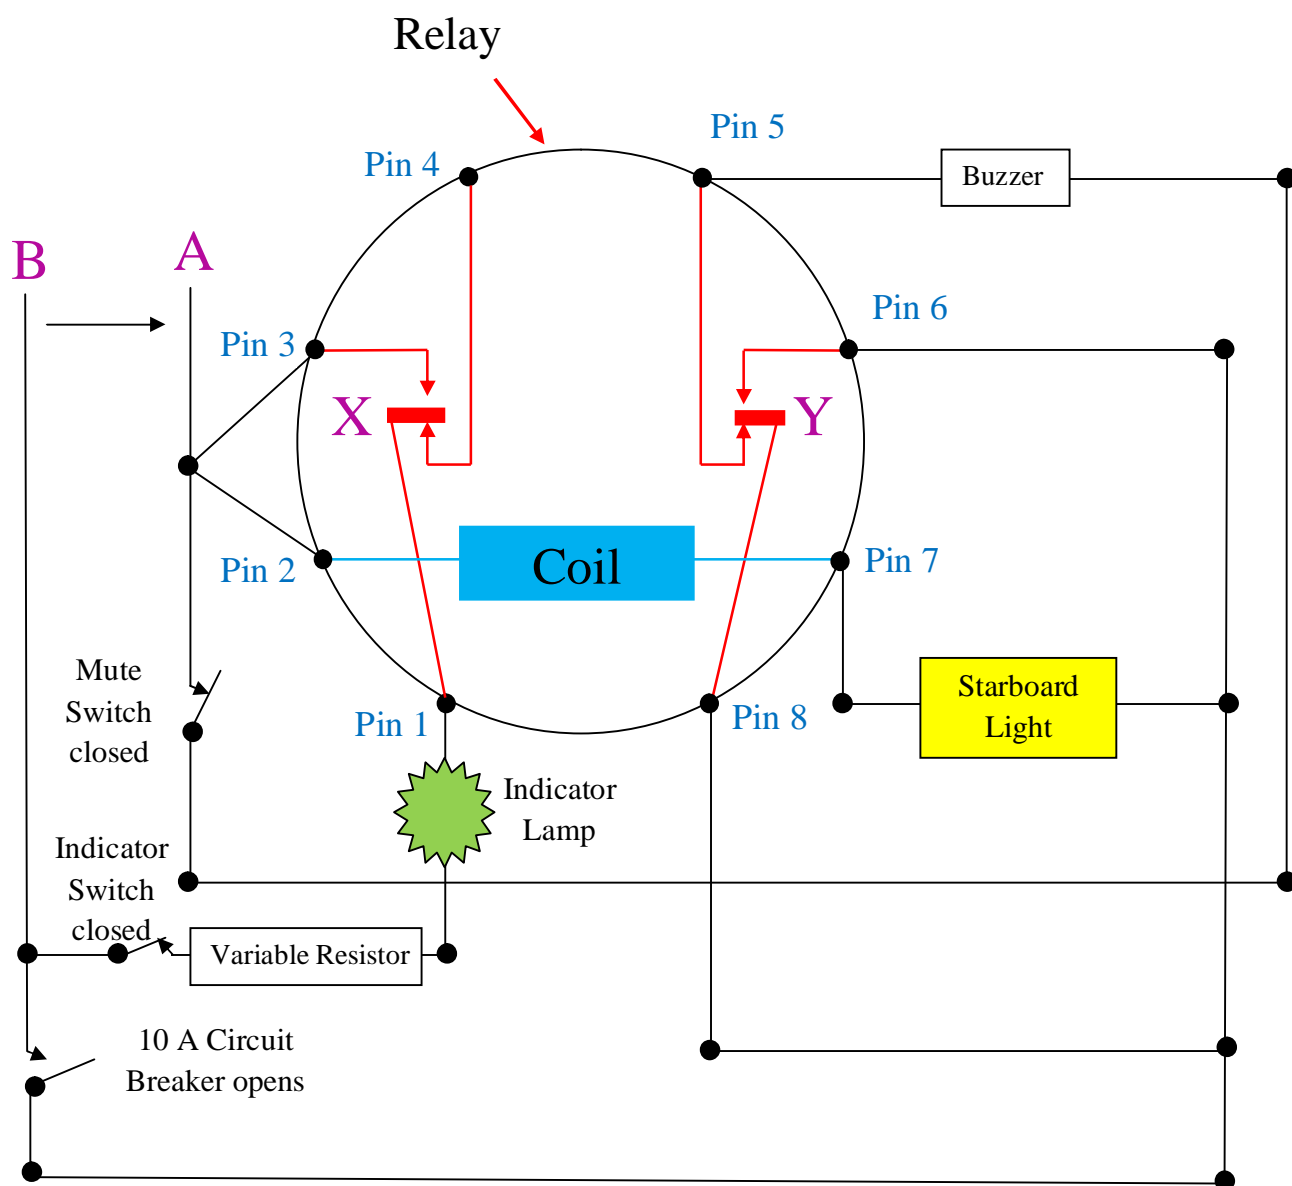
Fig. 5 The 10 A Circuit Breaker as shown in Photo 2 opens. Current cannot flow from location A into the path comprising Pin 2, the Coil, Startboard Light as the 10 A Circuit Breaker is open circuited. As no current flows through the Coil, the relay contacts at X and Y are as shown in Fig. 5. Electric current also cannot flow from location A into another path comprising Pin 3 and the Indicator Lamp because the circuit is broken at the relay contact X. There is no current flowing through the Buzzer either.

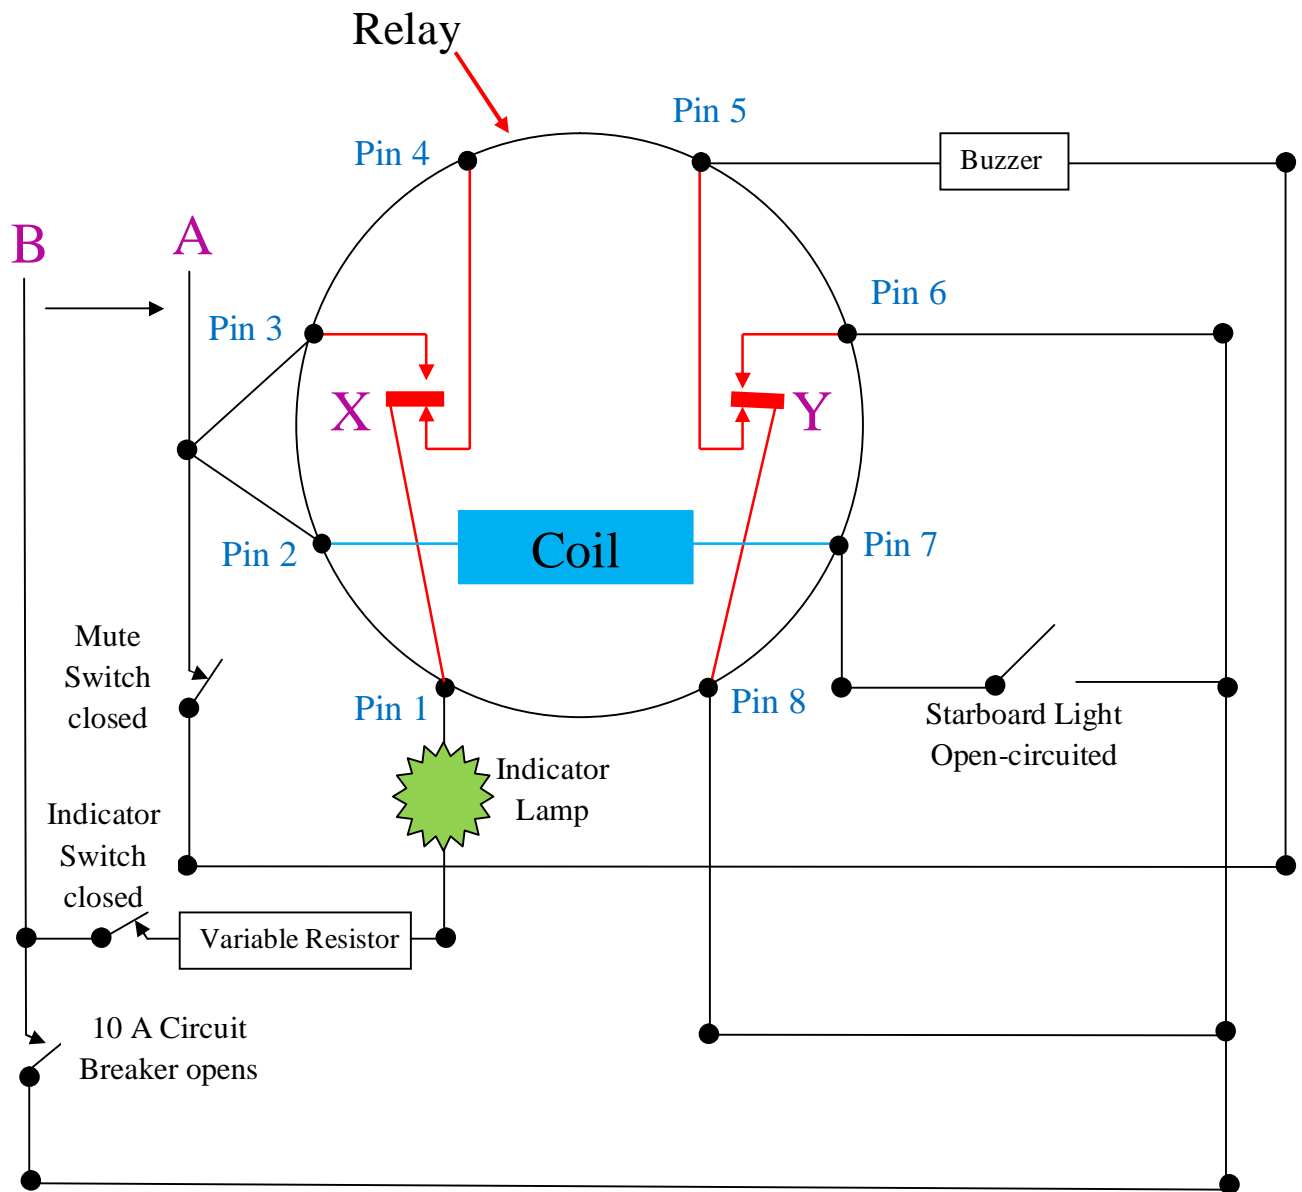
Fig. 6 The 10 A Circuit Breaker as shown in Photo 2 opens. The Starboard Light is also open-circuit due to a blown lamp bulb. Current cannot flow from location A into the path comprising Pin 2, the Coil, Startboard Light as both the 10 A Circuit Breaker and the Starboard Light Lamp Bulb are open circuited. As no current flows through the Coil, the relay contacts at X and Y are as shown in Fig. 6. Electric current also cannot flow from location A into another path comprising Pin 3 and the Indicator Lamp because the circuit is broken at the relay contact X. There is no current flowing through the Buzzer either.

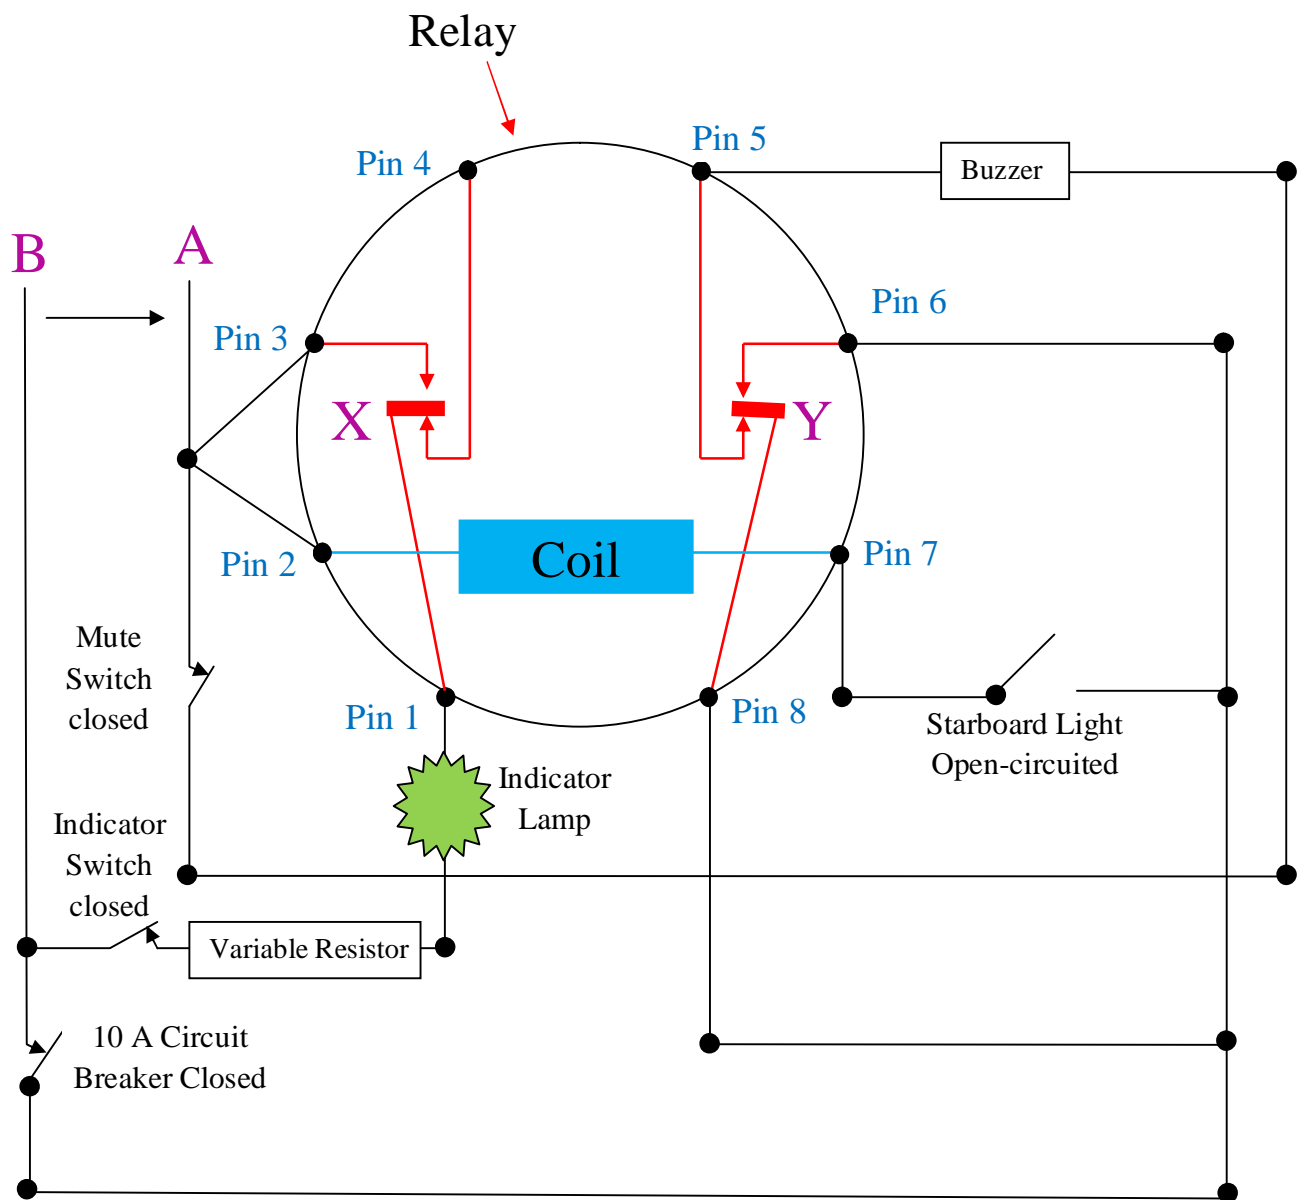
Fig. 7 The 10 A Circuit Breaker as shown in Photo 2 is closed. The Starboard Light is however open-circuit due to a blown lamp bulb. Current cannot flow from location A into the path comprising Pin 2, the Coil, Startboard Light as the Starboard Light Lamp Bulb is blown and becomes open circuited. As no current flows through the Coil, the relay contacts at X and Y are as shown in Fig. 7. Electric current also cannot flow from location A into another path comprising Pin 3 and the Indicator Lamp because the circuit is broken at the relay contact X. Current will however flow in a path comprising of A, the closed Mute Switch, the Buzzer, Relay contact Y, Pin 8 and then returns to B via the closed 10 A Circuit Breaker.
